U.S. Army Corps
of Engineers
Alaska District

ALASKA BASELINE EROSION ASSESSMENT

Erosion Information Paper – Point Hope, Alaska

Current as of March 10, 2008

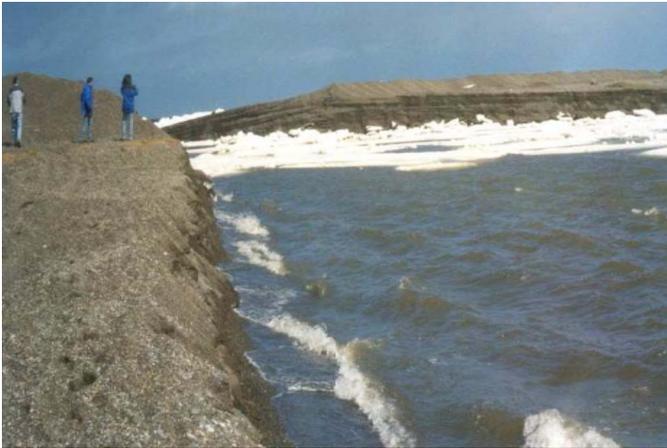
Ice jams during spring break up can raise inlet water levels considerably rising water level in caused by ice blockage. Ice blocking the natural outflow from Marryat Inlet in the spring of 2006 caused water to rise in the inlet, which breached a short section of 7-Mile Road and threatened to flood Point Hope. That event was declared a state disaster by the governor. The natural barrier that separates Marryat Inlet from the Chukchi Sea was intentionally breached to create a new outlet and lower flood waters. A 2006 Corps of Engineers *Trip Report* states the initial breach became enlarged by erosion from the outflow of Marryat Inlet. The breach channel was eroded to dimensions of approximately 300 feet long, 150 to 200 feet wide at the outlet, and 600 feet wide at the inlet.

Photo 1: A view of the breach from the Marryat Inlet entrance, 2006.

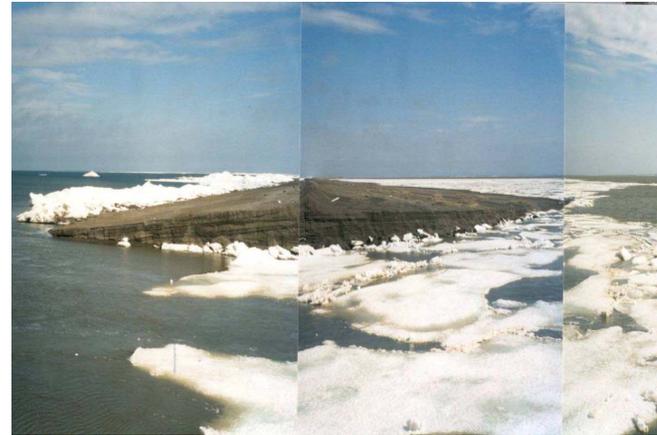
Photo 2: A panoramic view of the manmade breach looking east from the west bank of the breach, 2006.

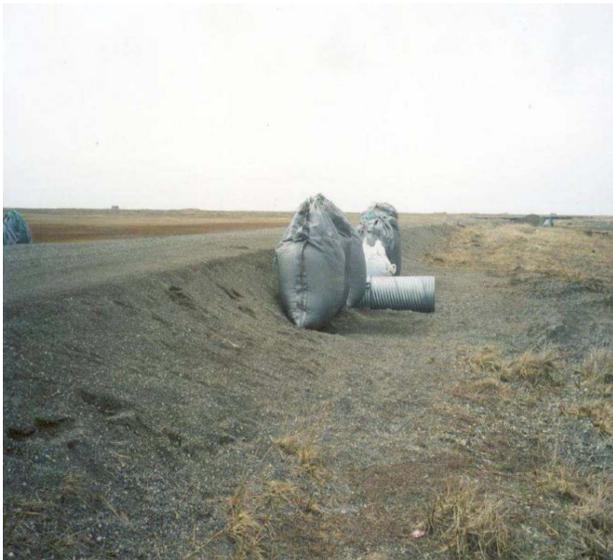
7-Mile Road, along the southern shore of the lagoon, is the access road to community's waterline and pump and is the only road off the peninsula. It has been occasionally covered by 2 to 3 feet of water from Marryat Inlet, which is fed by the Kukpuk River and is occasionally eroded.

Photo 3: Material washed out of the roadbed by rising waters of Marryat Inlet, 2006.

The NSB plans to raise "7-Mile Road" about 5 feet. The Corps 2002 *Trip Report* indicated that large sand bags and tubes placed along the section of the road threatened by erosion appear to be working. The cost of opening and later repairing the intentional Marryat Inlet breach was estimated in a Corps 2006 *Trip Report* at nearly \$433,000. The breach repair was accomplished by the placement of poly bags – or "super sacks" (4.5 feet by 4.5 feet in size).

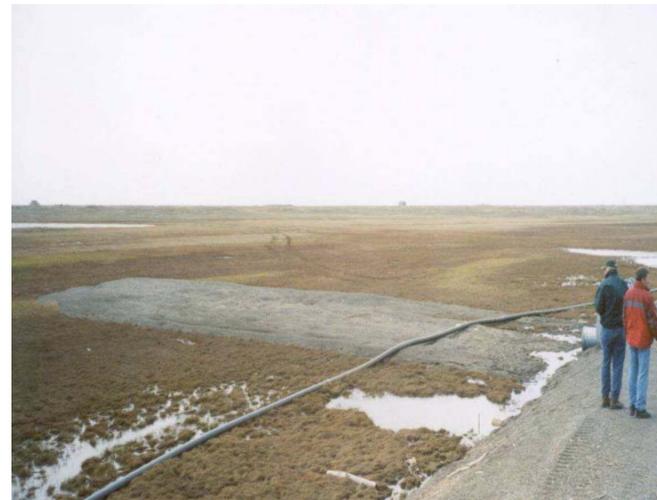
Photo 4: Road embankment at the point of the washout, 2006.

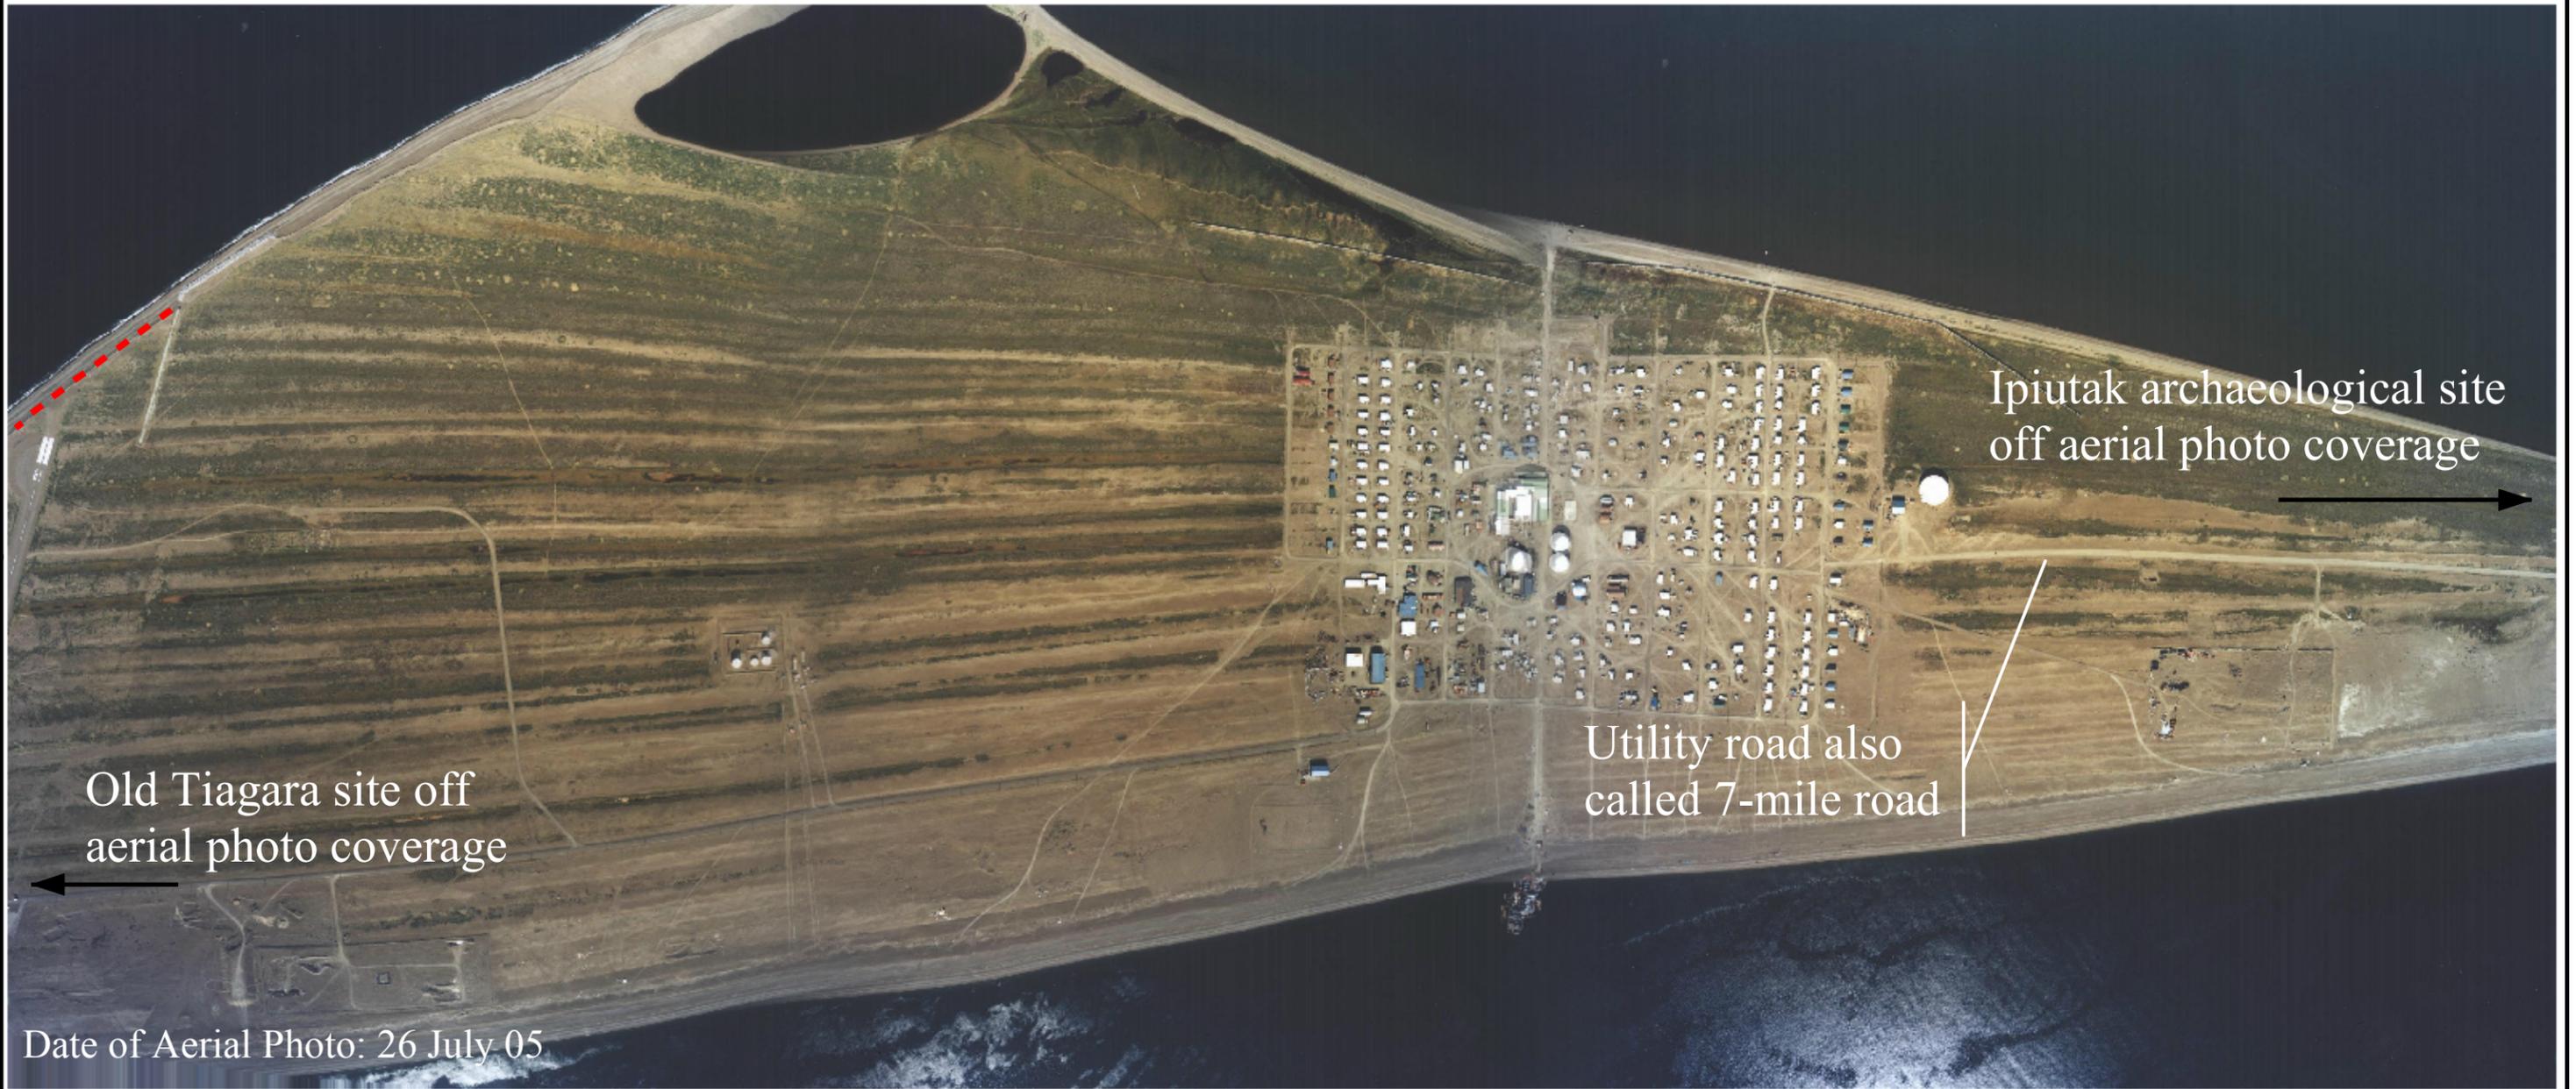
Attached photos are from the June 2006 *Trip Report*. The attached diagram shows the linear extent of erosion.

NOTE: The extent of erosion shown on this figure is based on interviews with the community. This data has not been field verified. This figure is only intended to show areas of erosion, not rates or severity of erosion
