U.S. Army Corps
of Engineers
Alaska District

ALASKA BASELINE EROSION ASSESSMENT

Erosion Information Paper – Port Graham, Alaska

Current as of August 28, 2007

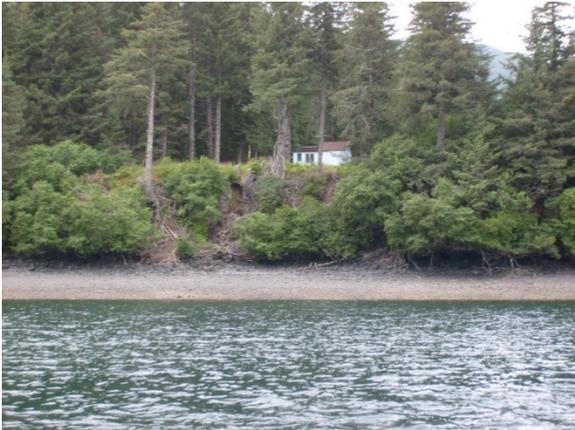
Photo 1: Bluff near Duncan Slough that is eroding. 2007

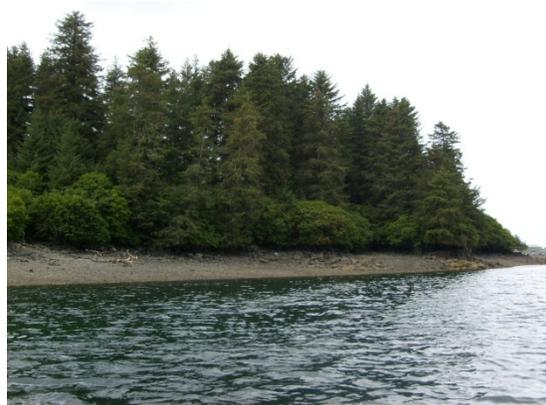
Photo 2: Cemetery Bluff. 2007

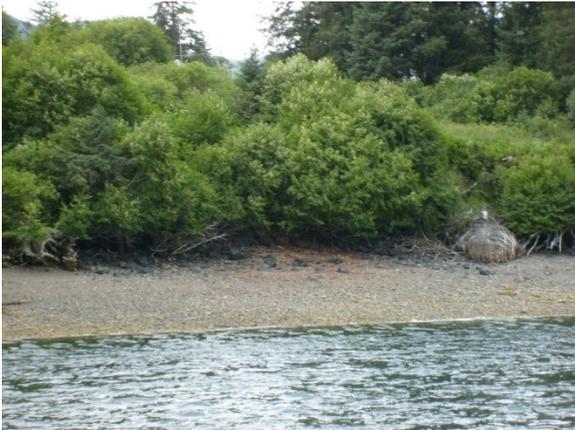
Photo 3: Heavy vegetation obscuring the view of coastal bank erosion. 2007

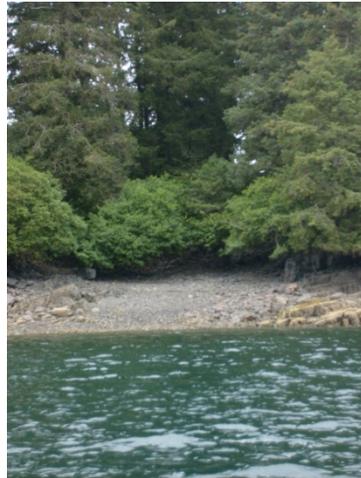
Photo 4: In the middle of photo is the closest erosion to the cemetery. 2007

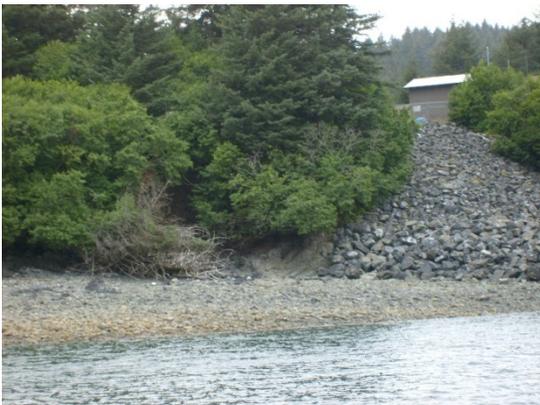
Erosion at the site of Port Graham's community school poses the most concern, but other sites along the Port Graham coastline are also vulnerable to continuing erosion. Those areas are as follows: (a) At both ends of the riprap placed at the base of the bluff below the Port Graham school some erosion is continuing and drainage runoff adds to the erosion of the bluff from the top side; (b) Part of the road that connects the community to the loading transfer facility (LTF) and provides access to the water reservoir is threatened. The community water line adjacent to the road also is threatened; (c) An area is eroding adjacent to the building referred to as the Fort Knox building, located near the fish processing plant; (d) The estimated 60-foot-high bluff below the community cemetery on the east side of the community has eroded to within 70 feet of the cemetery and threatens damage to it.; (e) The area below a residence on the east side of the community above an estimated 60-foot-high bluff is eroding. Erosion may be related to a sewer pipe that protruding from the bluff and is within 17 feet of a residence and 6 feet of the home's wastewater tank.

Photo 5: Riprap below Port Graham school gymnasium and erosion area. 2007

The borough received \$275,000 from the Federal Emergency Management Agency (FEMA) to address the immediate problem at the school. The Alaska Department of Community and Economic Development, Division of Municipal and Regional Assistance administered the grant funds. Riprap at the school and at the fish processing plant is reported to have been effective.

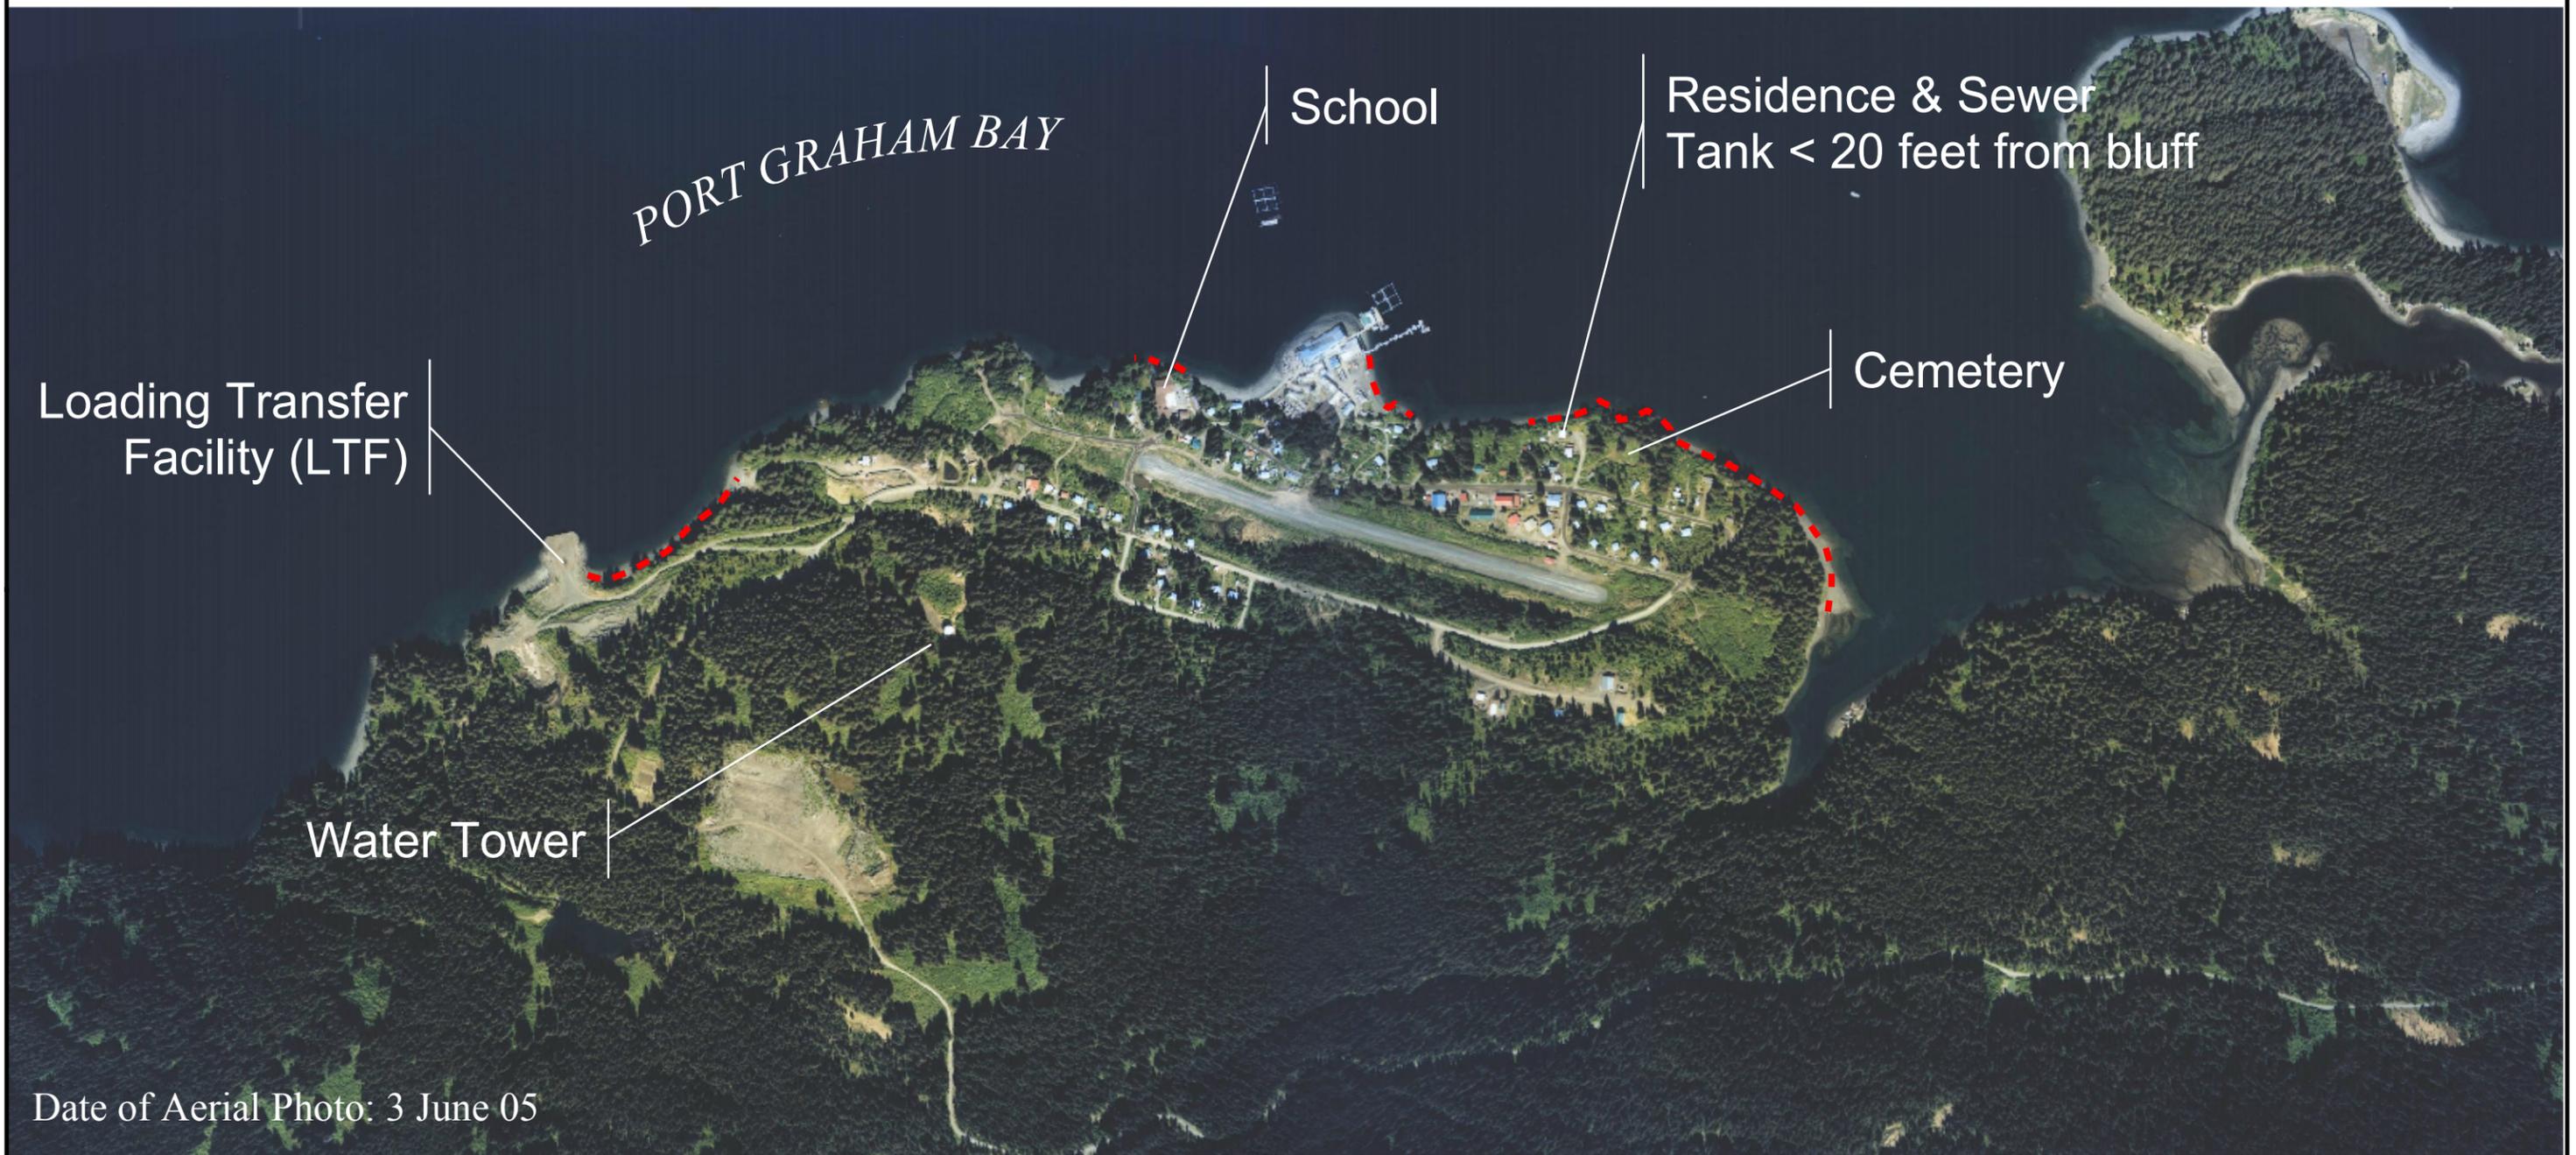
Photos of erosion provided by the Port Graham Village Council environmental officer are attached. Also, attached is a diagram depicting the linear extent of erosion in the community.
