U.S. Army Corps  
of Engineers  
Alaska District

## **ALASKA BASELINE EROSION ASSESSMENT**

### **Erosion Information Paper - Red Devil, Alaska**

Current as of April 2, 2008

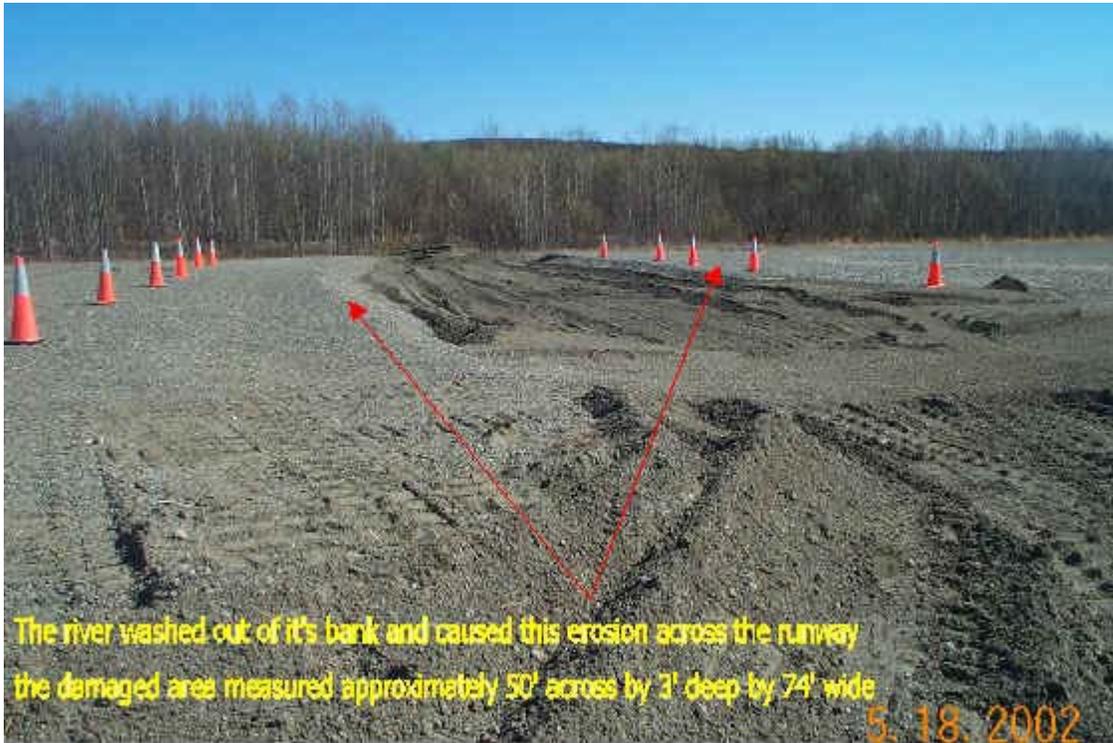
Photo 1: Red Devil airport erosion caused by 2002 ice jam flood. Area measures 50 feet across by 3 feet deep by 74 feet wide. Photo courtesy of DHSEM, 2002.

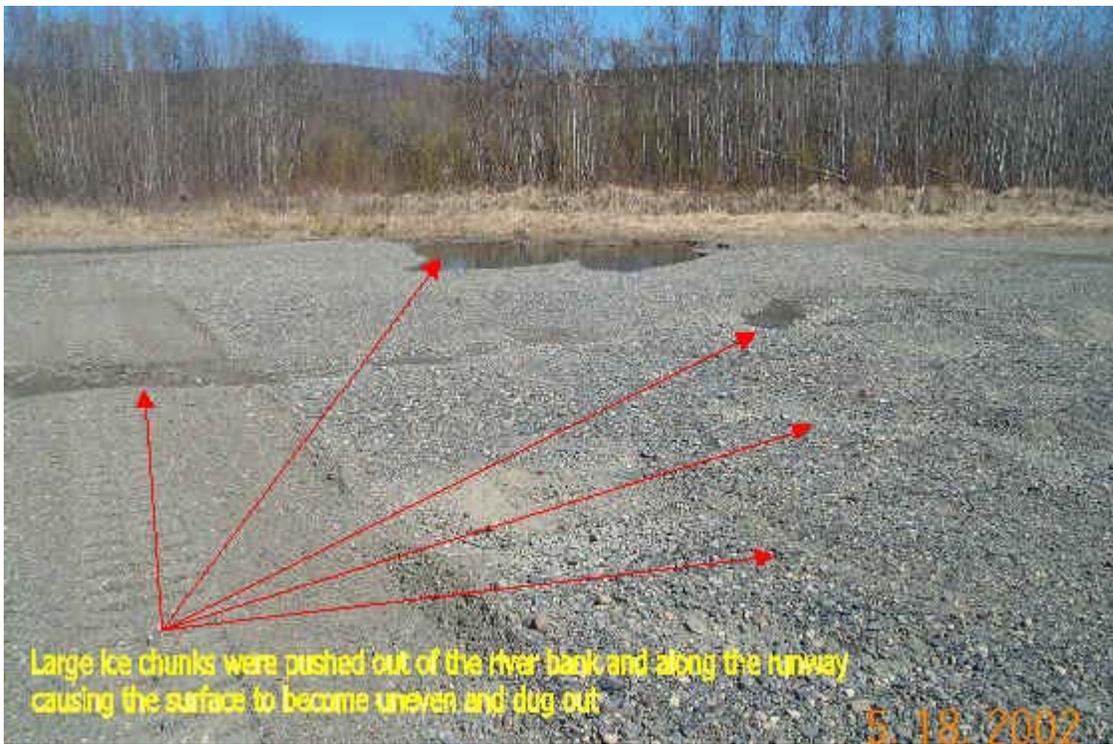
Photo 2: Ice pushed out of the Kuskokwim River caused erosion to the runway. Photo courtesy of DHSEM, 2002.

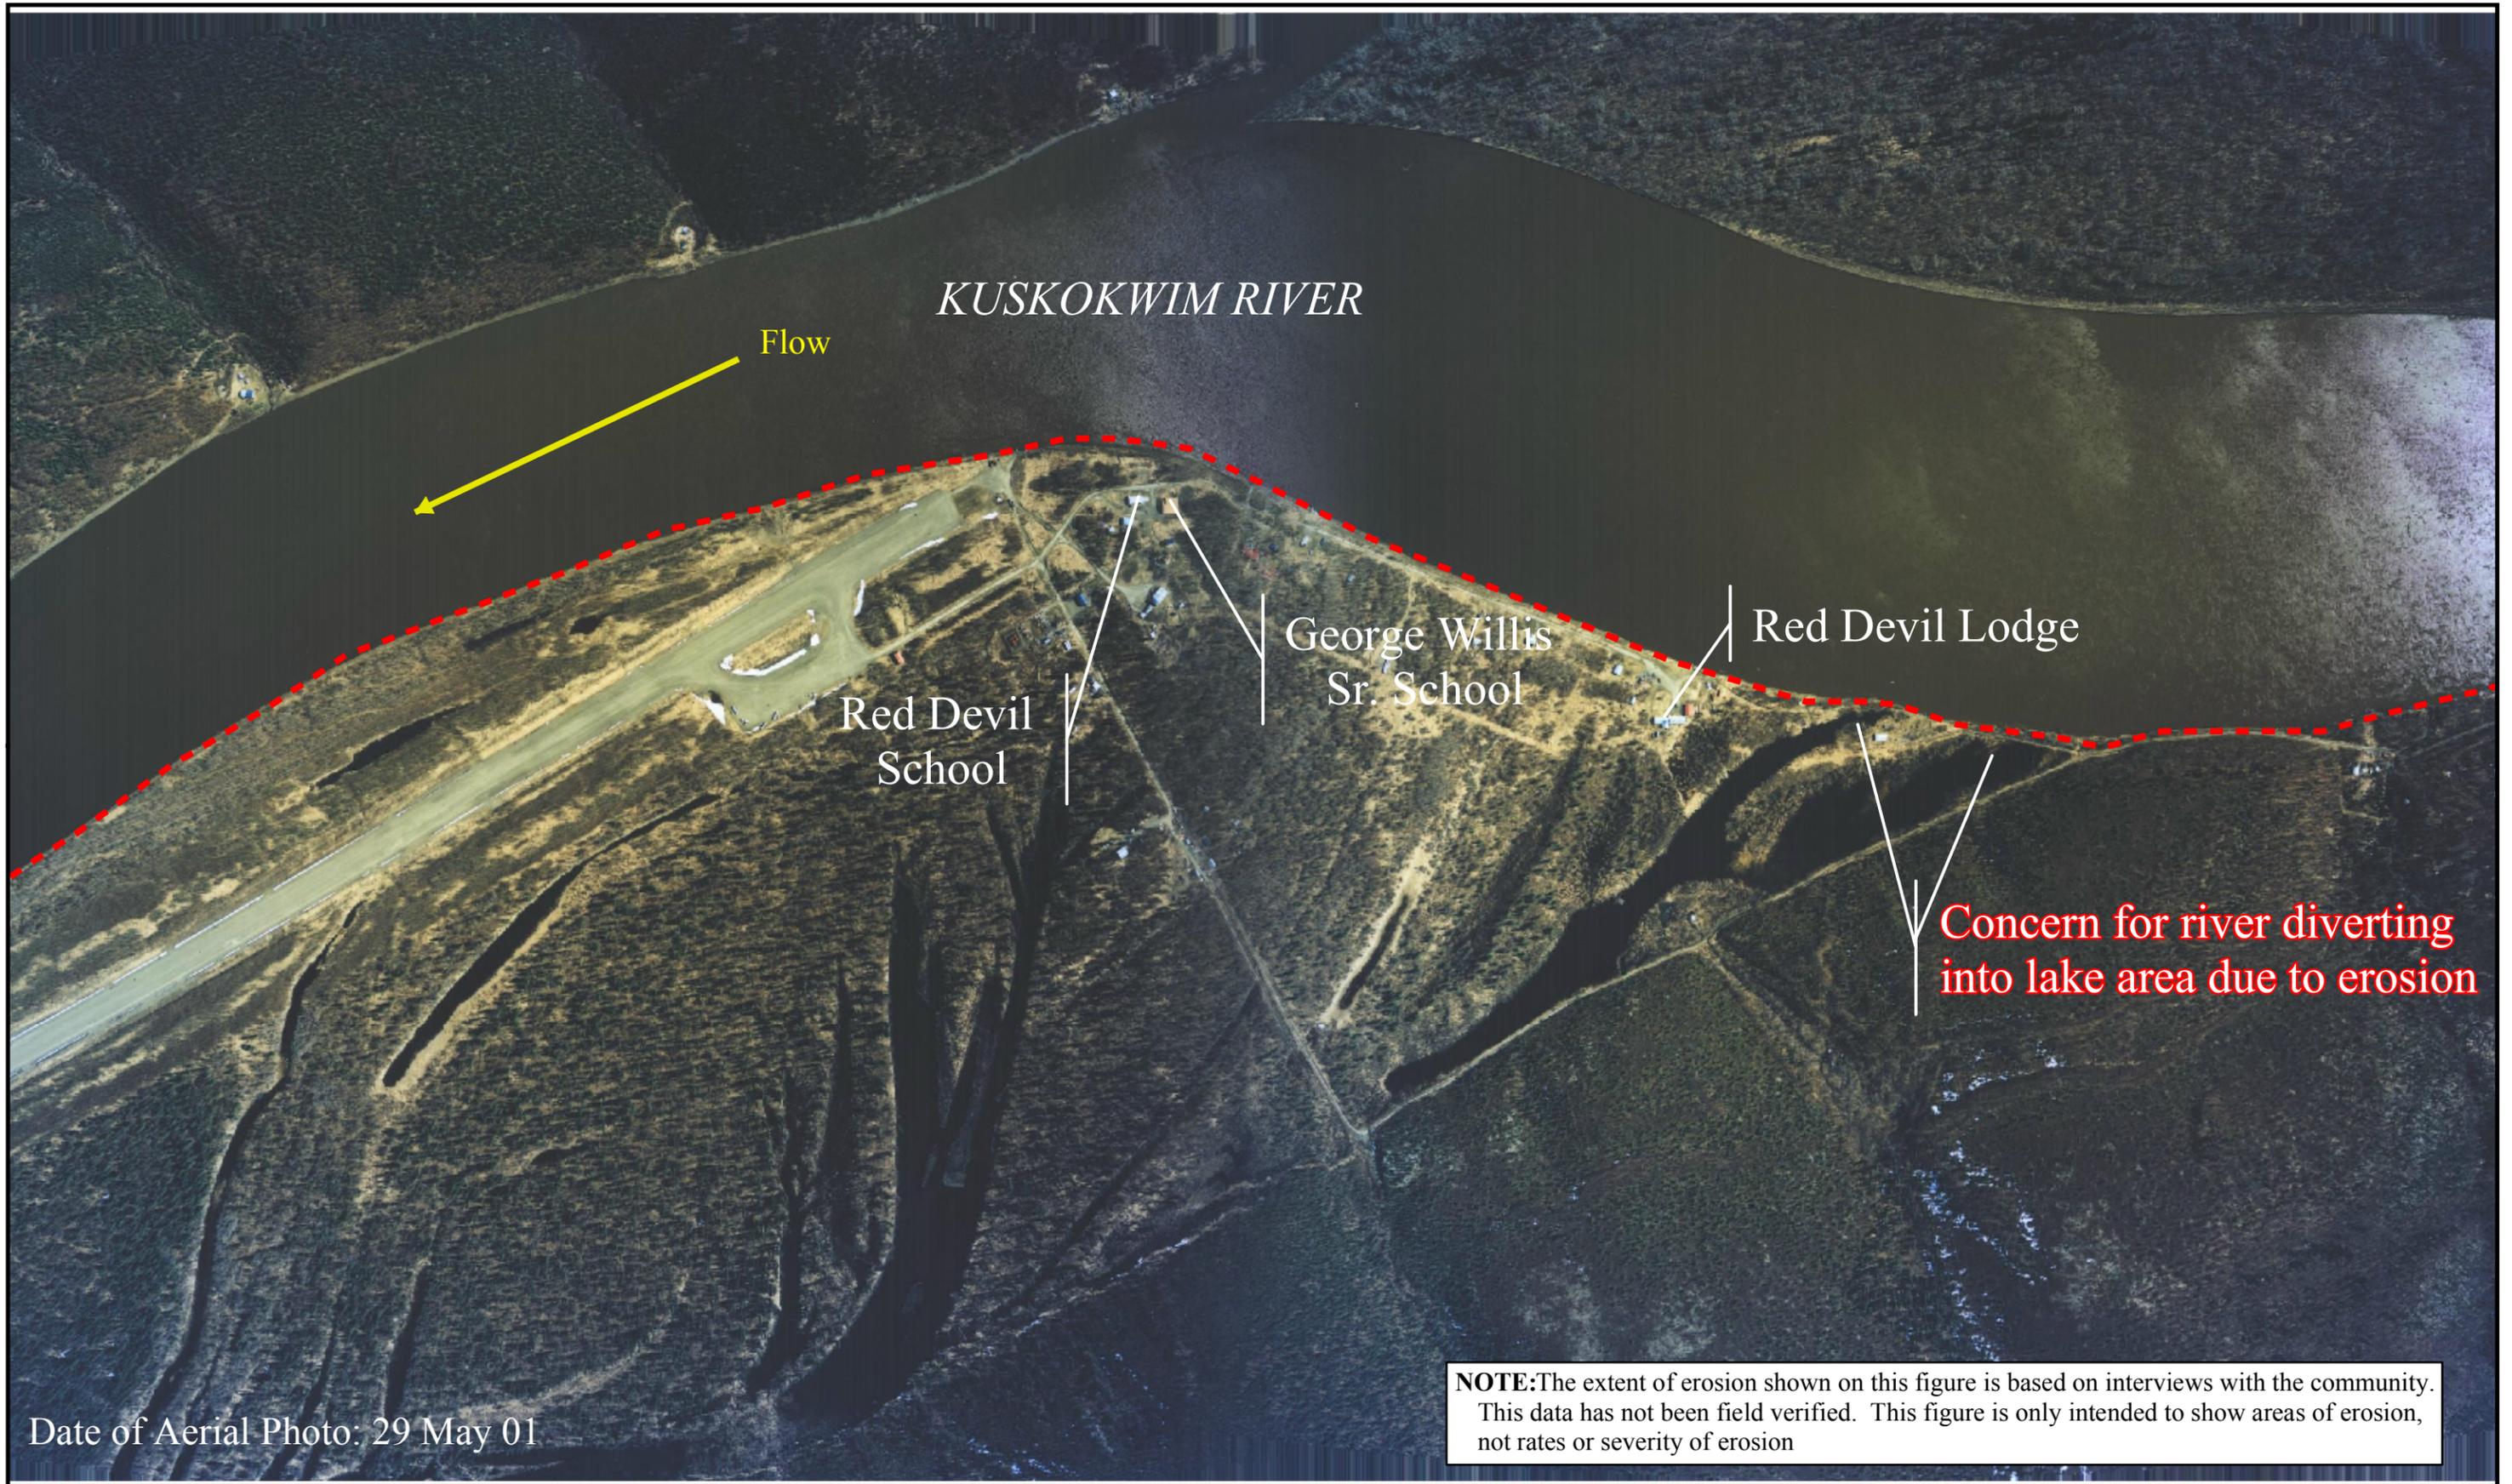
Alaska Baseline Erosion  
Red Devil, Alaska

----- Linear Extent of Erosion
