U.S. Army Corps  
of Engineers  
Alaska District

## **ALASKA BASELINE EROSION ASSESSMENT**

### **Erosion Information Paper - Salcha, Alaska**

Current as of January 9, 2008

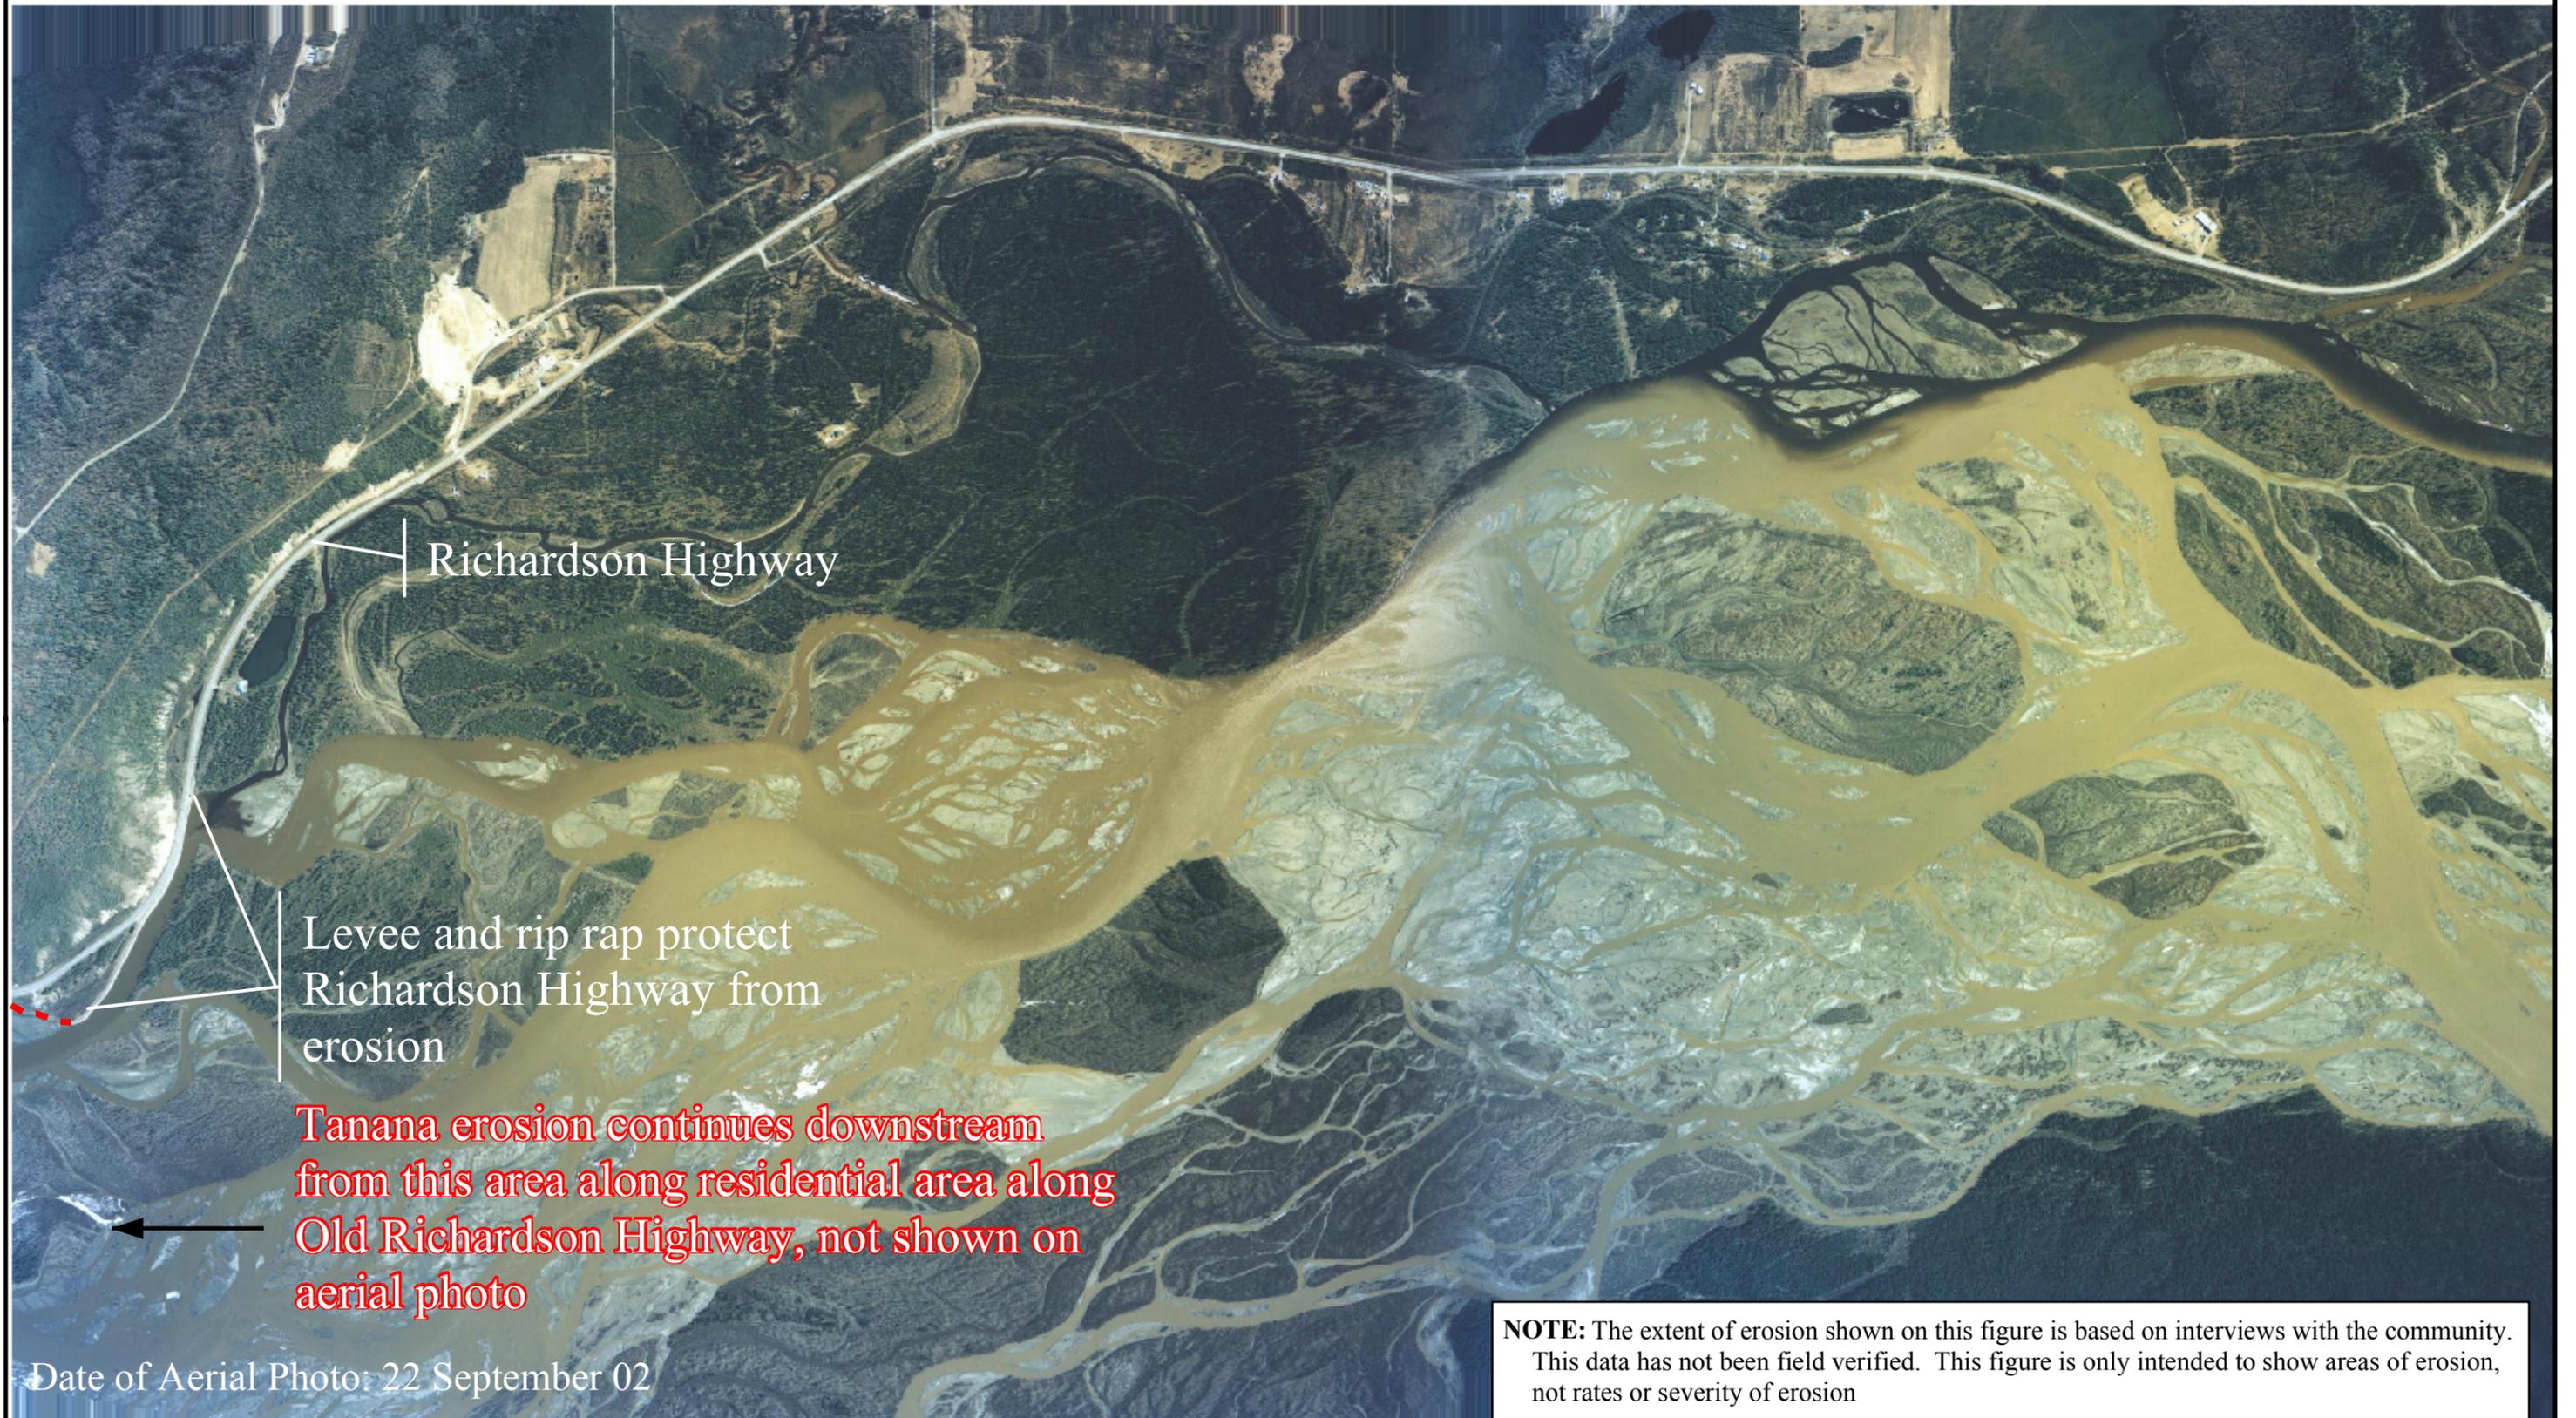
--- Linear Extent of Erosion  
Tanana Valley

No photos were provided by the community or other sources. The attached diagram depicts the linear extent of erosion in an area upstream from the focus area in this erosions information paper.
