ALASKA BASELINE EROSION ASSESSMENT

Erosion Information Paper - Savoonga, Alaska

Current as of November 2, 2007

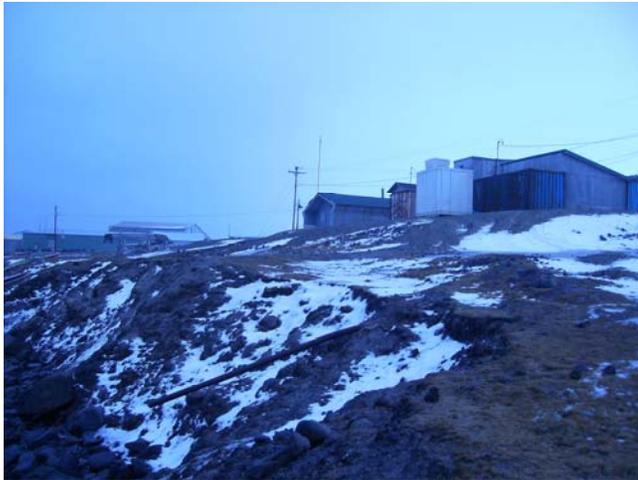
Photo 1: Savoonga Coastline, Nov. 2007.

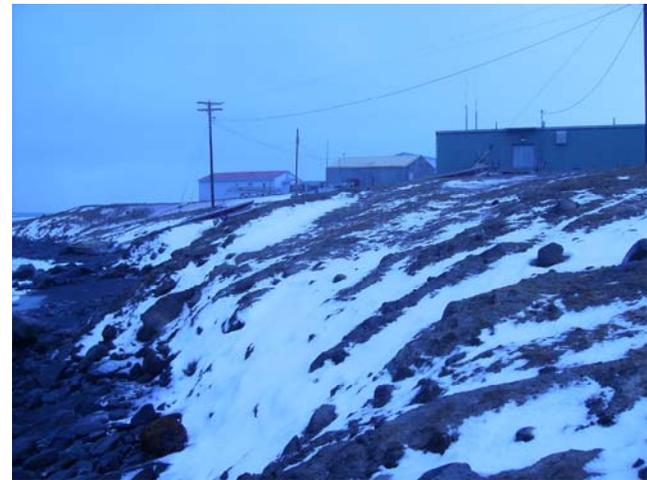
Photo 2: Ishnuk Bay is in front of Native Village store, Nov. 2007.

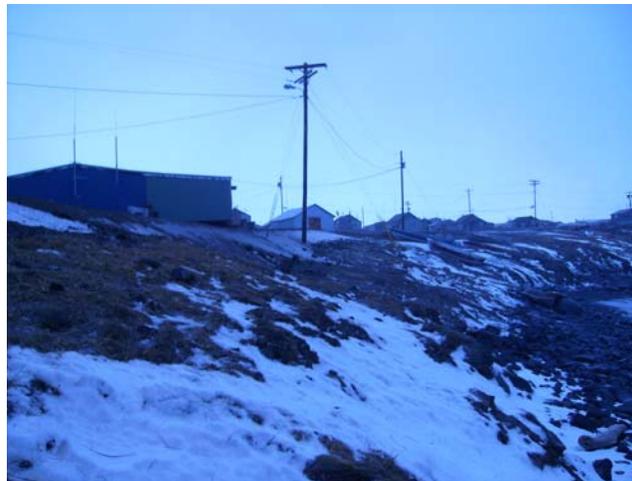
Erosion has been significant over the years, steadily washing away the bank of the shoreline. From 1972 to 2002, about 50 feet of bank eroded and was lost along Ishnuk Bay. Every fall and spring more soil is lost, and more rocks appear along the shoreline. This ongoing erosion has made the bank very steep (>45 degrees) and increasingly boulder-strewn, causing significant problems with boat launching and landing.

Photo 3: Savoonga's beach has eroded inland 50 ft in 30 years; also changed from pebble gravel to boulders, Nov. 2007

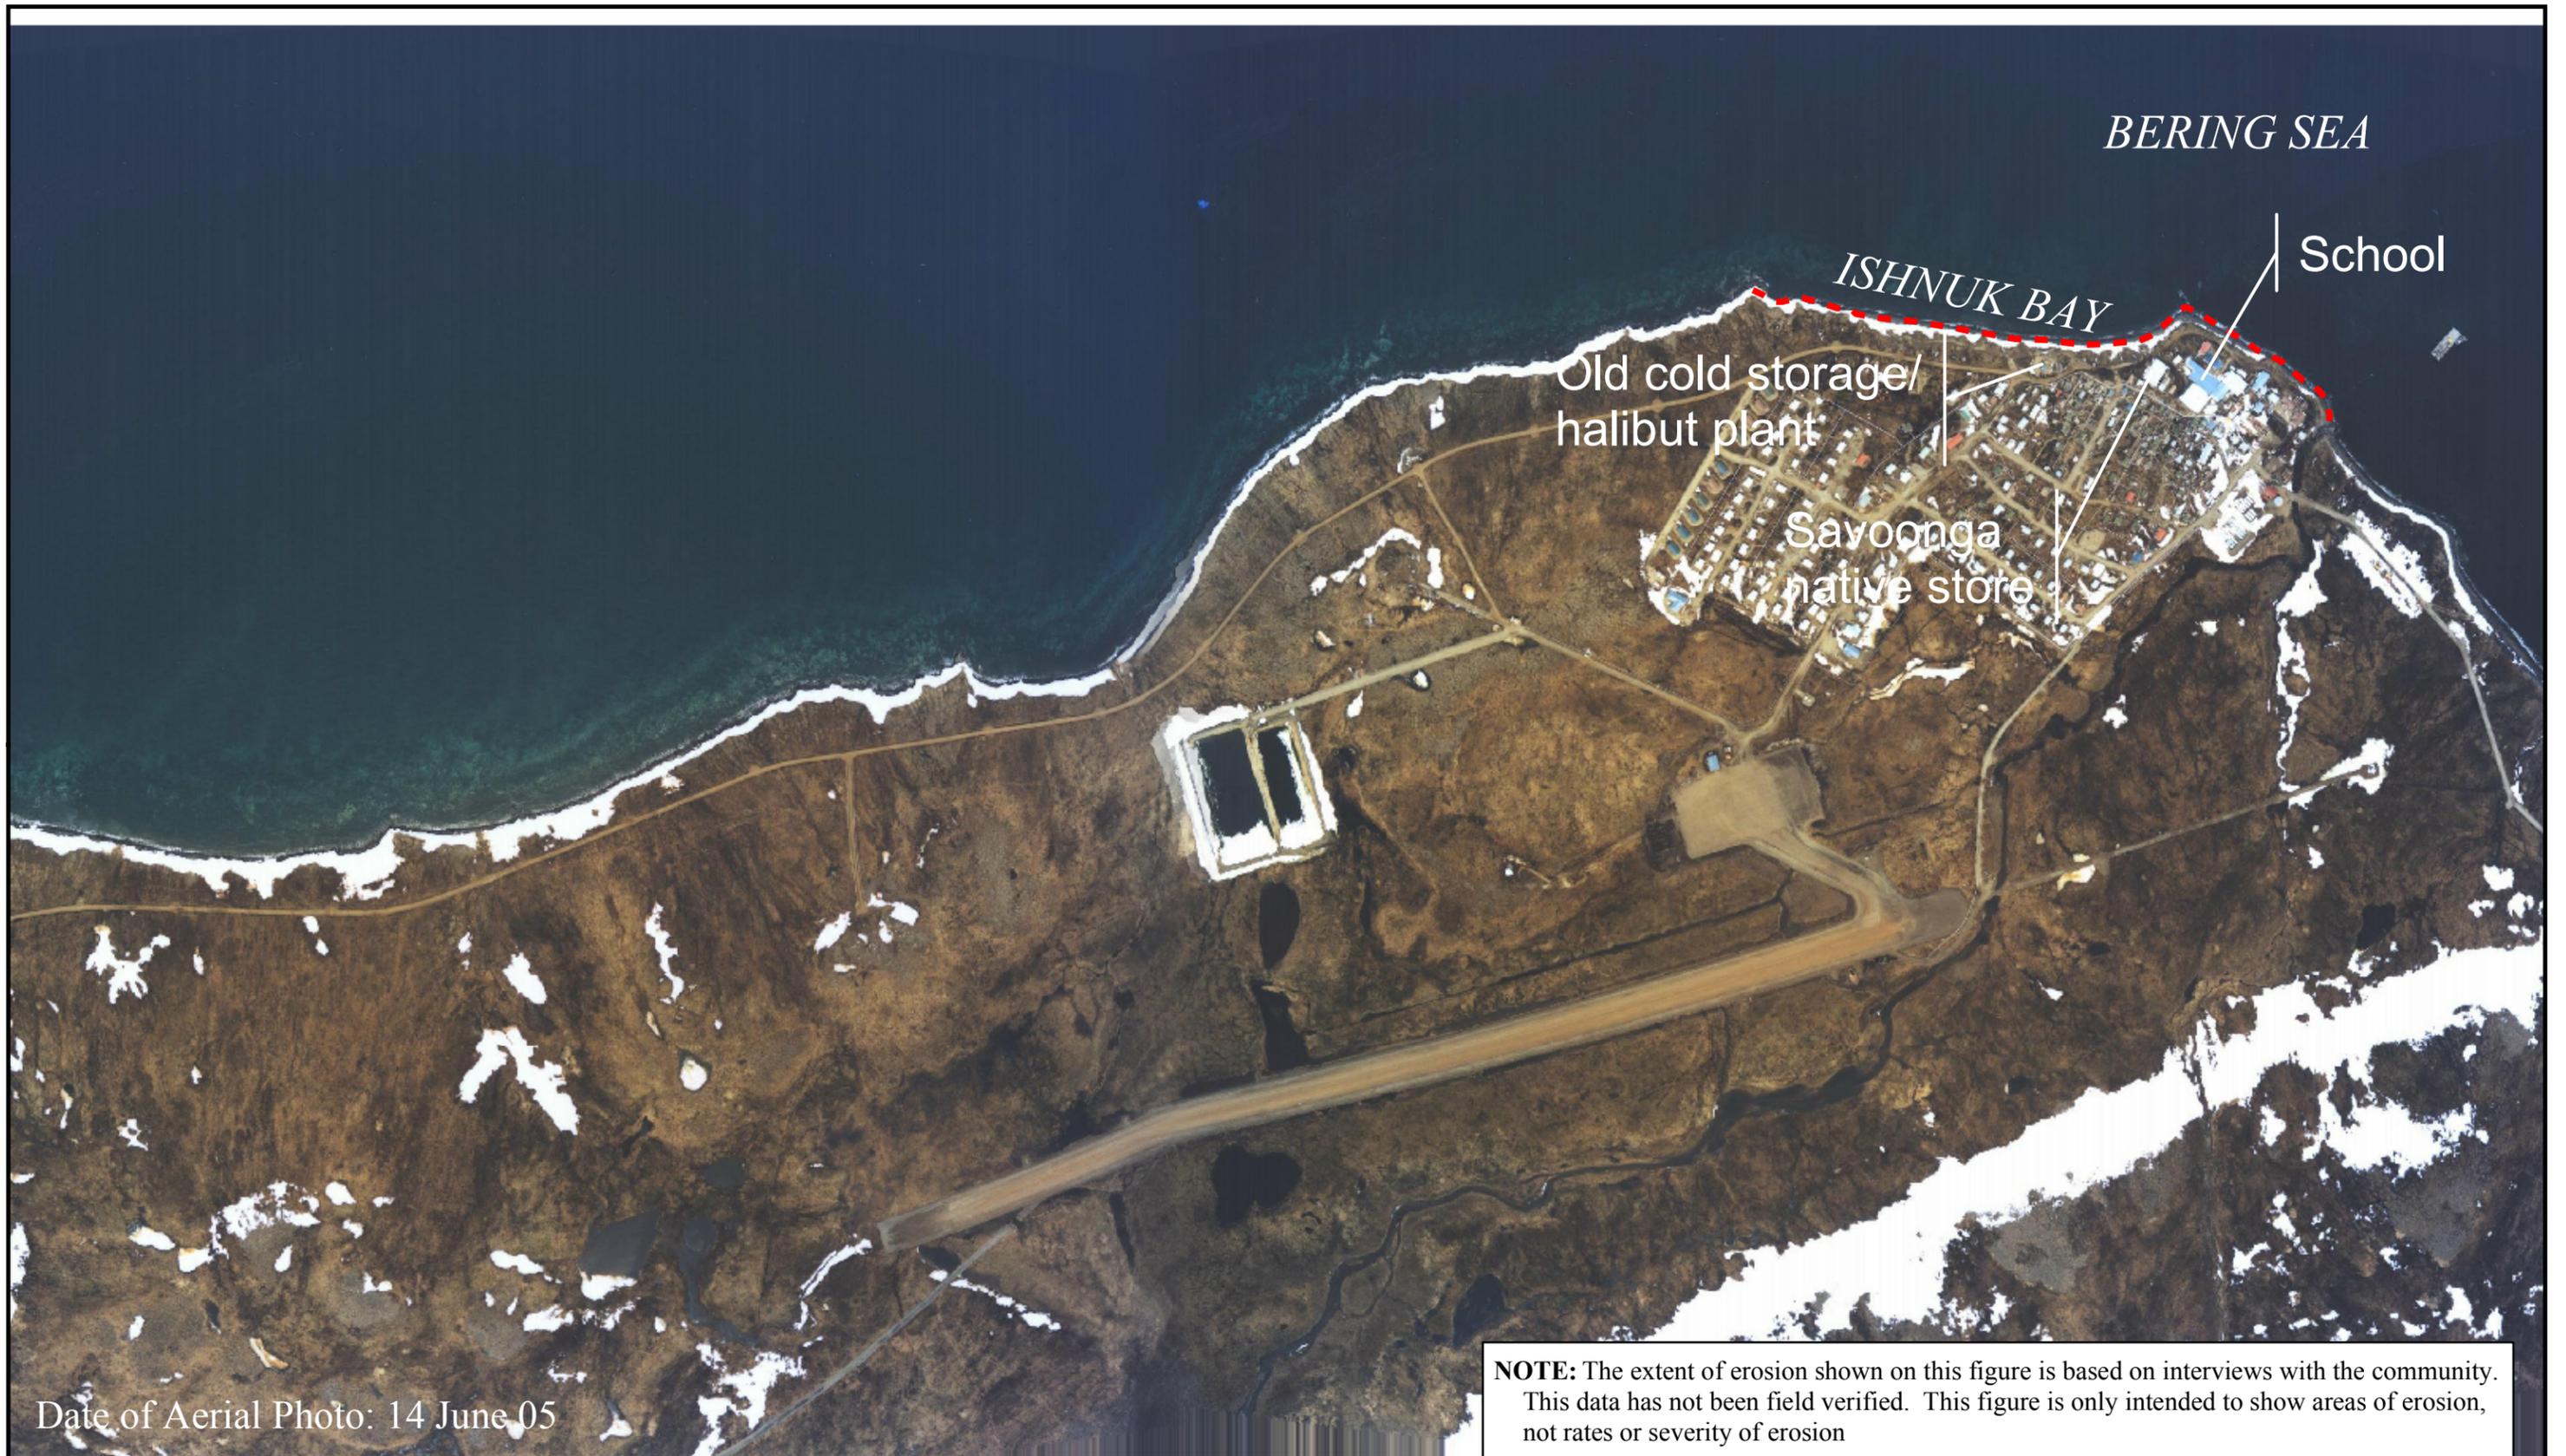
Alaska Baseline Erosion
Savoonga, Alaska

Savoonga reported coastal erosion from the Bering Sea. High tides, storm surges, wind, waves, melting permafrost, late-forming coastal ice, boat traffic, and vehicle and pedestrian traffic along the shoreline are reported causes and factors contributing to the erosion. The estimated erosion of the shoreline near the community is 1.7 to 2 feet per year. The erosion area is directly in front of the community and measures 80 feet horizontally and 30 to 35 feet vertically.

--- Linear Extent of Erosion
