U.S. Army Corps
of Engineers
Alaska District

ALASKA BASELINE EROSION ASSESSMENT

Erosion Information Paper - Seward, Alaska

Current as of July 17, 2008

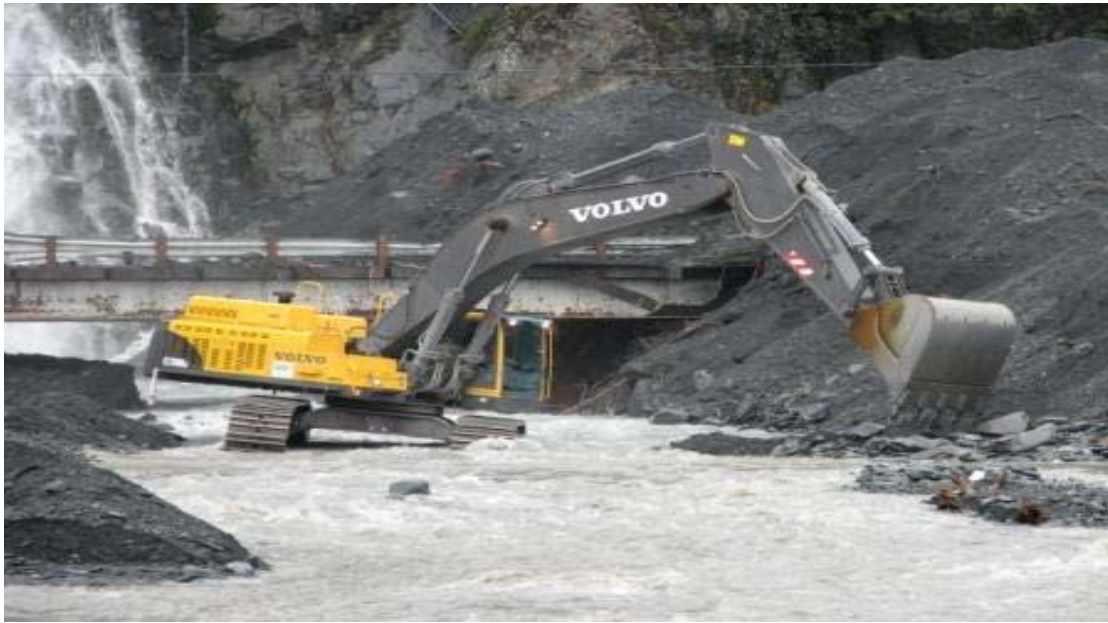
Photo 1: Lowell Creek tunnel outfall being cleared after the October 2006 flood buried the bridge blocking Lowell Point Road, October 2006.

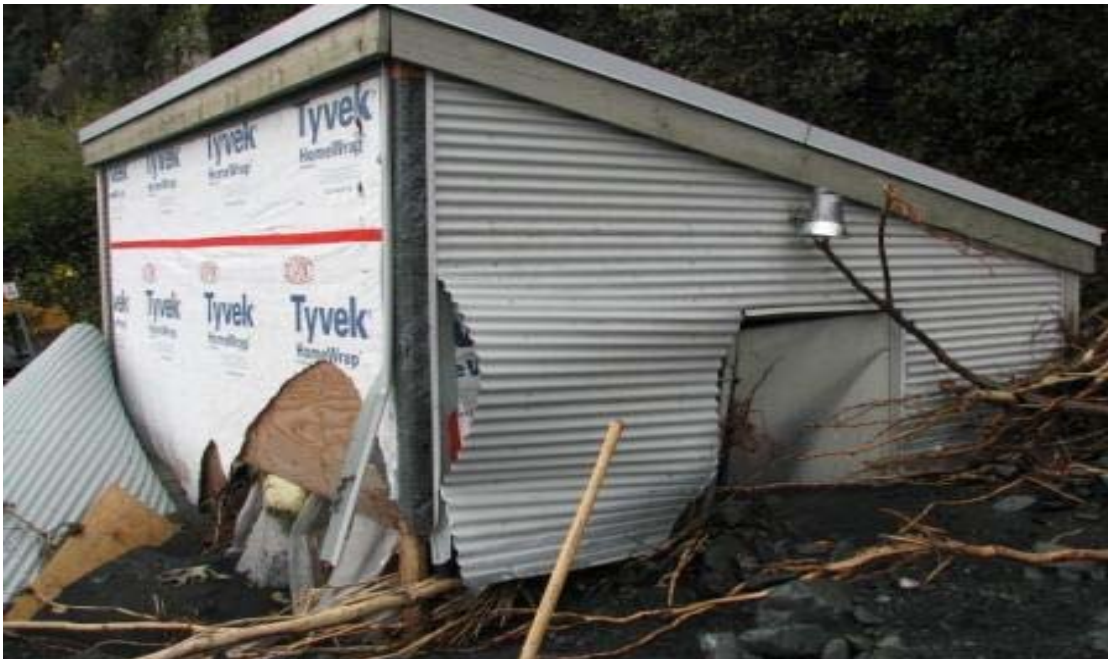
Photo 2: Alaska Sea Life Center outbuilding debris damage from Lowell Tunnel flooding, October 2006.

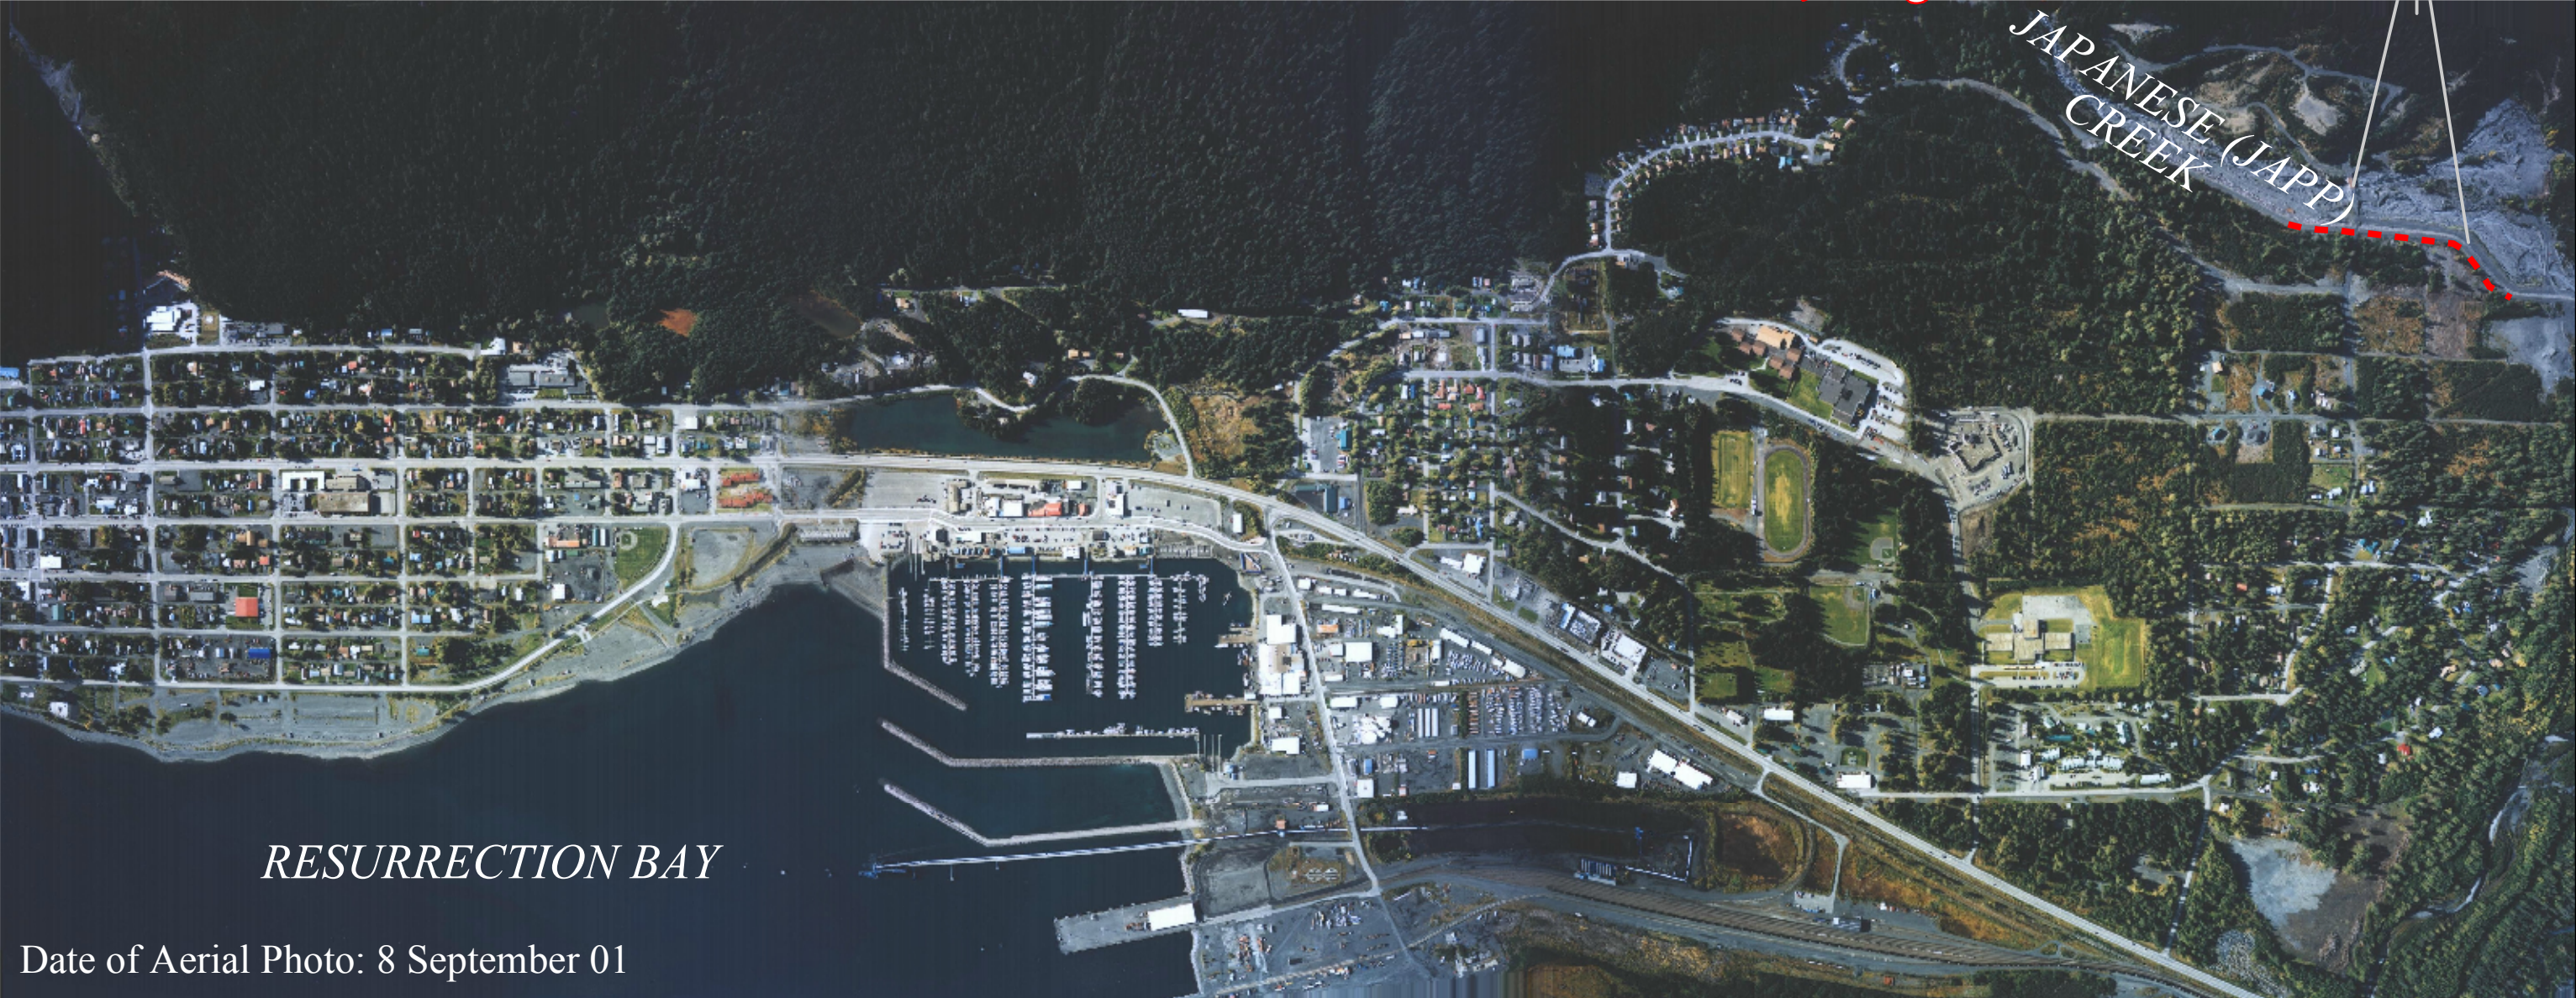
Japanese Creek levee-erosion caused damage to the toe of the levee during the 2006 flood, bridge was washed out
