ALASKA BASELINE EROSION ASSESSMENT

Erosion Information Paper - Shageluk, Alaska

Current as of March 6, 2008

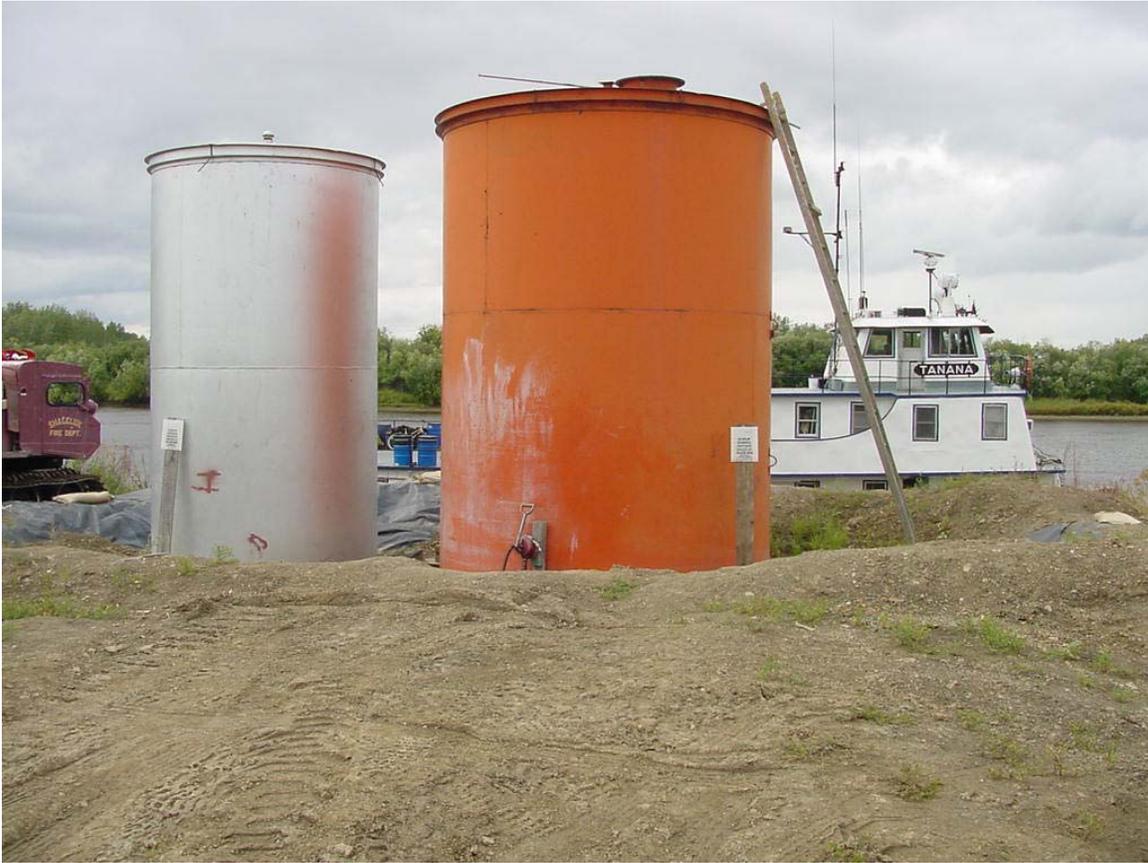
**Photo 1: Shageluk city tank farm with fuel barge docked on Innoko River in background.
Photo courtesy DEC.**

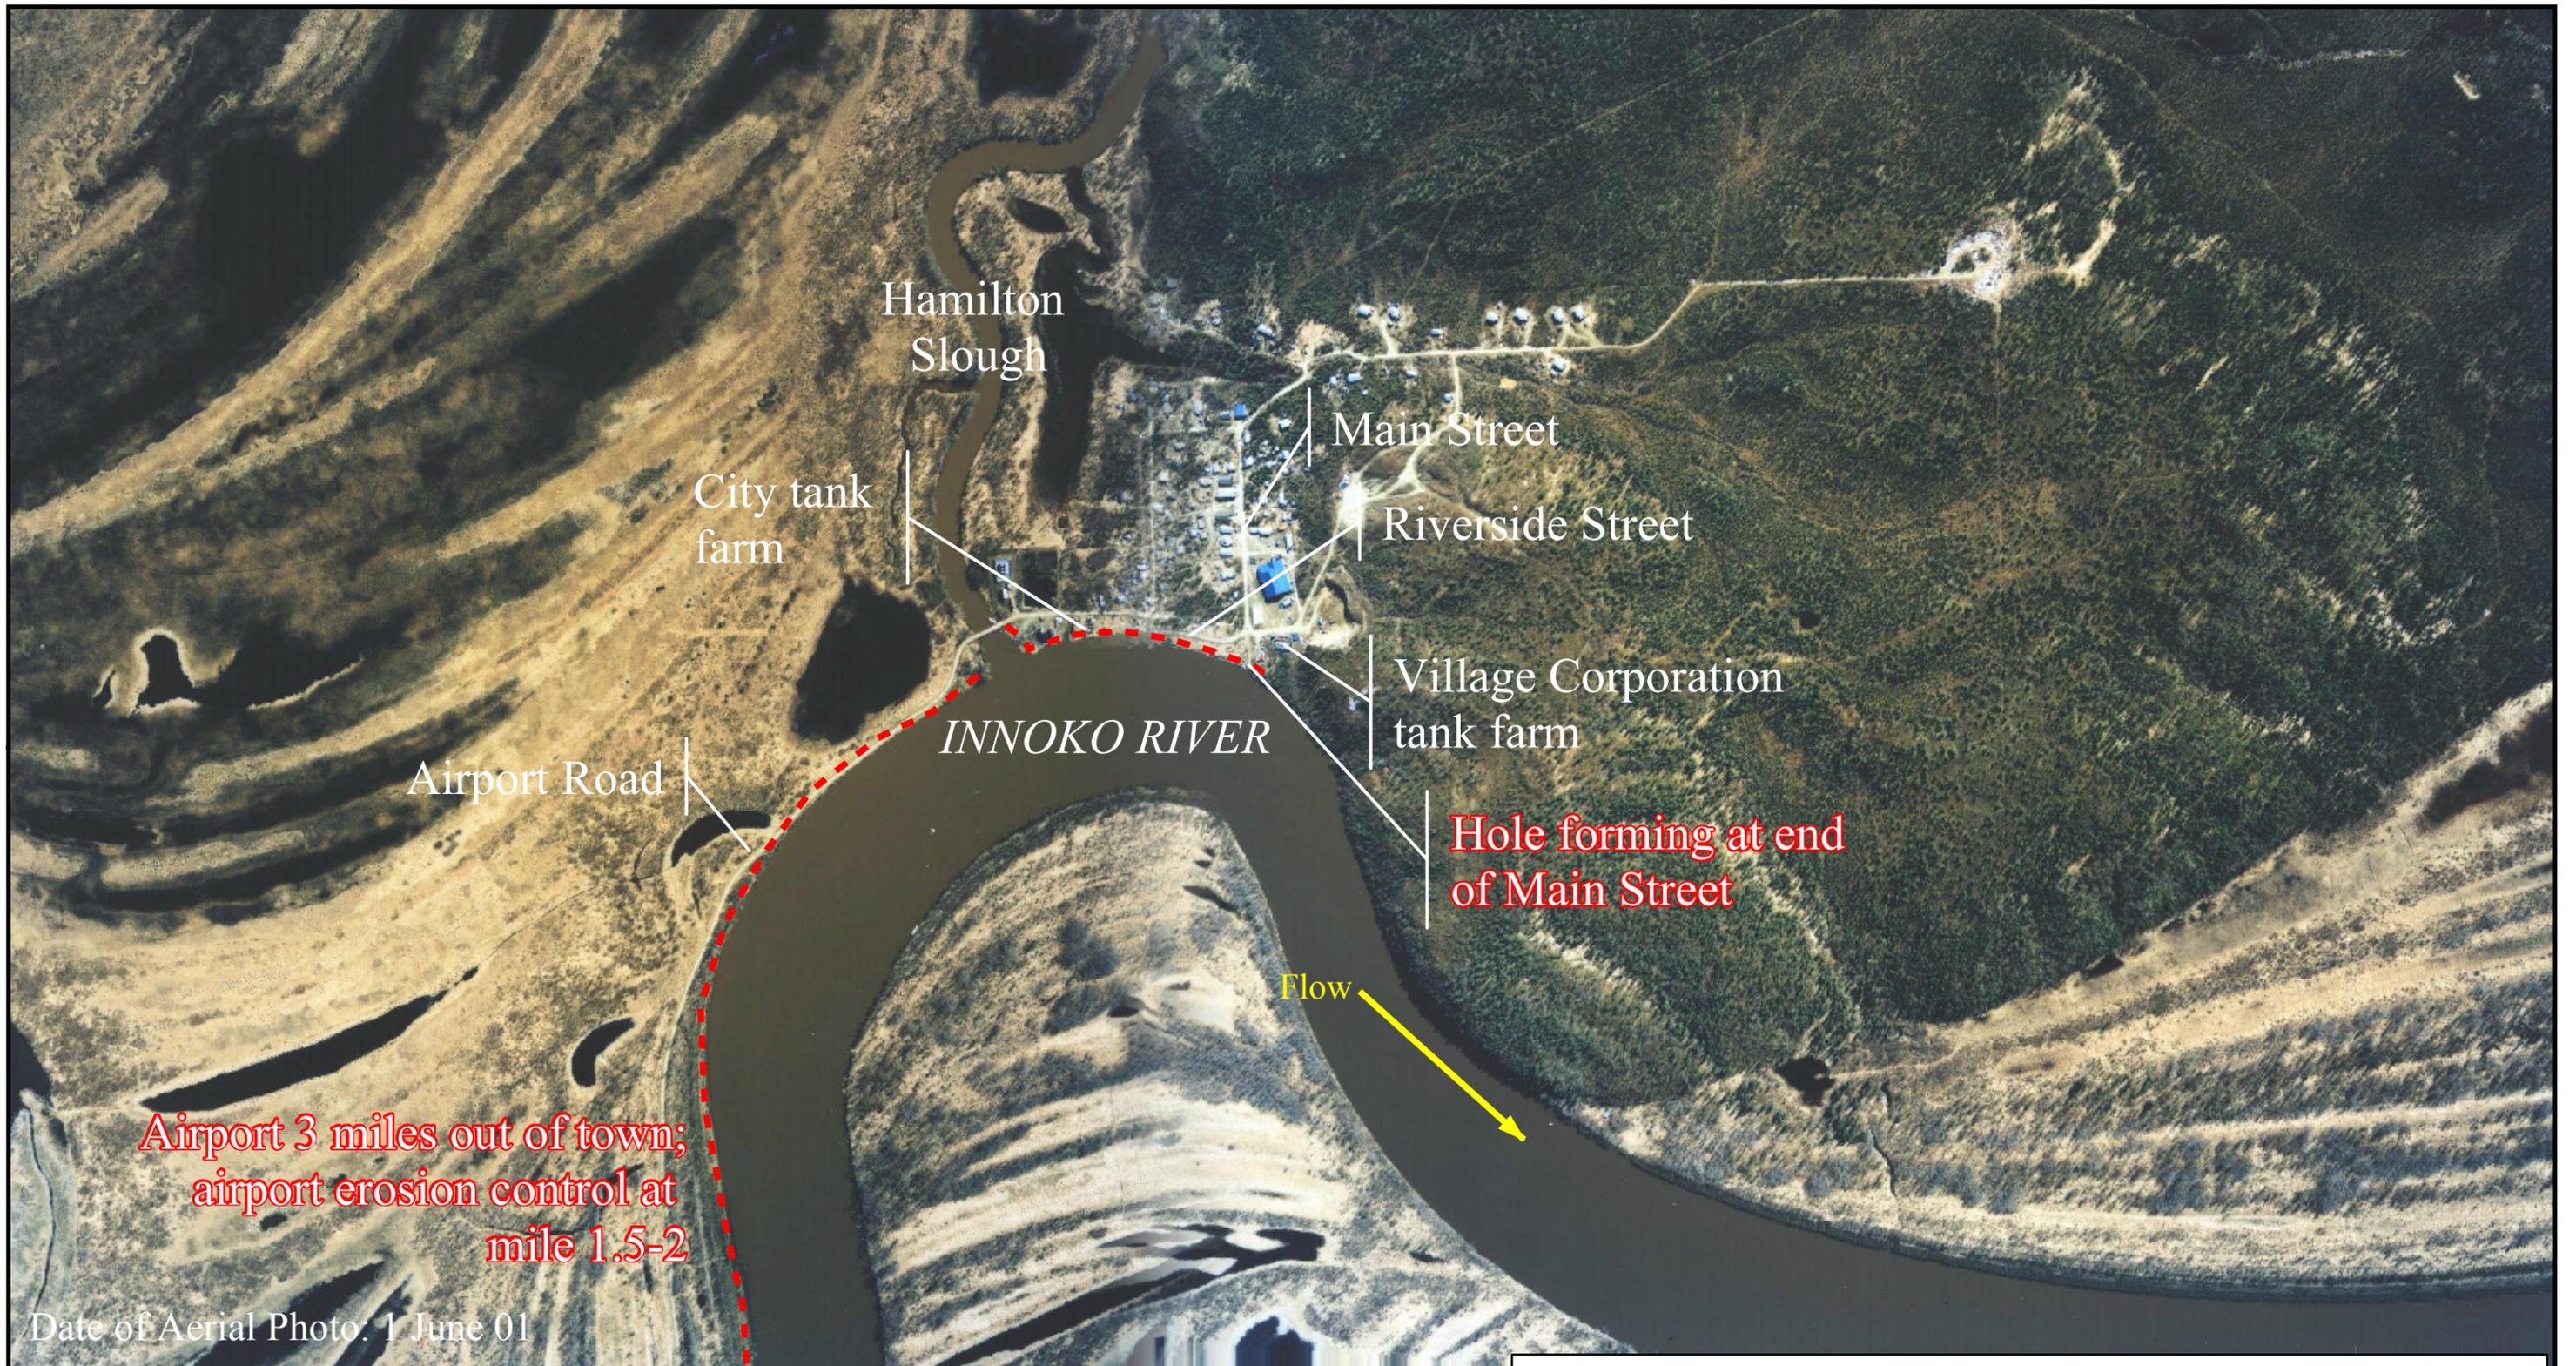
Alaska Baseline Erosion
Shageluk, Alaska

The community has slow periodic erosion along the banks of the Innoko River. Periodic fluctuations in river flow and water levels, ice jams, spring break up, storm water runoff, and permafrost melt all contribute to erosion. The main erosion area is approximately 300 feet long with bank height that varies from 10 to 15 feet. The majority of community development is on higher ground where the reported erosion rate is gradual, at an estimated 1 to 3 feet per year. Riverside Street is estimated to be 40 to 60 feet from the eroding bank. Erosion is causing a large hole at the end of Main Street, which leads downhill to the river.

--- Linear Extent of Erosion
