U.S. Army Corps
of Engineers
Alaska District

ALASKA BASELINE EROSION ASSESSMENT

Erosion Information Paper - Skagway, Alaska

Current as of July 24, 2008

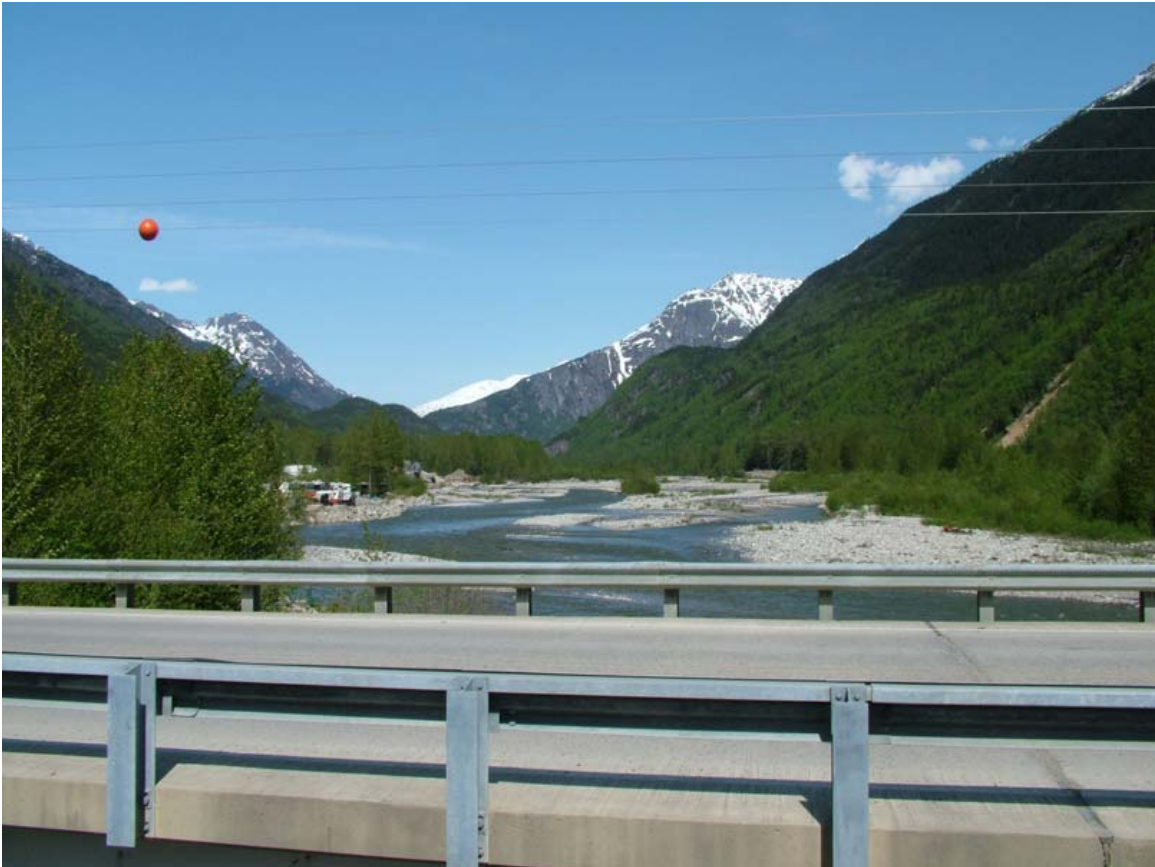
Photo 1: Skagway River valley, looking upstream. No photo date.

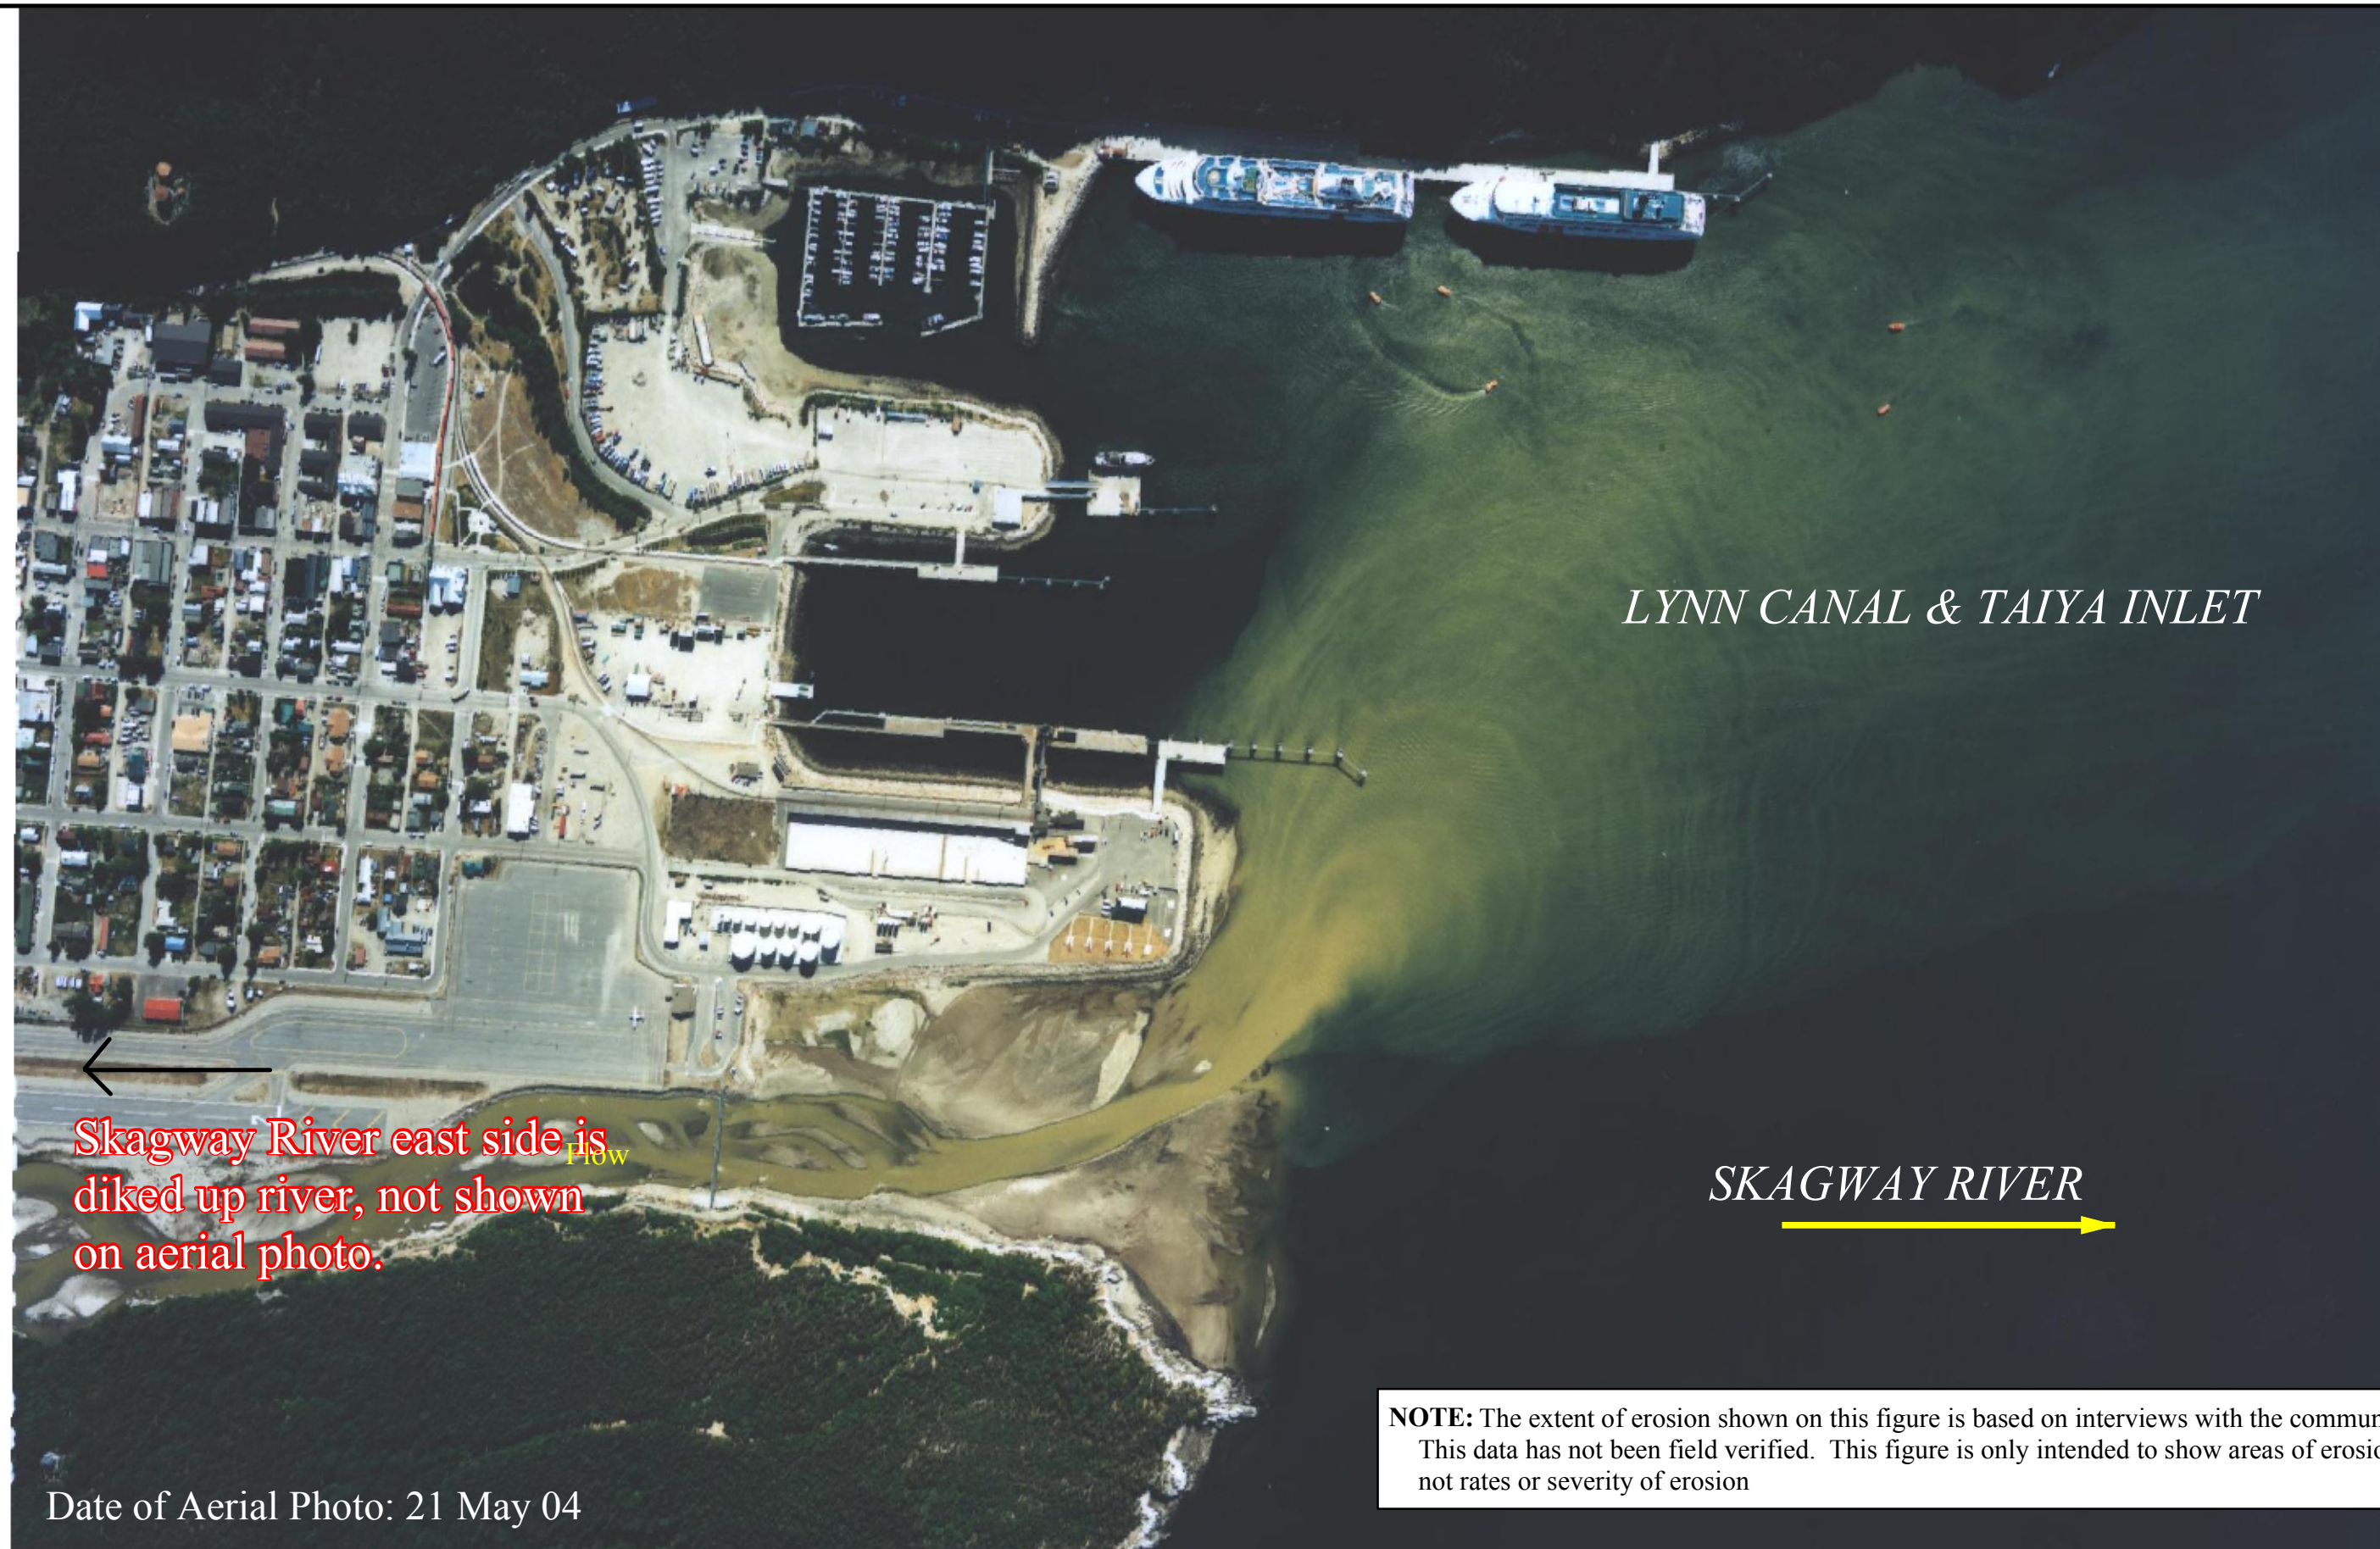
A photo is attached, taken from the *City of Skagway, Skagway River AMSA Plan* prepared by Sheinberg and Associates. The attached diagram shows the harbor area and mouth of the Skagway River, and no erosion is indicated.

Skagway River east side is
diked up river, not shown
on aerial photo.
