## ALASKA BASELINE EROSION ASSESSMENT

# **Erosion Information Paper - Soldotna, Alaska**

Current as of March 28, 2008

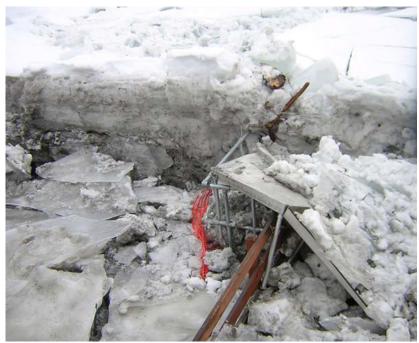
Photo 1: Staircase at the Kenai River Center damaged by ice in 2007.
