U.S. Army Corps
of Engineers
Alaska District

ALASKA BASELINE EROSION ASSESSMENT

Erosion Information Paper - South Naknek, Alaska

Current as of November 14, 2007

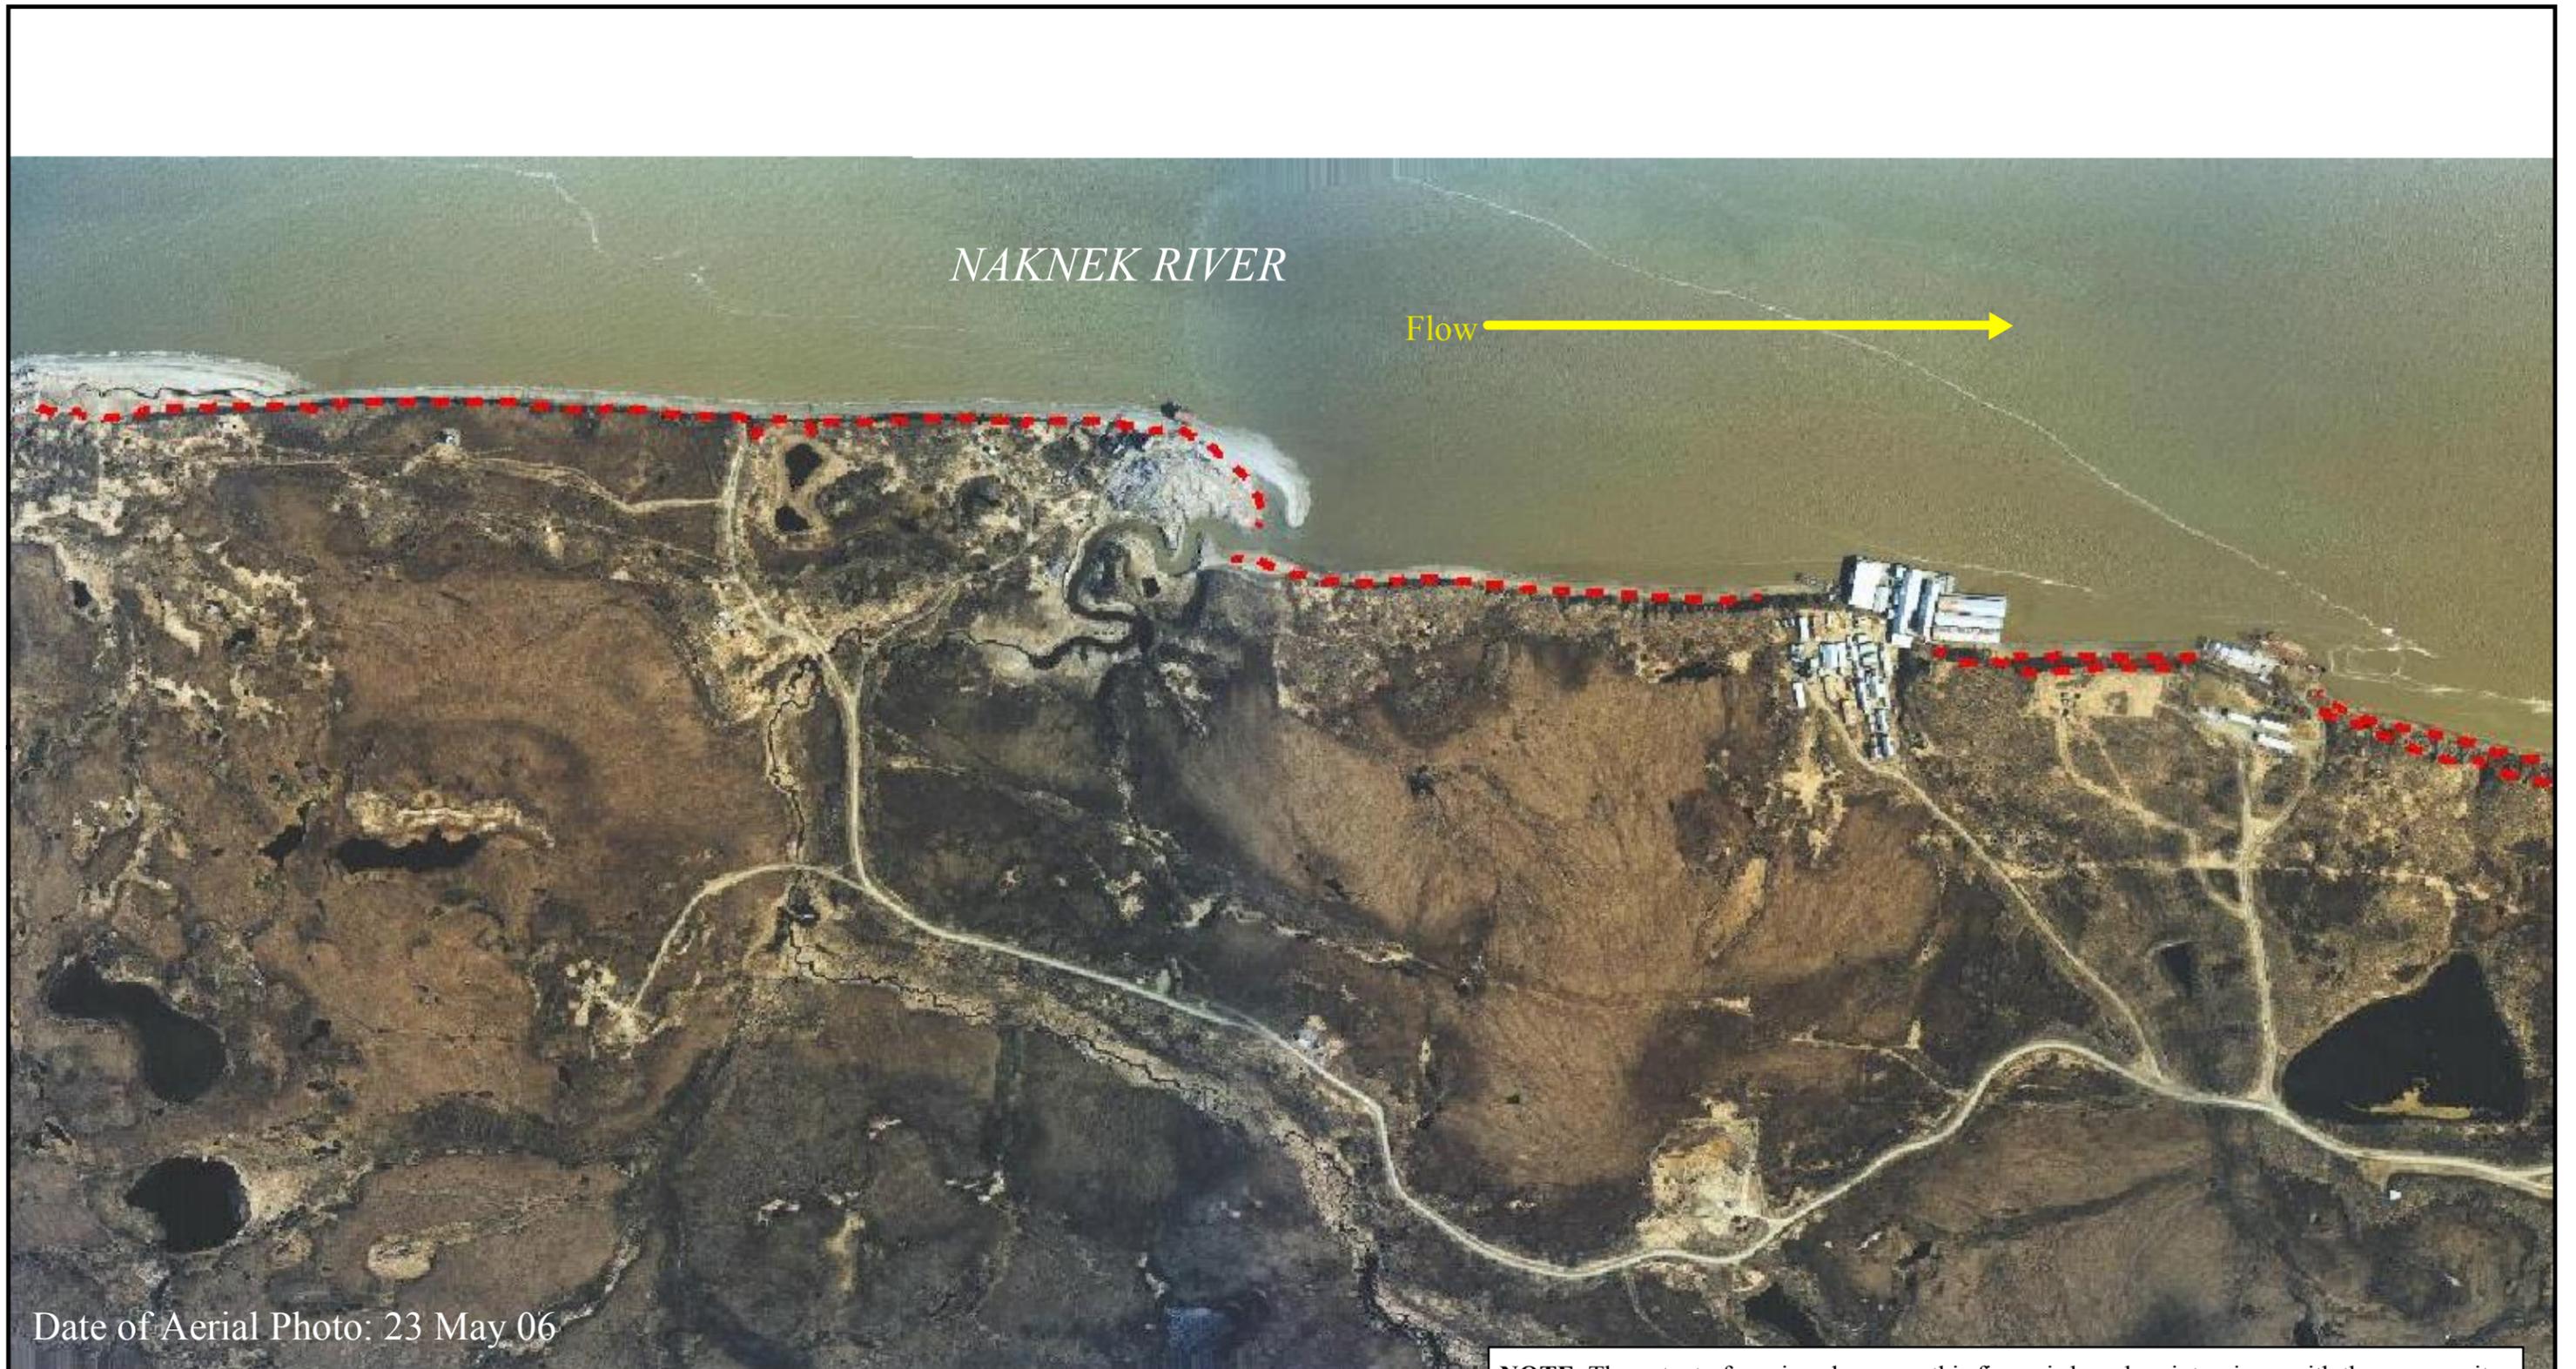
--- Linear Extent of Erosion
Part 1

To Bristol Bay →
Erosion continues along the
river and Bristol Bay coastline
