ALASKA BASELINE EROSION ASSESSMENT

Erosion Information Paper - Stebbins, Alaska

Current as of March 20, 2008

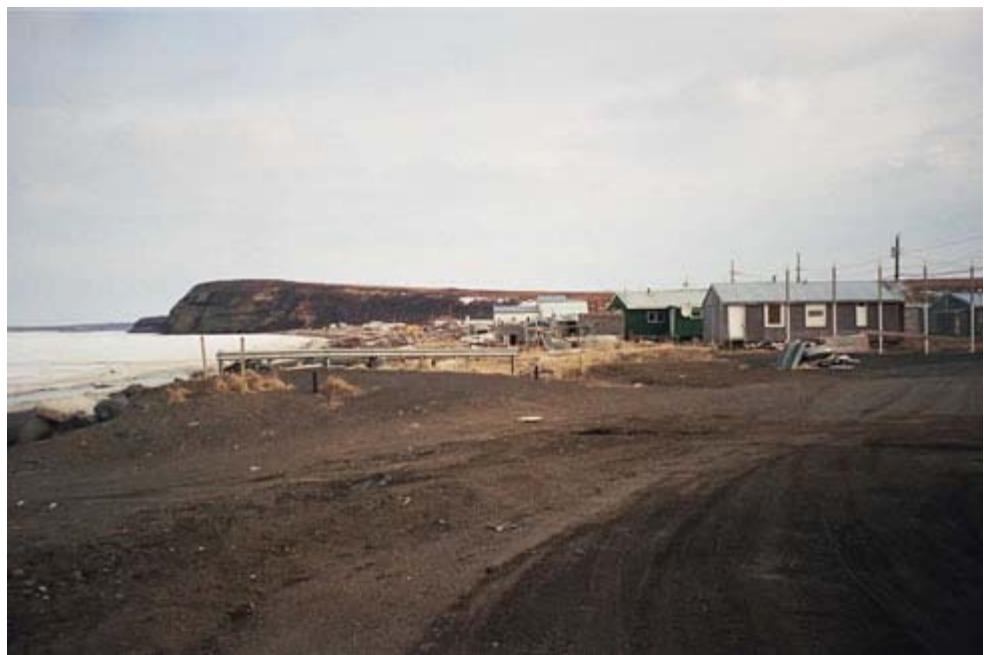
There was up to 40 feet of ground and vegetation between the beach and the first row of housing in the early 1960s. Only 8 feet currently remain, leaving many homes close to the beach. Water level is close to the houses during storms. A revetment of sand-filled oil drums was constructed along the beach by the Youth Corp and the City of Stebbins in an effort to control erosion during the 1960s. The revetment has deteriorated as the oil drums have corroded and washed away.

Photo 1: Homes along the Norton Sound beach front in Stebbins; photo courtesy of the Division of Community and Regional Affairs, 2003.

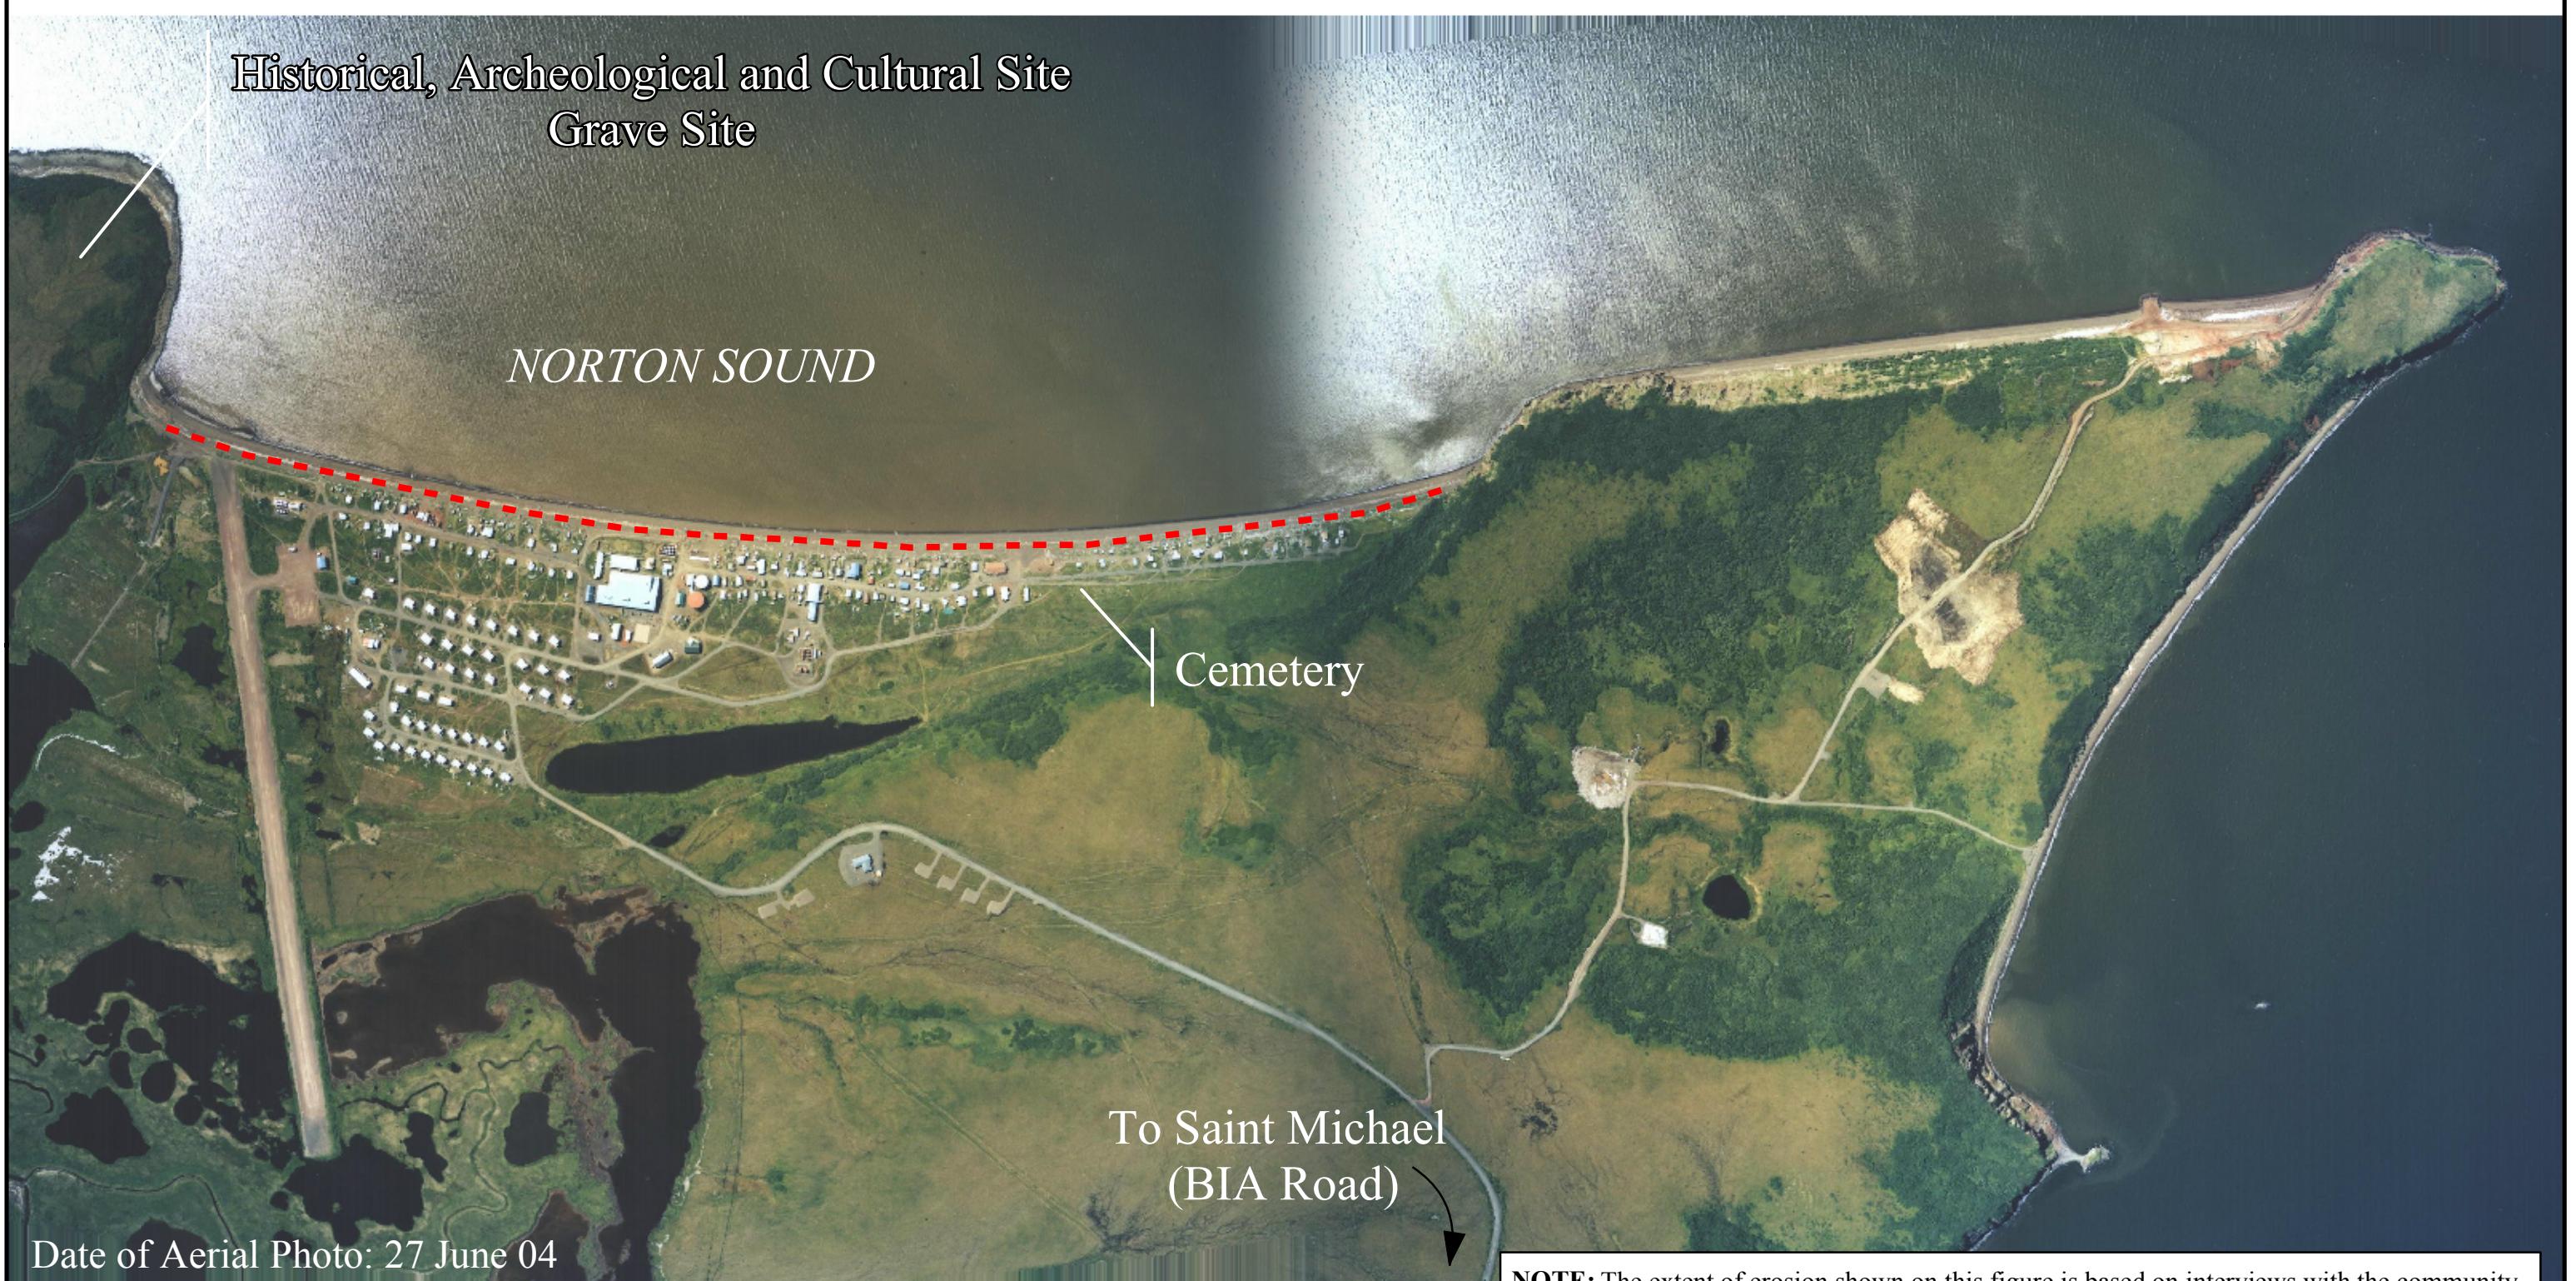
Alaska Baseline Erosion
Stebbins, Alaska

Stebbins has coastal erosion along Norton Sound reportedly caused primarily by storm surges and wind-driven waves. Over the last 40 years there have been approximately 10 major erosion events caused by storms, resulting in a loss of 30 to 40 feet of land above the beach. The 2007 *Stebbins Hydrologic and Hydraulic Report*, prepared for the Alaska Department of Transportation and Public Facilities by Baker and Coastal Frontiers states: “Based on this analysis from 1951 to 2004, the shoreline along the beach west of Stebbins has been relatively stable with little erosion or accretion. However, it was observed during the site visit, that the area from the west end of the runway to Bonok Point is not stable. The low beach berm in this area had been damaged during the 2004 storm season. The beach was subsequently repaired, but the long-term stability is tenuous. If this low beach section is breached, the back shore will flood and the runway may be flanked.” The report also states, “The shoreline south of Bonok Point has experienced approximately 300 to 600 feet of shoreline recession over the last 53 years. The resulting average shoreline retreat is approximately 5.7 to 11.3 feet per year.”

----- Linear Extent of Erosion
