U.S. Army Corps
of Engineers
Alaska District

ALASKA BASELINE EROSION ASSESSMENT

Erosion Information Paper – Sutton-Alpine, Alaska

Current as of December 3, 2007

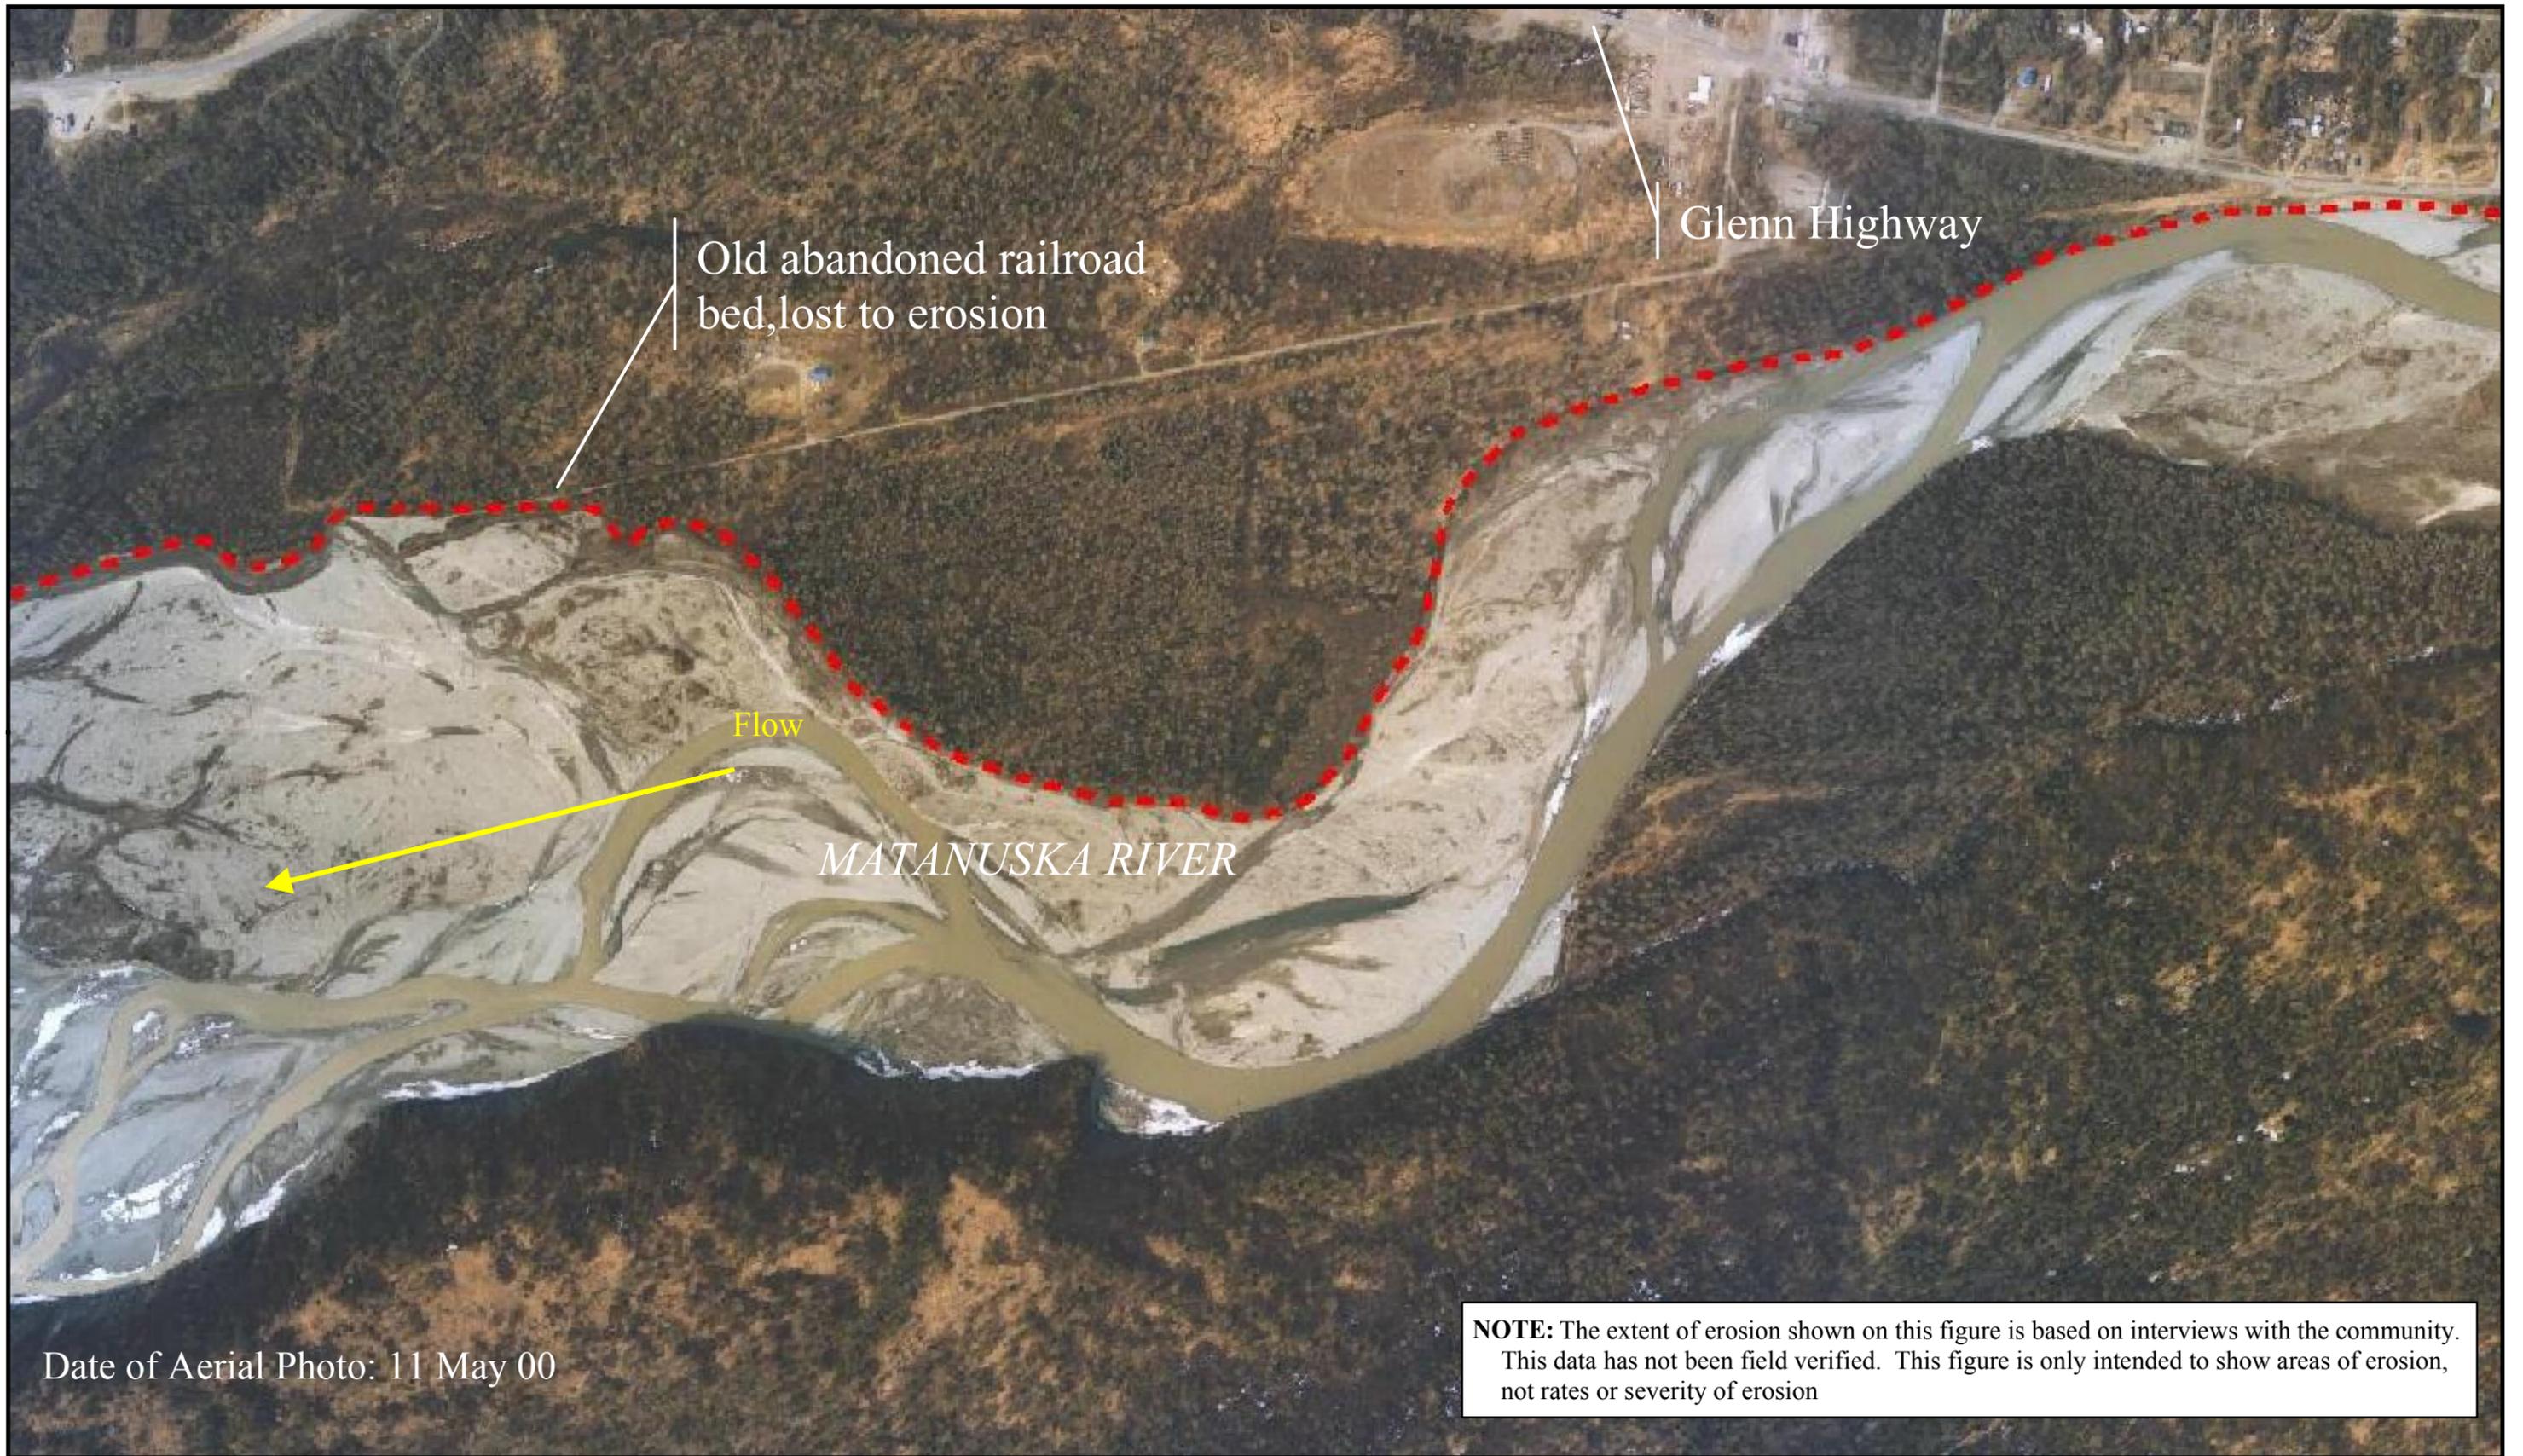
--- Linear Extent of Erosion
Part 1

No photos of erosion have been provided by the community or other sources. The attached diagram depicts the linear extent of erosion in the community.

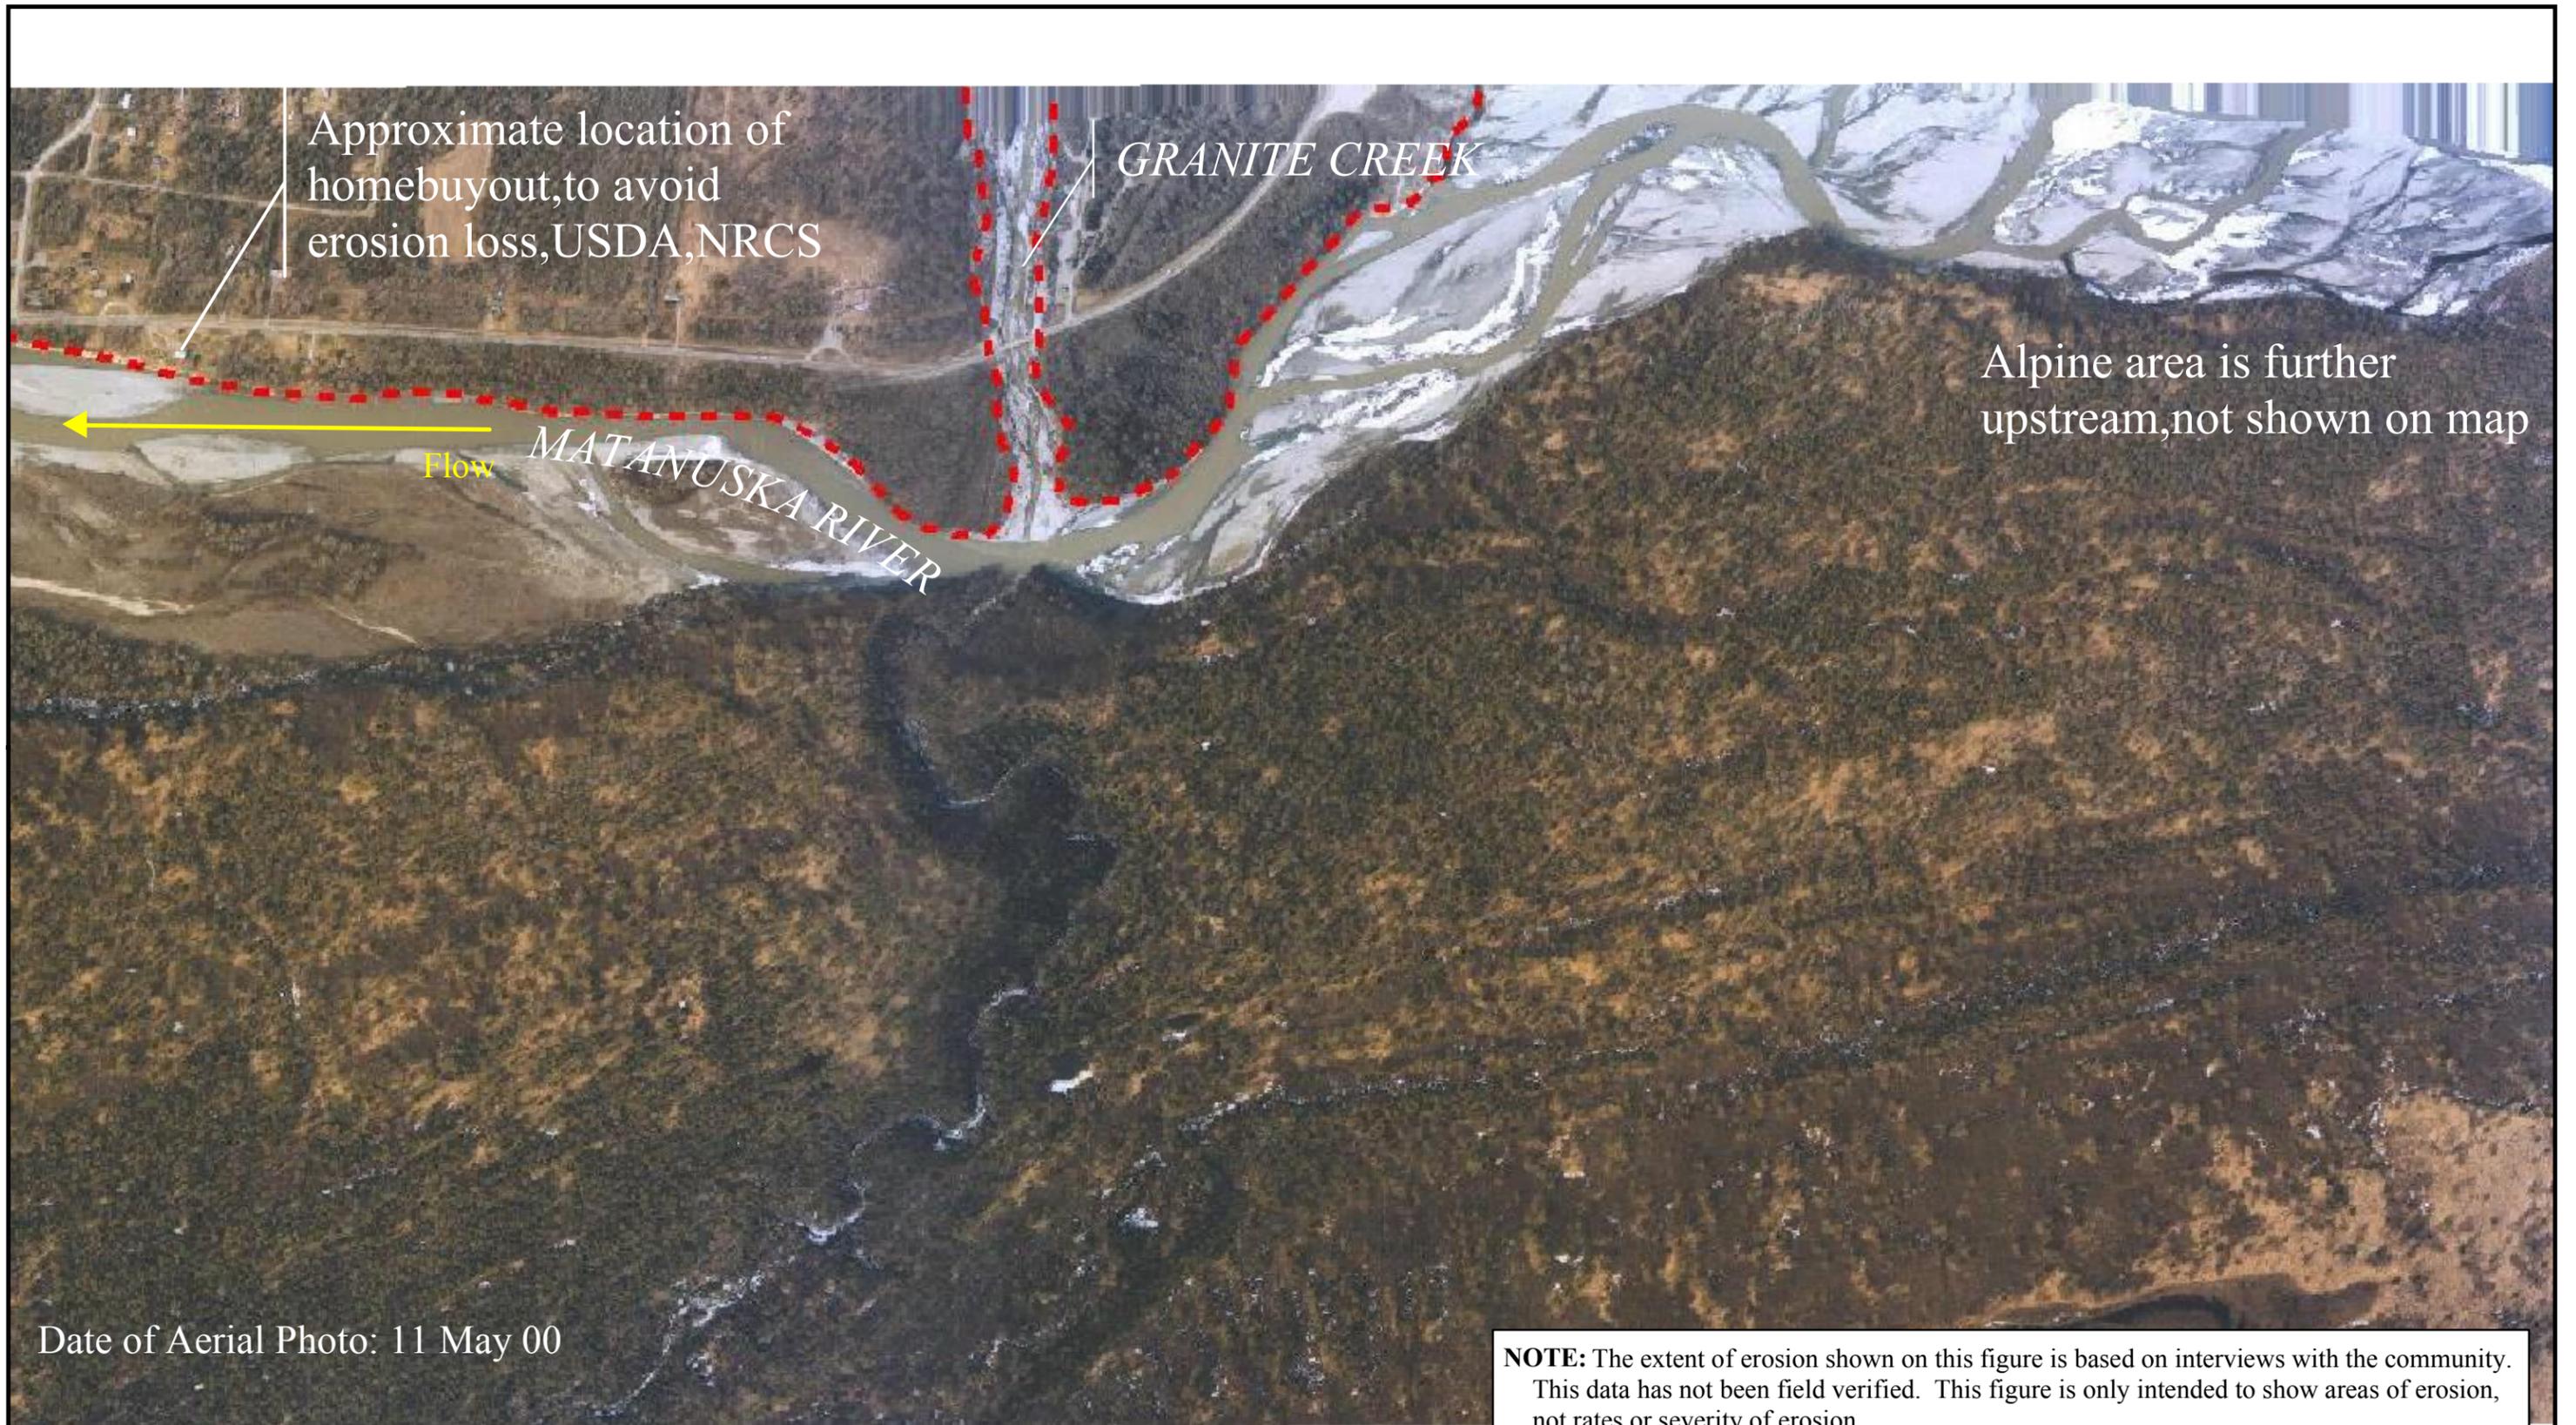
NOTE: The extent of erosion shown on this figure is based on interviews with the community. This data has not been field verified. This figure is only intended to show areas of erosion, not rates or severity of erosion
