U.S. Army Corps  
of Engineers  
Alaska District

## **ALASKA BASELINE EROSION ASSESSMENT**

### **Erosion Information Paper - Togiak, Alaska**

Current as of February 20, 2009

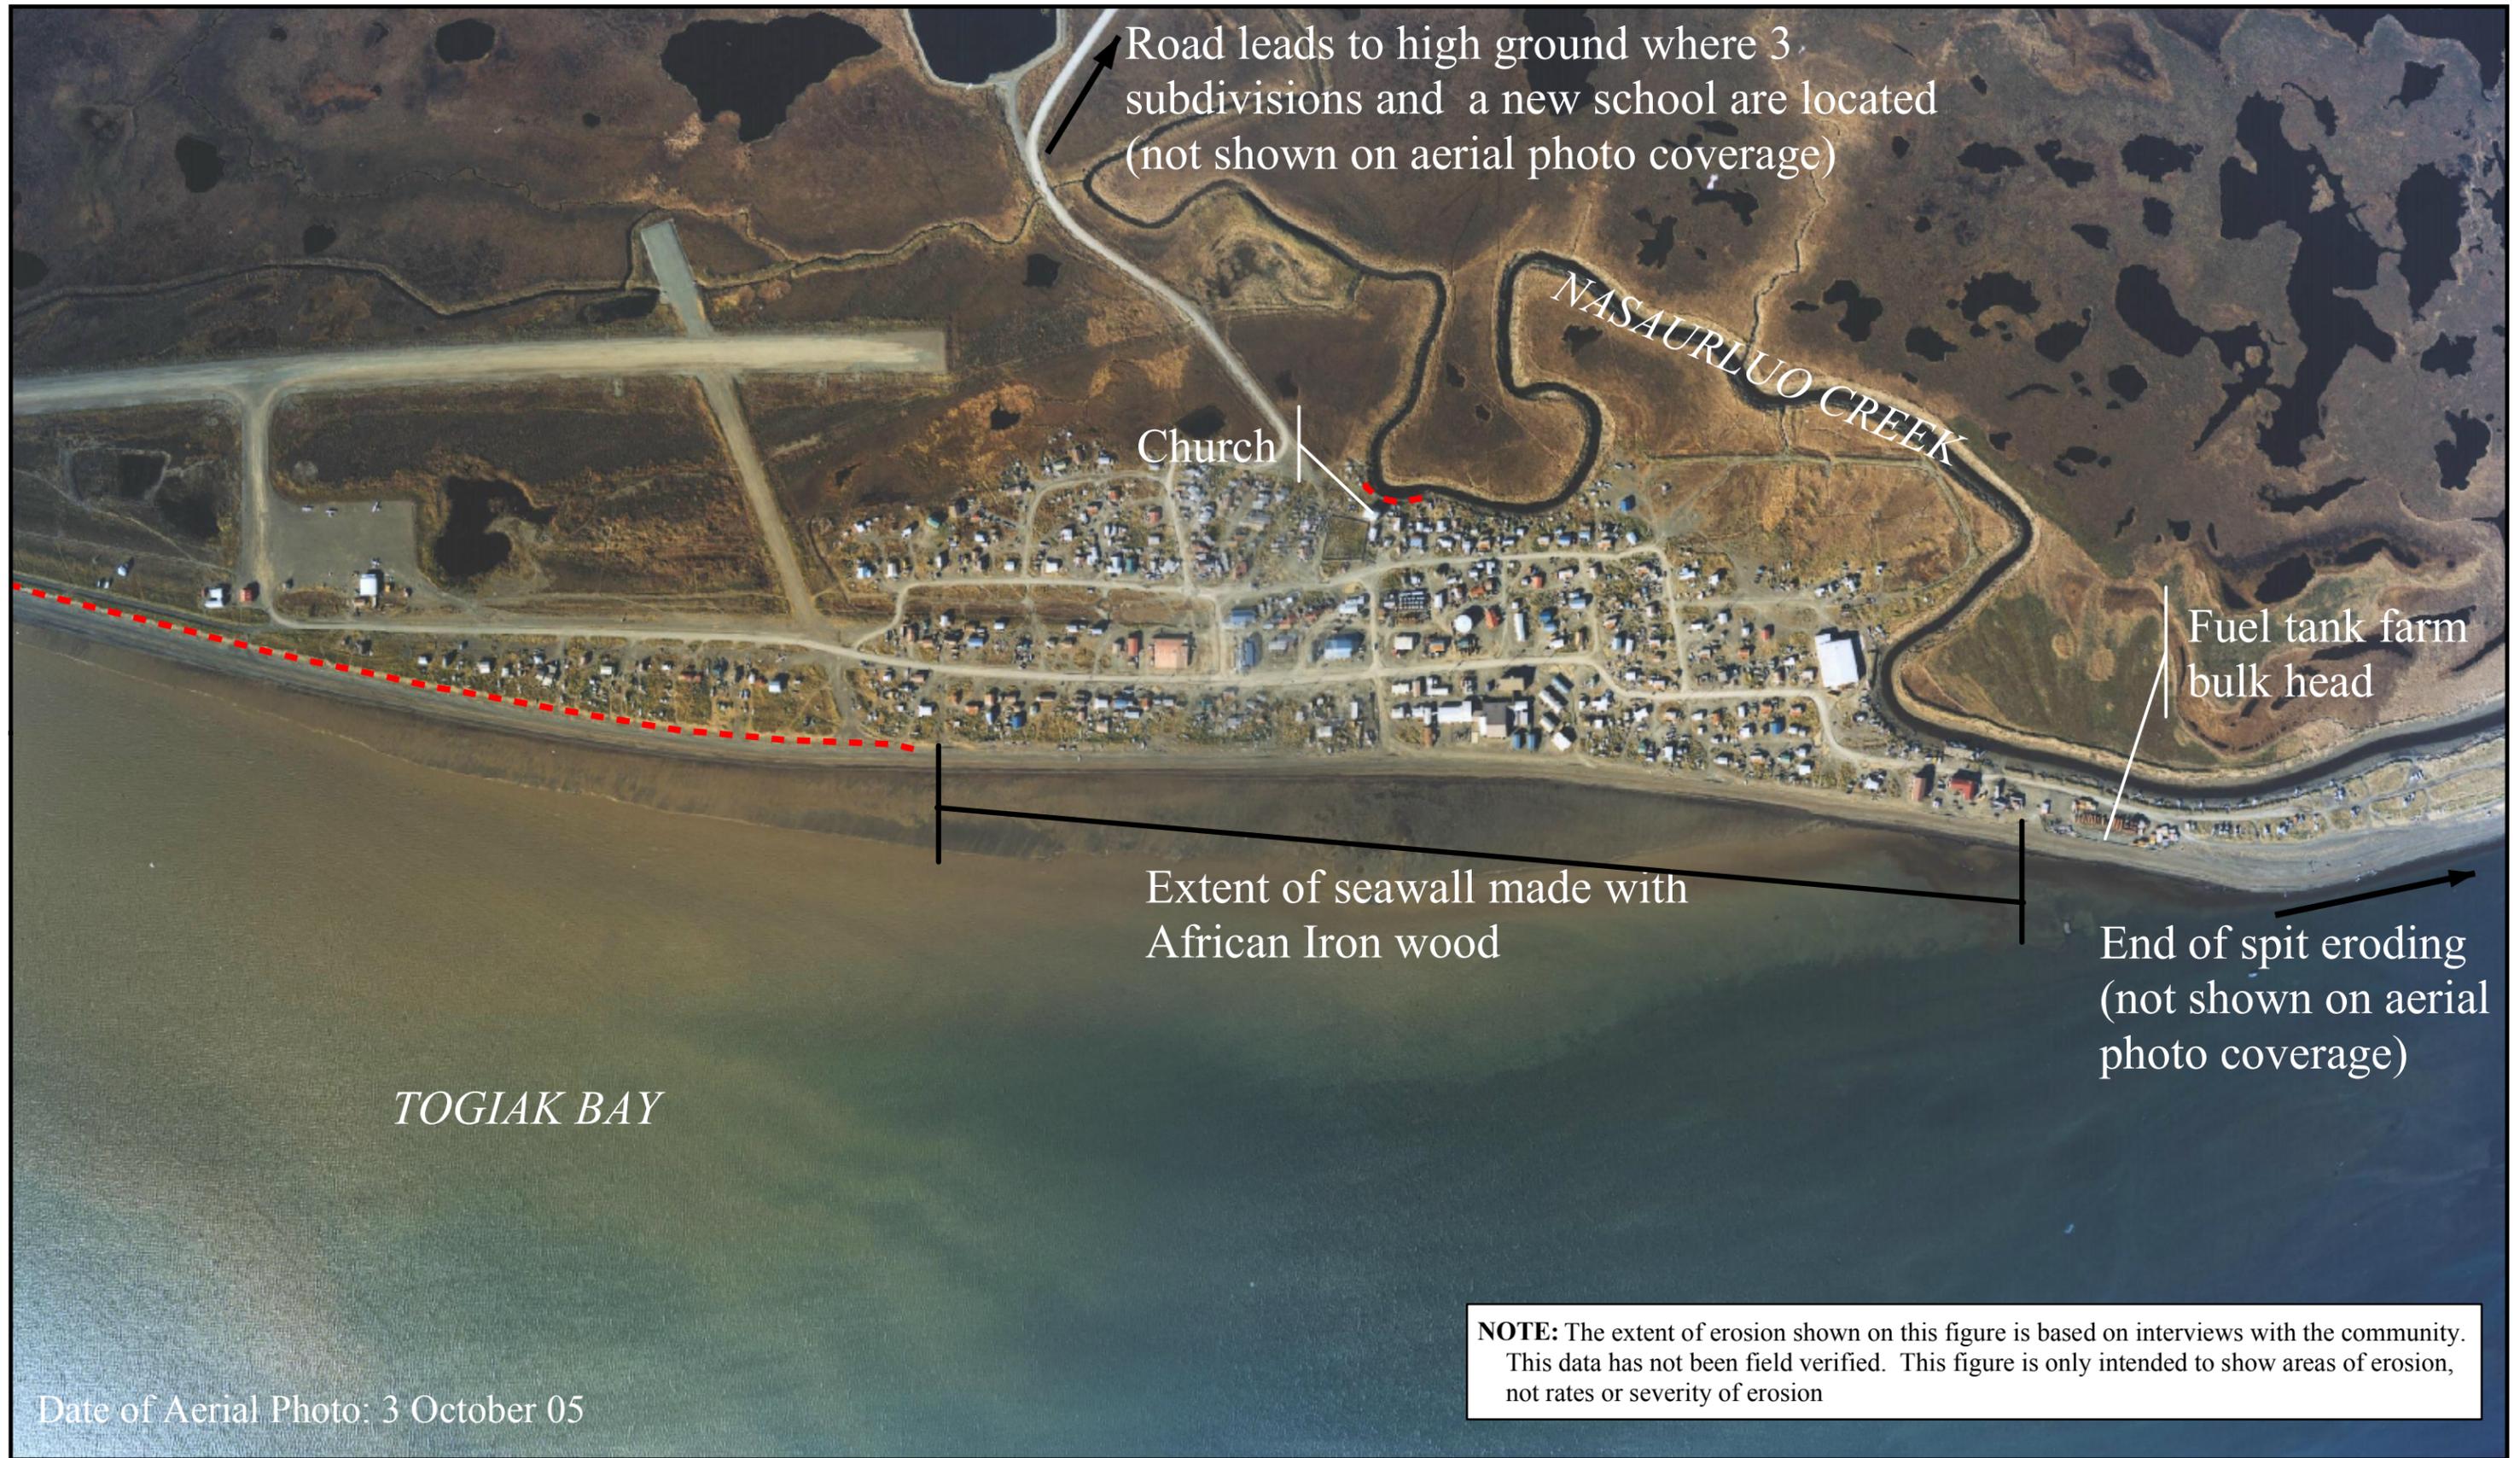
<p>Alaska District Corps of Engineers Civil Works Branch</p>	<p>--- Linear Extent of Erosion</p>			<p>Alaska Baseline Erosion Togiak, Alaska</p>
--	--	-------------------------------------	--	--	---
