U.S. Army Corps
of Engineers
Alaska District

ALASKA BASELINE EROSION ASSESSMENT

Erosion Information Paper - Tununak, Alaska

Current as of March 18, 2008

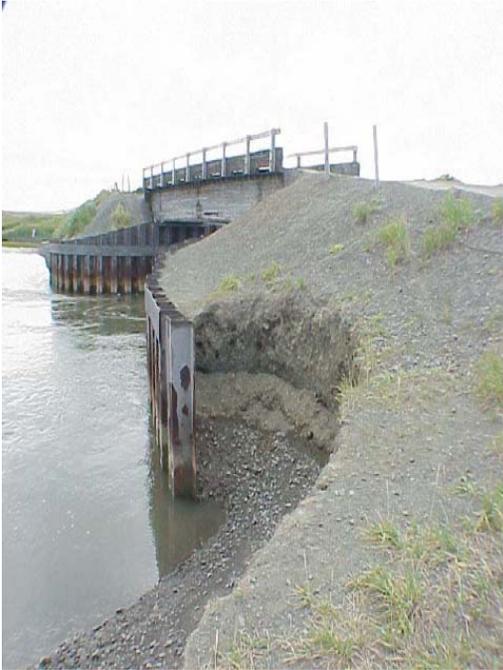
Seasonal fluctuations in river flows and water levels, flooding, ice jams, and melting permafrost all contribute to riverbank erosion. The riverbank reportedly is eroding at an estimated 1 to 2 feet per year. The Tununak River is eroding along the frontage road near the Tununak Bridge, which connects the community to the airport. The erosion site is 200 to 250 feet in length. The riverbank is about 50 feet high at the erosion site.

Photo 1 : Erosion at the Tununak bridge that connects to the airport, 2003.

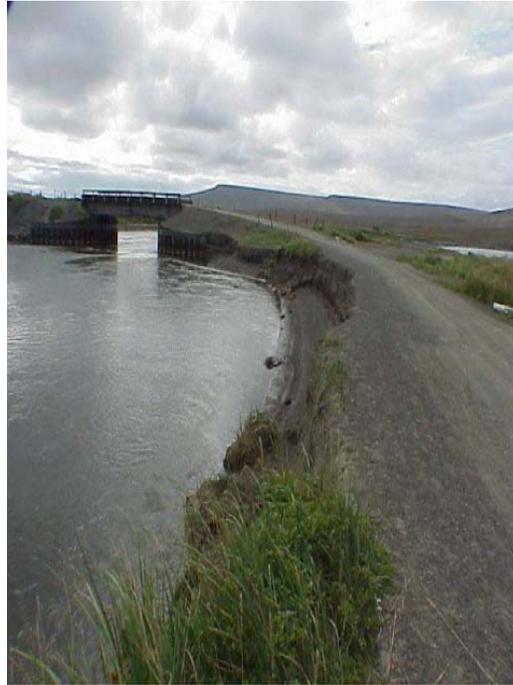
Photo 2: Erosion of the road to the airport, September 2003.

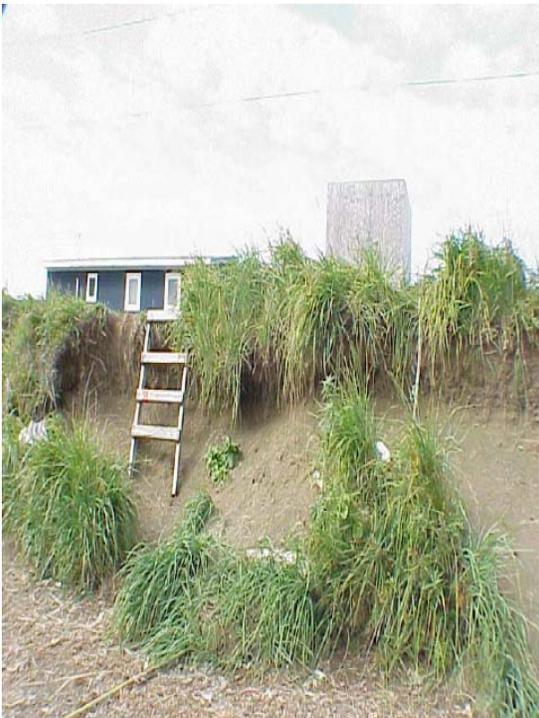
No protective measures have been installed to address erosion along the riverbank. Outbuildings and sheds, food storage structures, drying racks and smoke houses, the boat launch, boat storage, the post office, and the fishery office are less than 100 feet from erosion areas

Photo 3: Bank behind the Post Office, 2003.

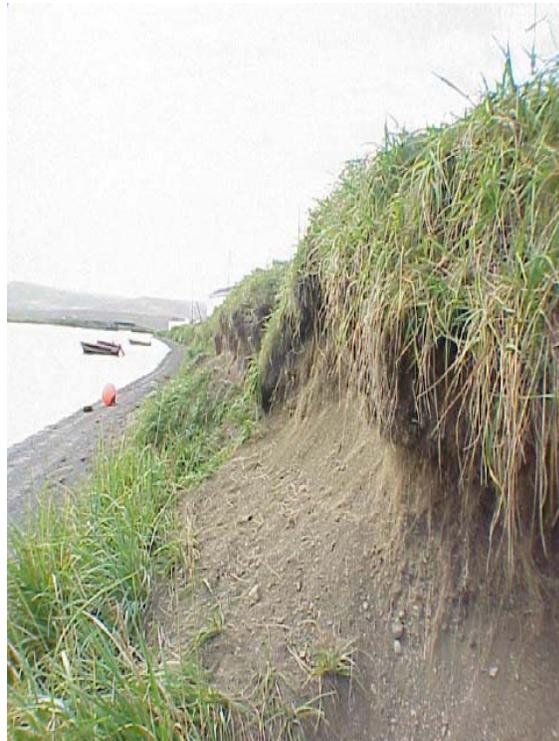
Photo 4: Bank near tribal office; Tununak River Bridge is in the background, 2003.

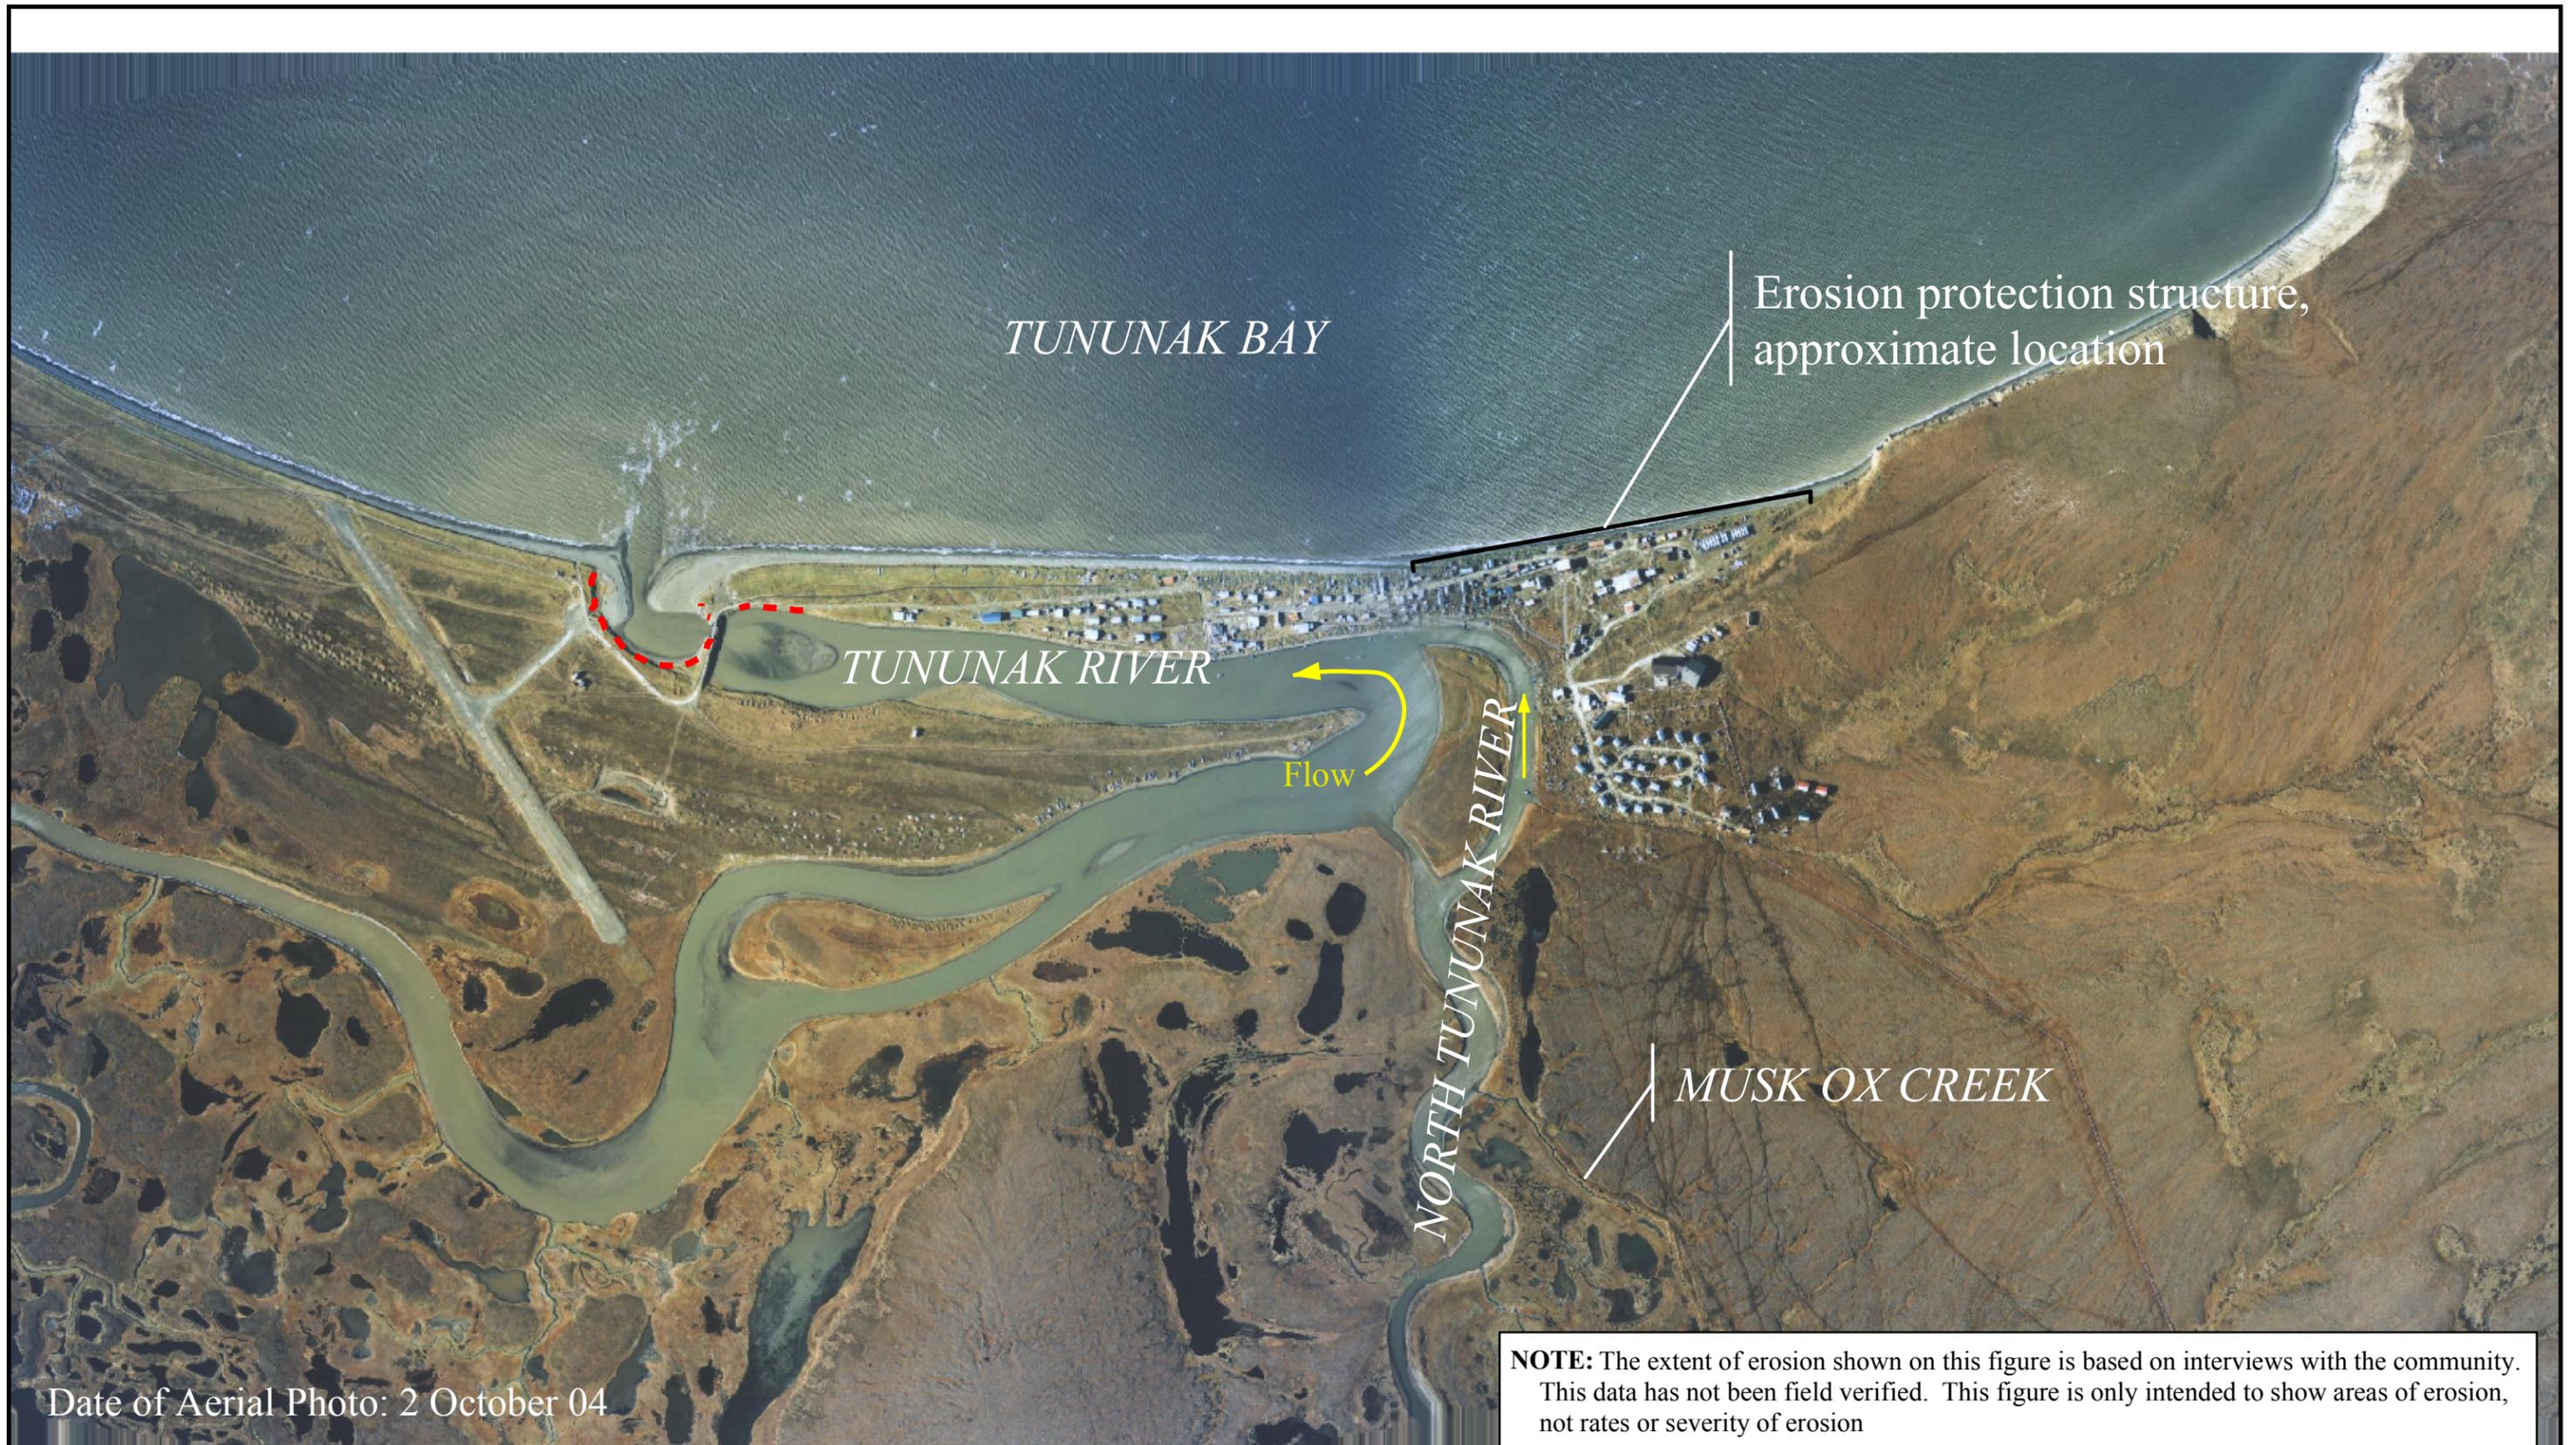
Alaska Baseline Erosion
Tununak, Alaska

--- Linear Extent of Erosion
