ALASKA BASELINE EROSION ASSESSMENT

AVETA Report Summary - Unalakleet, Alaska

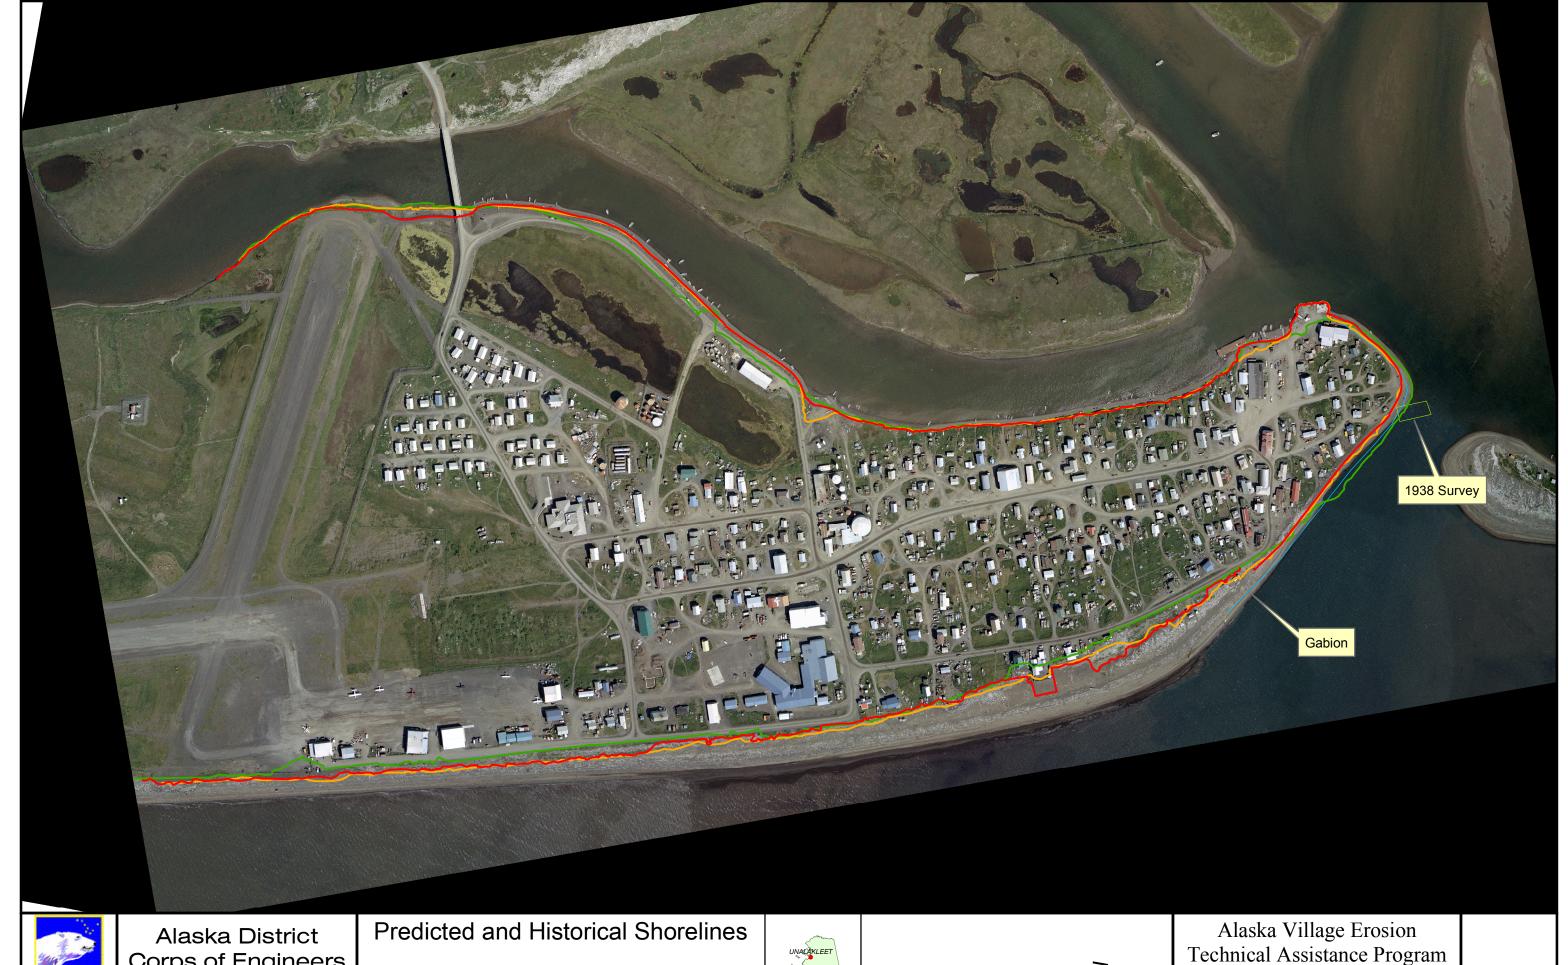
Catastrophic failure of the sand spit is not expected; however, the community will continue to suffer property damage and loss from erosion. Unalakleet suffers from erosion on both the ocean side (Norton Sound) and from the Unalakleet River. The erosion rate on the Norton Sound side averages 1 foot per year and occurs when storm surge attacks the spit, washing away beach material. The rate of erosion from the Unalakleet River is more severe and averages 2 feet per year.

1938 1980 1996 2004 2054
