U.S. Army Corps  
of Engineers  
Alaska District

## **ALASKA BASELINE EROSION ASSESSMENT**

### **Erosion Information Paper - Wainwright, Alaska**

Current as of September 29, 2008

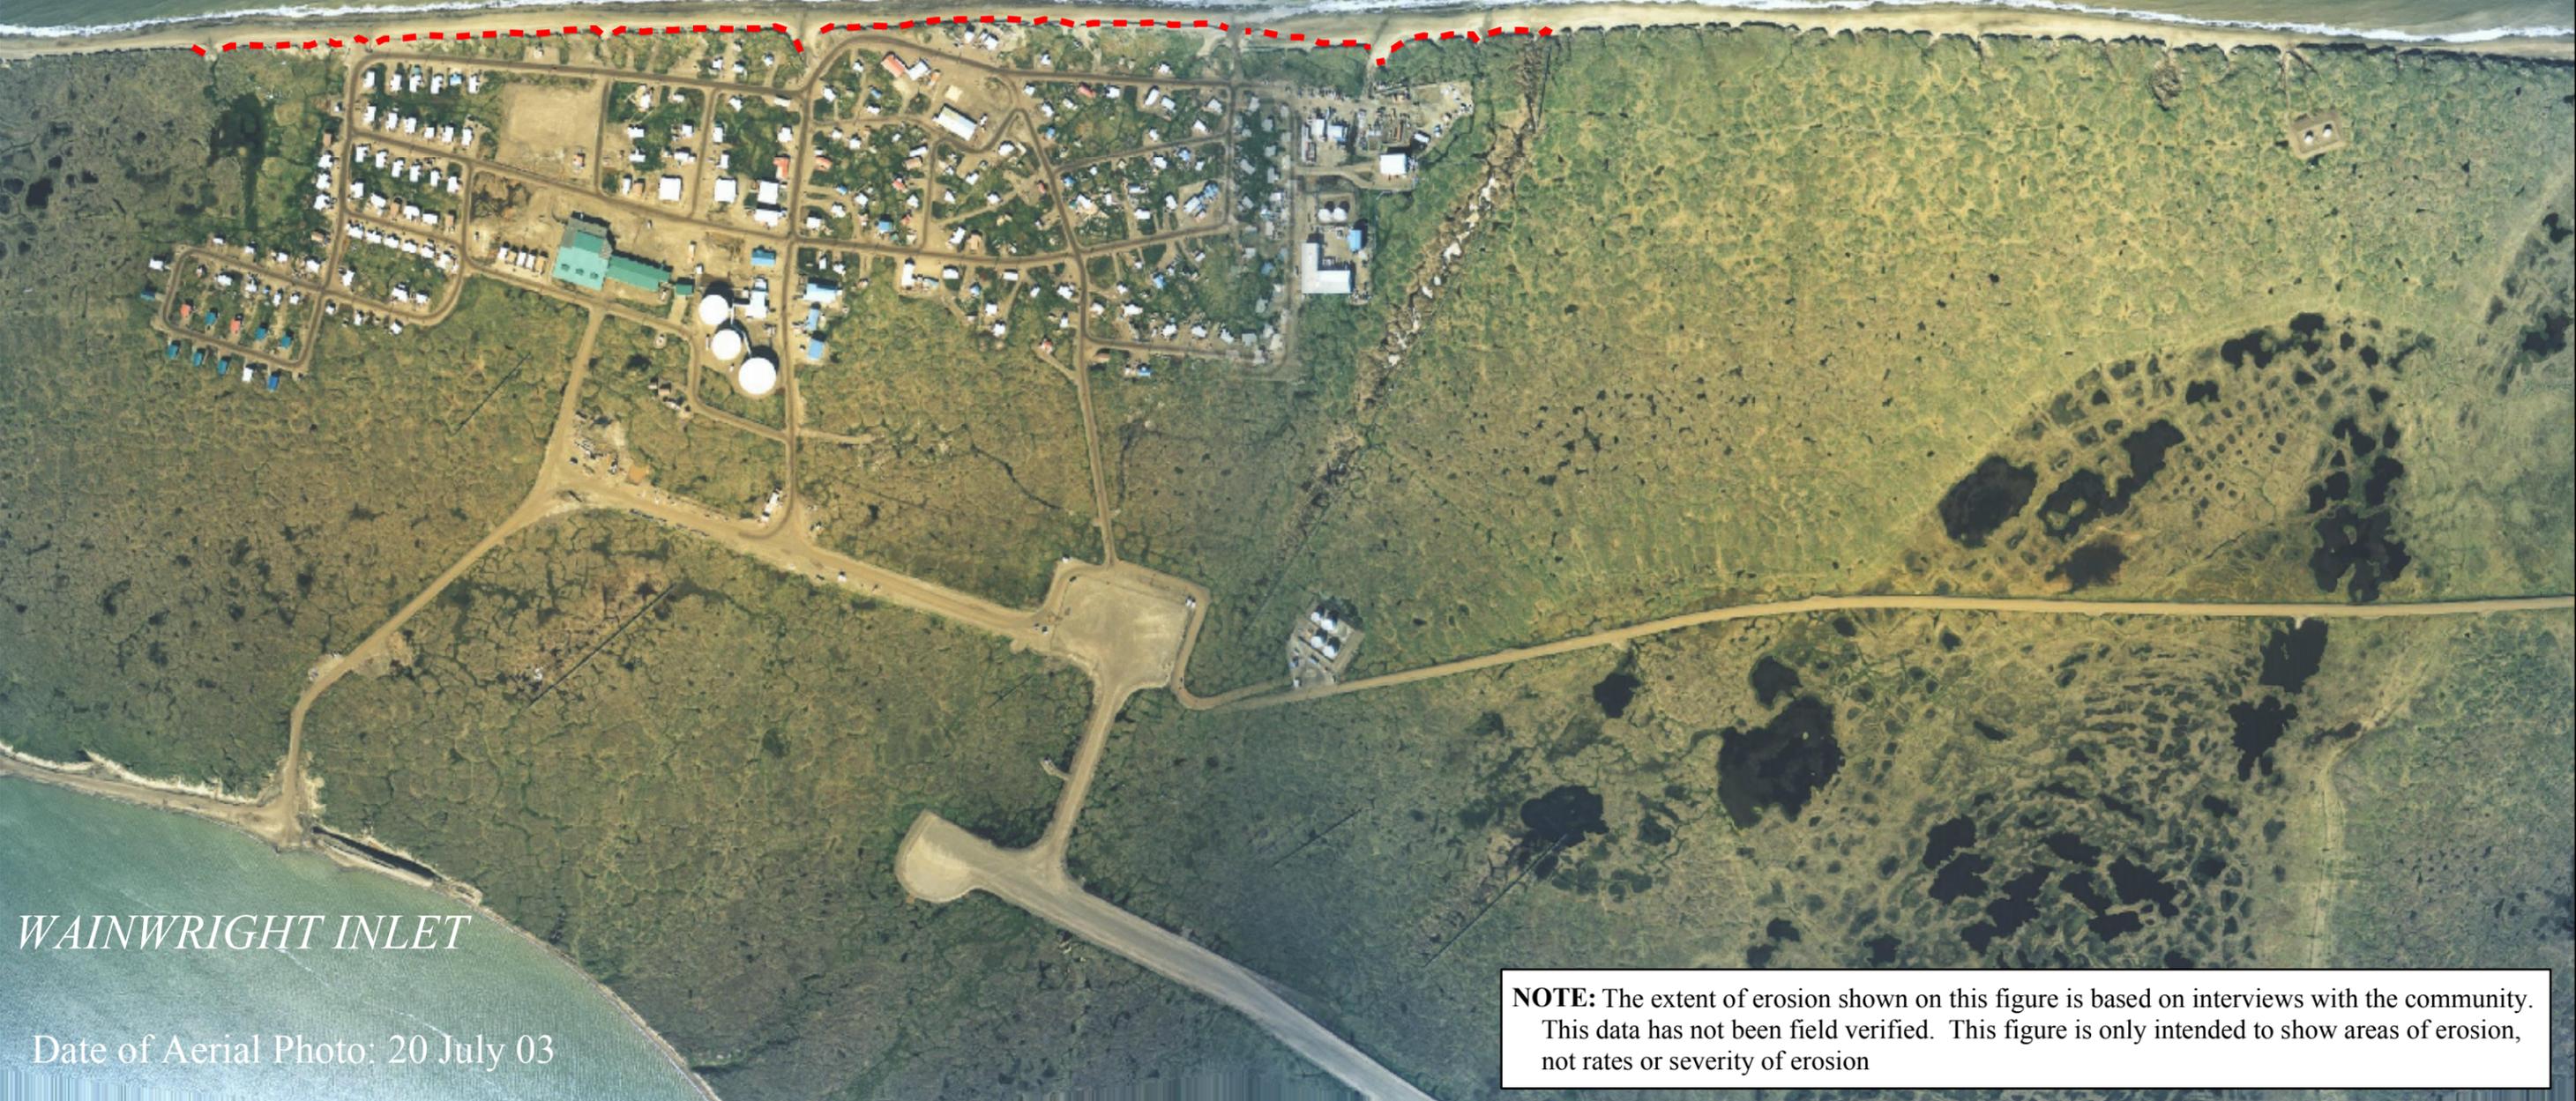
No photos were provided by community or other sources. The attached diagram shows the linear extent of erosion.
