GEOTECHNICAL INVESTIGATION AND SITE CONDITIONS REPORT

KENAI RIVER BLUFF EROSION

KENAI, ALASKA

February, 2007

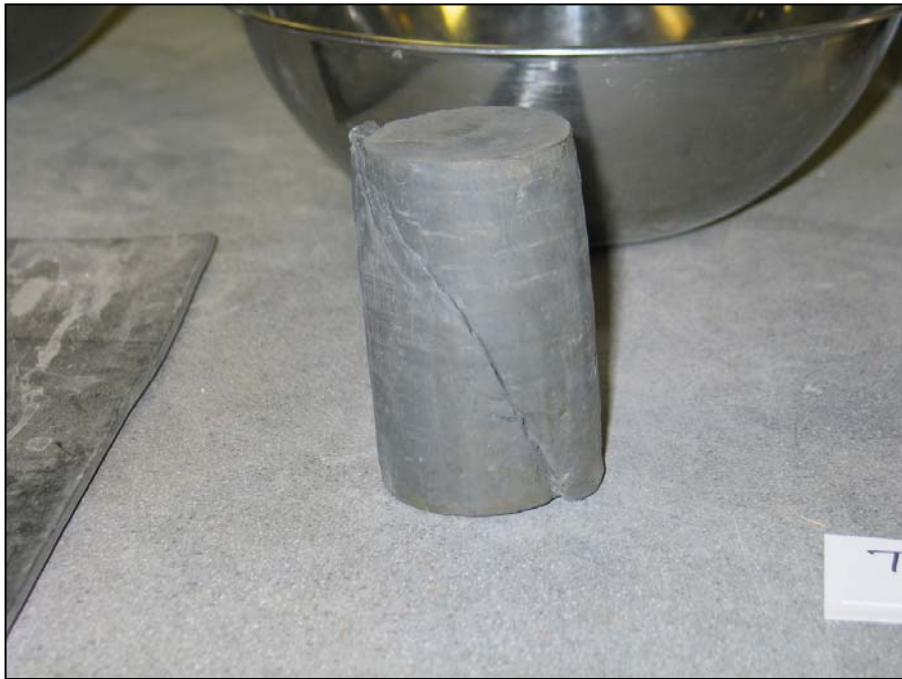
b. Sample TB-2C No. 16 (AP-611-MW) after testing. Note failure plane.

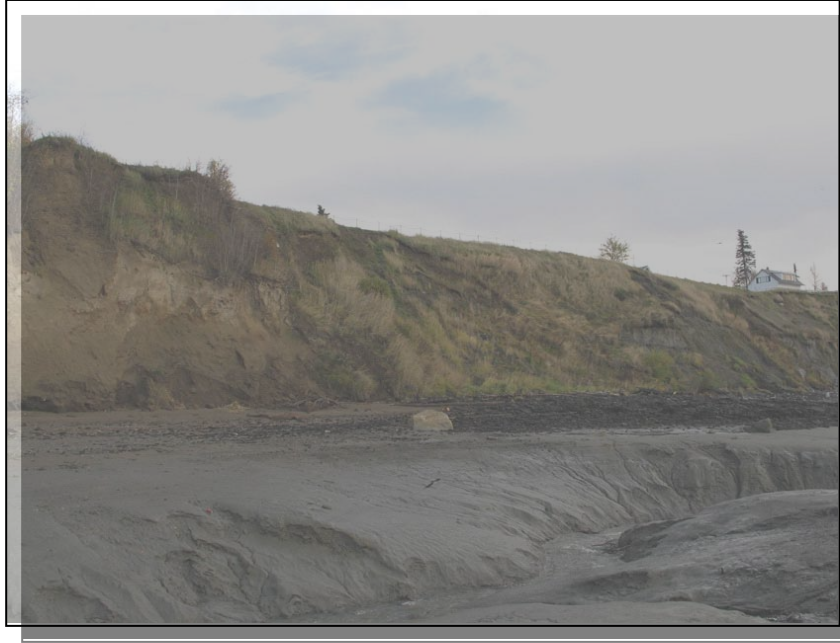
Small fills containing construction debris were observed dispersed throughout the surficial soils along the crest of the bluff, which included abandoned parking lots, abandoned utility trenches, and building foundations. At the west end of the project there was a large fill consisting of debris, organic material and silty soils located near the Group 1 test borings (see Figure 10a). This area was reportedly used as a disposal site for many years until a portion of the fill failed and some of the material slid down onto the tidal flats. Based on observations of the slope and data from the test borings, it appeared that fill material was dumped over the bluff between Hansen Park and Mission Avenue near Broad Street. Most of the remaining fill was encountered on the property on which the Group 1 test borings were drilled and the property to the west between the Group 1 borings and Hansen Park. It appeared that the fill slope was being undercut near these two properties as the slope was actively raveling (see Figure 10b).

- a. Area adjacent to Mission Road where fill was pushed over the edge of the bluff.
The black material on the flats was broken asphalt.
The fill slopes have reportedly failed during the past. September, 2006.

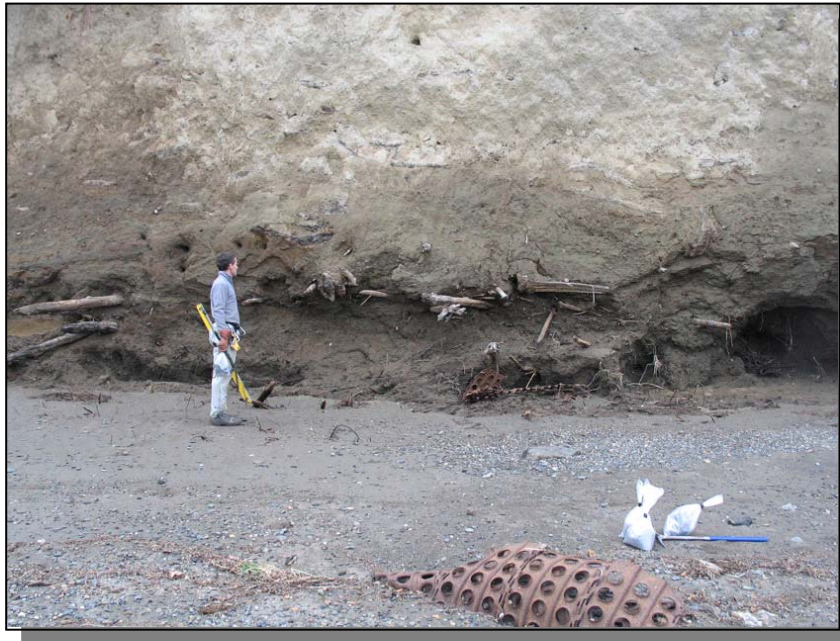
- b. Photograph taken at bottom of slope on left side of photo above.
Note undermining of the slope and "Marston Mat" in foreground. October, 2006.

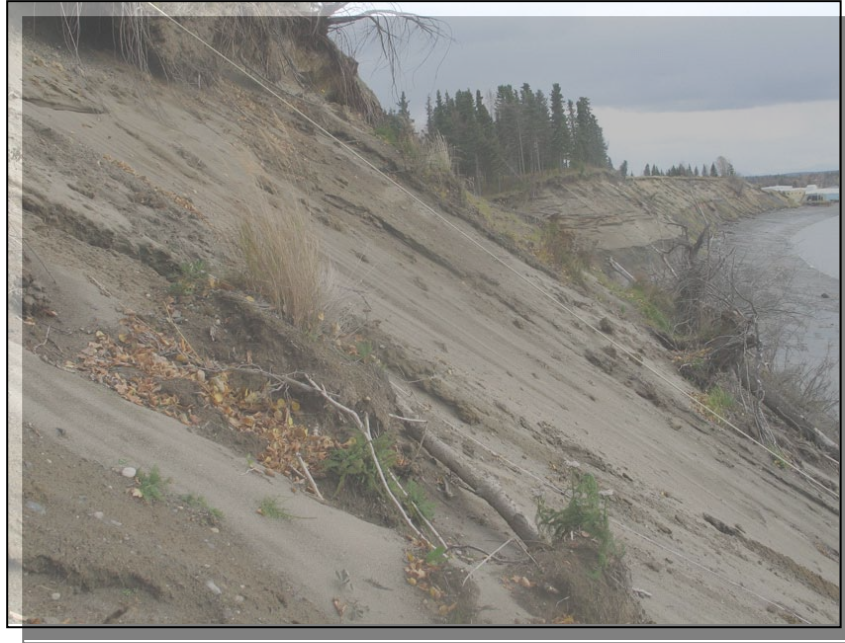
a. Slope in alluvial unit at Soil Profile SP-F.
Overhanging surficial soil layer can be seen at upper left. October, 2006.

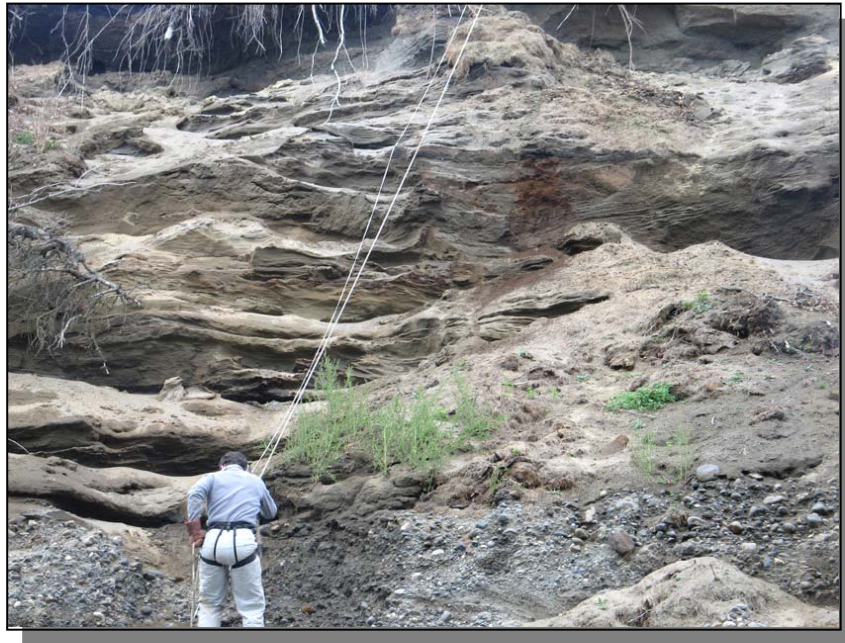
b. Cemented layers of sand at Soil Profile SP-C.
Cementation appears to allow the sand to stand almost vertical. October, 2006.

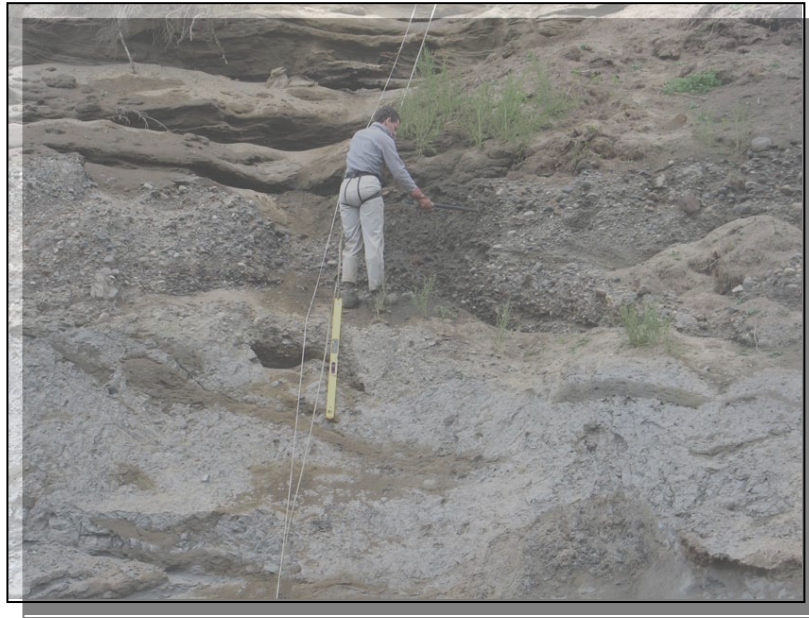
Lag gravel consisted of a relatively thin layer of more highly permeable material on top of the glacial till. For the most part, this layer was observed to be less than one foot thick; however near Soil Profile SP-C it was approximately six feet thick (see Figure 12).

a. Cemented lag gravel (darker center bed in photo) at Soil Profile SP-C.
The light gray bed below it was the dense glacial till with cobbles and boulders.
There was no water observed seeping from the bluff at this location. October, 2006.

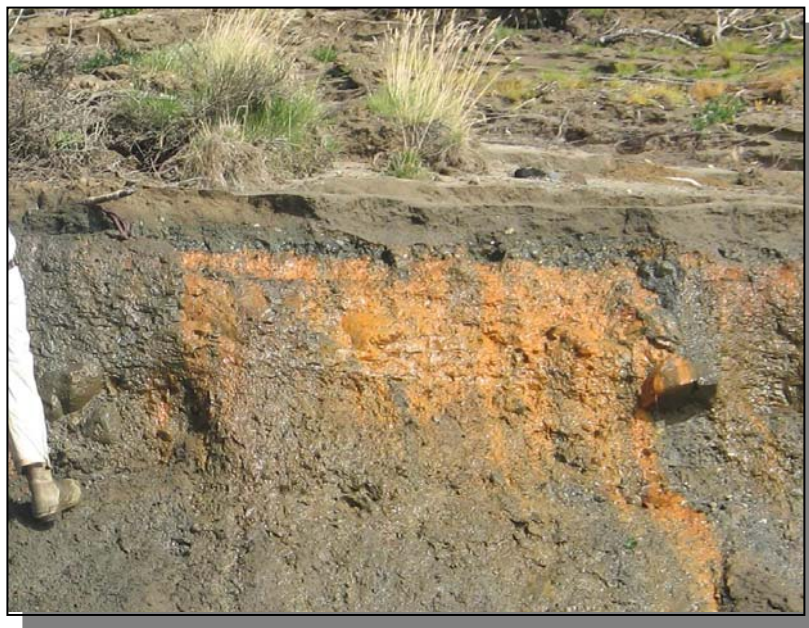
b. Thin layer of lag gravel near Soil Profile SP-H. Layer ranged from two to six inches thick
and can be seen between the rust stained glacial till below and brown sand above.
Water was observed flowing out of the gravel at this location. October, 2006.

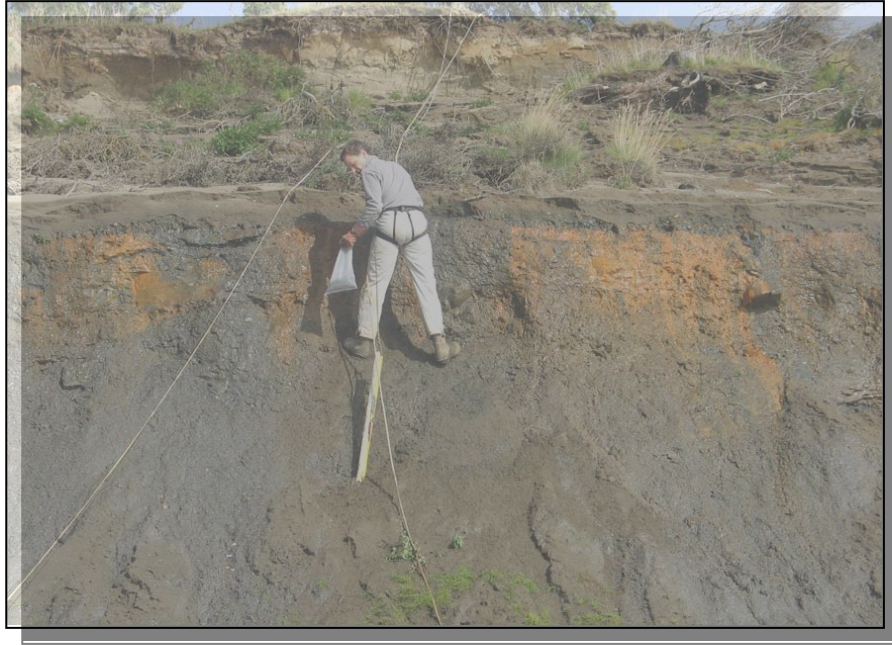
The glacial till consisted of a very hard, heterogeneous mixture of clay, sand, and gravel, with cobbles and boulders ranging widely in shape and size. The glacial till stood near vertical close to the top of the unit (Figure 13a). In some locations the glacial till had the appearance of soft, poorly indurated bedrock similar to the Tertiary-age Kenai Group found on the lower Kenai Peninsula (Figures 13b and 14a). The clay was very hard when dry, becoming softer when exposed to water. It could be carved with a knife, excavated with difficulty using a hand pick, and scratched readily with the fingernail. The clay was plastic with an average liquid limit of 27 and a plasticity index of 11. The plasticity index generally appeared to decrease with increasing sand content.

a. Top of glacial till unit at Soil Profile SP-H. Note gravel layers in till. October, 2006.

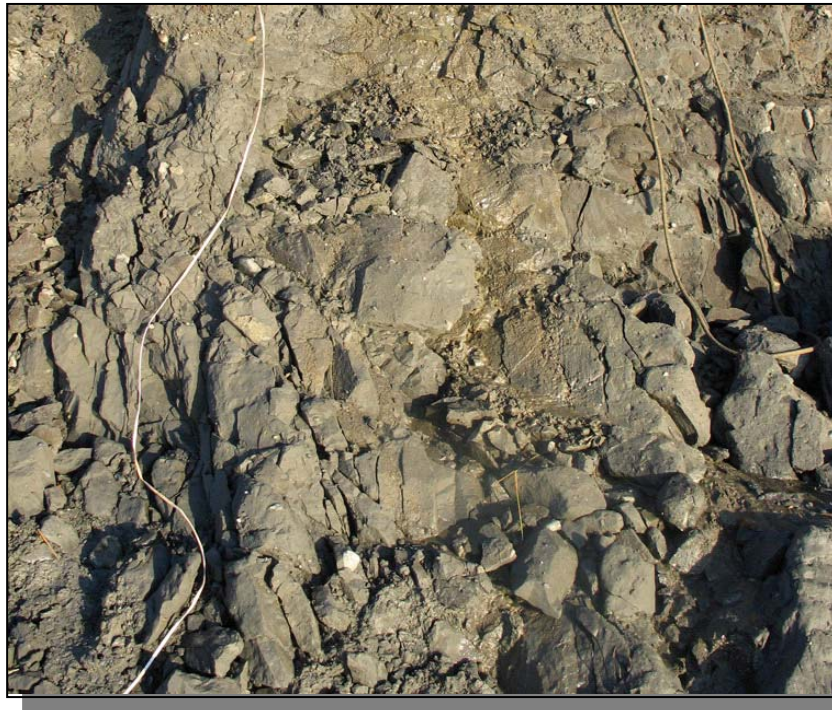
b. Glacial till exposed at the bottom of the bluff.
Note the bedrock-like jointed appearance of the clay. October, 2006.

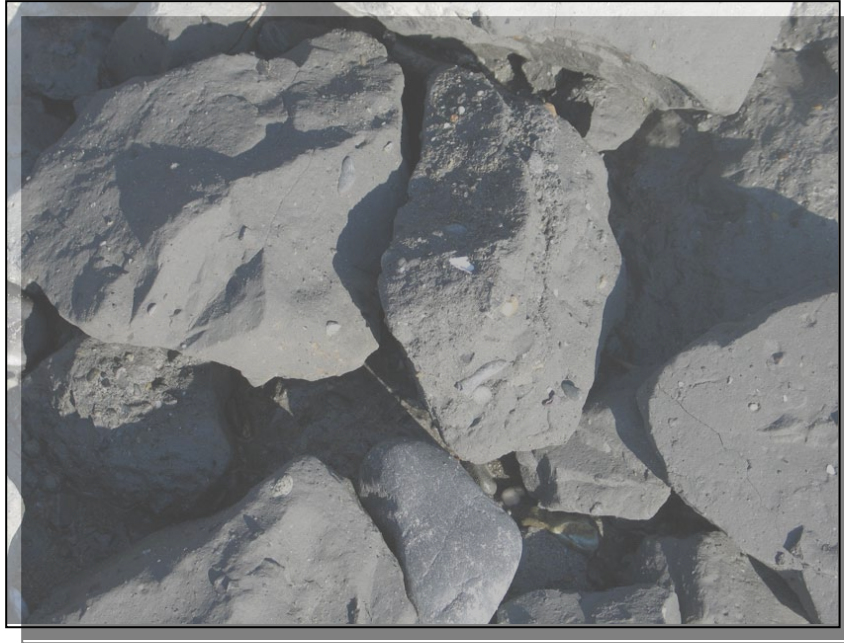
a. Large chunks (boulders) of clay found at bottom of bluff.
From a distance, these chunks can be mistaken for cobbles and boulders. October, 2006.

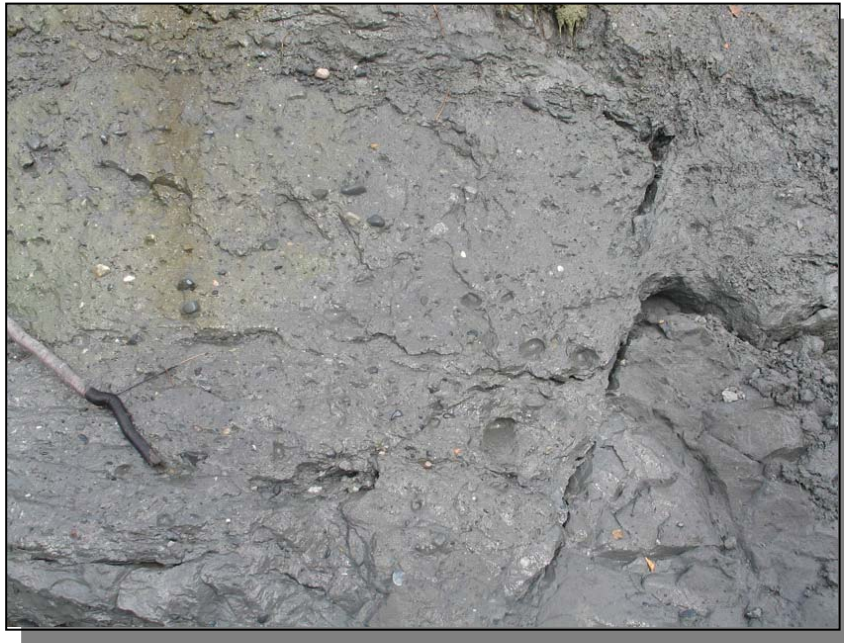
b. Scattered gravel in clayey glacial till.
Much of this gravel may be “dropstones” derived from floating glacial ice. October, 2006.

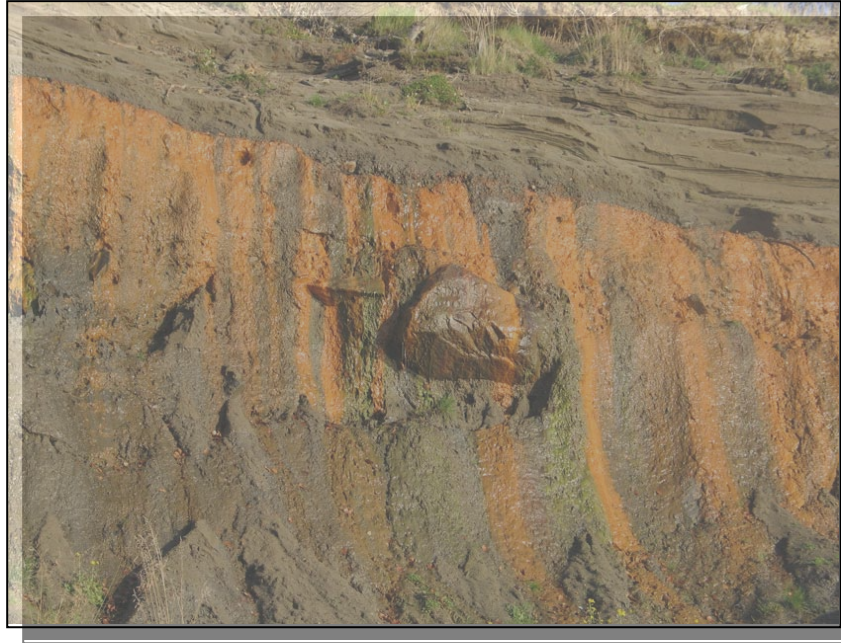
Large glacial erratics were observed protruding from the bluff in several places and there were many large boulders located on the tide flats (Figure 15). Bates and Jackson (1980) define erratics as rock fragments carried by glacial ice and deposited at some distance from the outcrop from which they were derived. Erratics are often randomly scattered throughout glacially derived material.

a. Large boulder protruding from glacial till unit in bluff near Soil Profile SP-E. The boulder was approximately five feet in length. October, 2006.

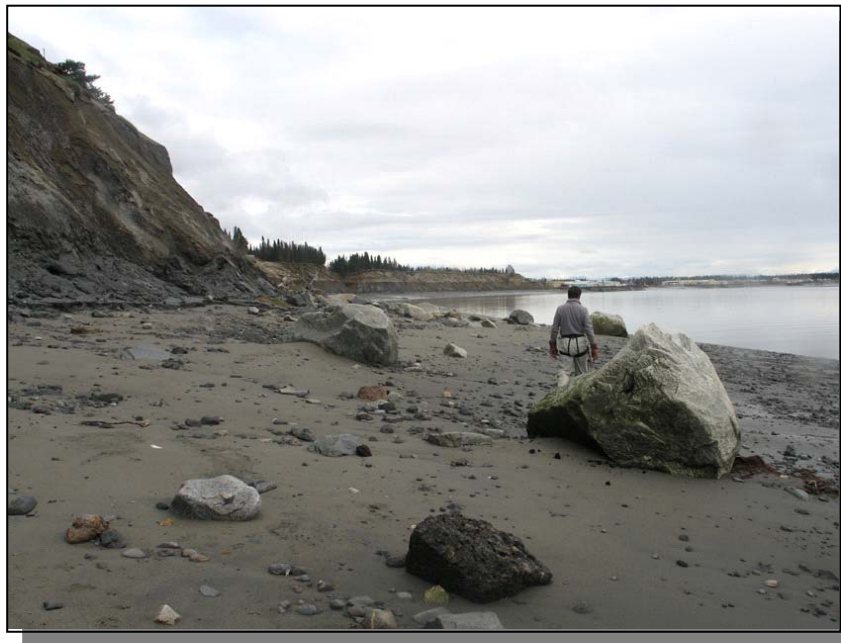
b. Large boulders on beach near Soil Profile SP-C. October, 2006.

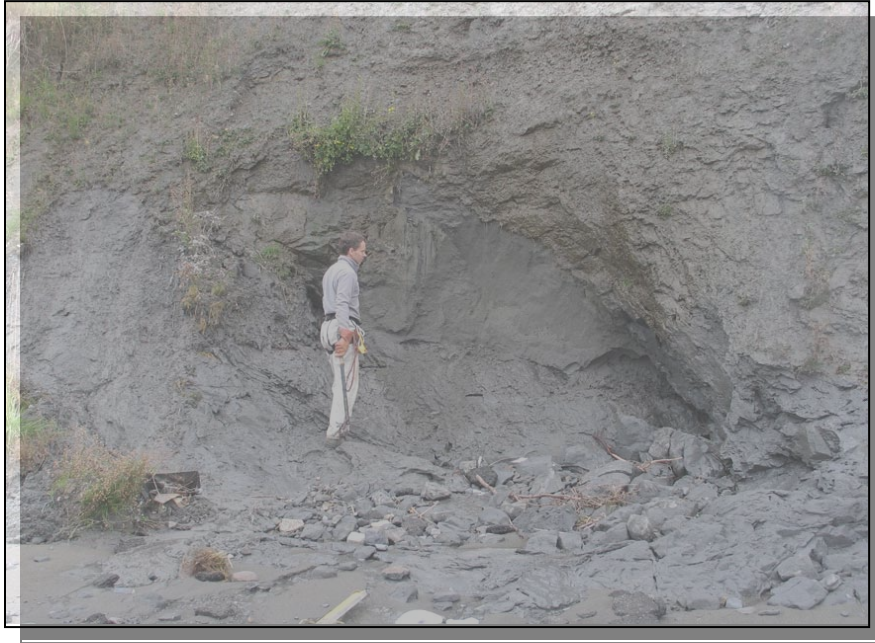
Sand pockets within the glacial till consisted predominately of fine sand with some fine to medium dark gray nonplastic sand (SP and SP-SM). Larger pockets of sand were also noted along the bluff (Figure 16a). The largest of these pockets ranged up to about 12 feet high and 100 feet long (Figure 17b). The size and incidence of the sand pockets appeared to increase toward the west end of the project and a significant portion of the glacial till unit was composed of this sand at the Group 1 test boring location.

a. Sand pocket in glacial till showing signs of erosion. October, 2006.

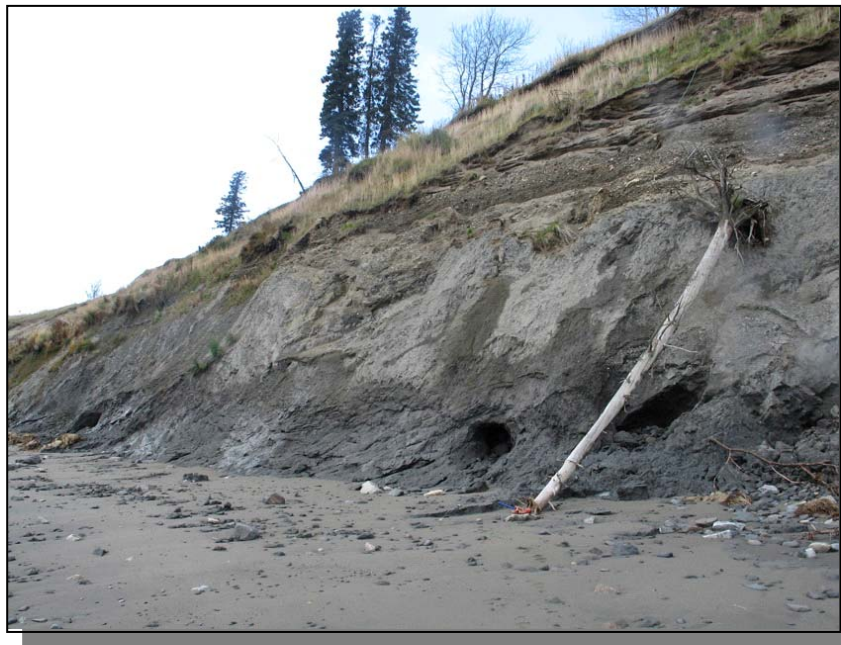
b. Caves interpreted to have been created by the erosion of sand pockets along bottom of the bluff near Soil Profile SP-C. October, 2006.

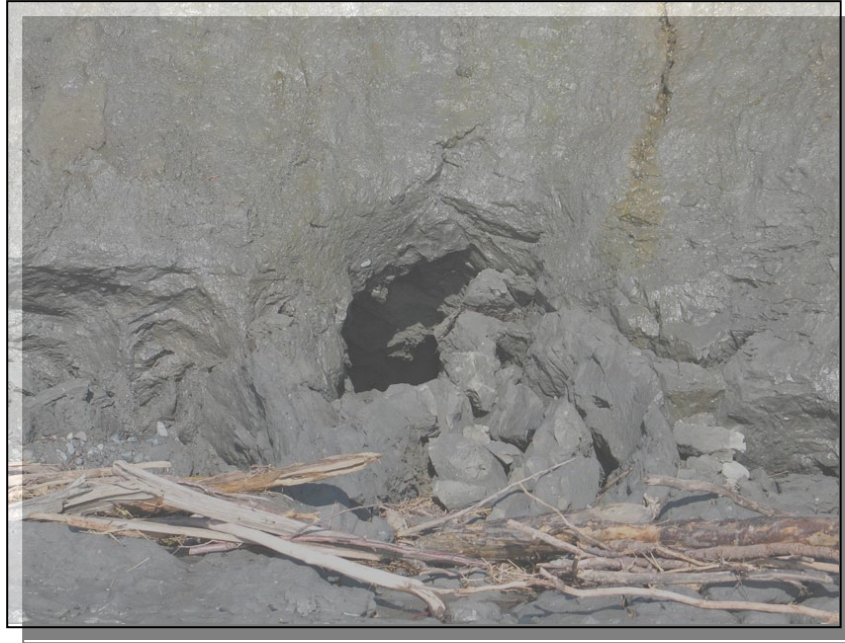
a. Caves formed in bluff by erosion of sand pockets.
Note caving of clay caused by undermining due to removal of sand. October, 2006.

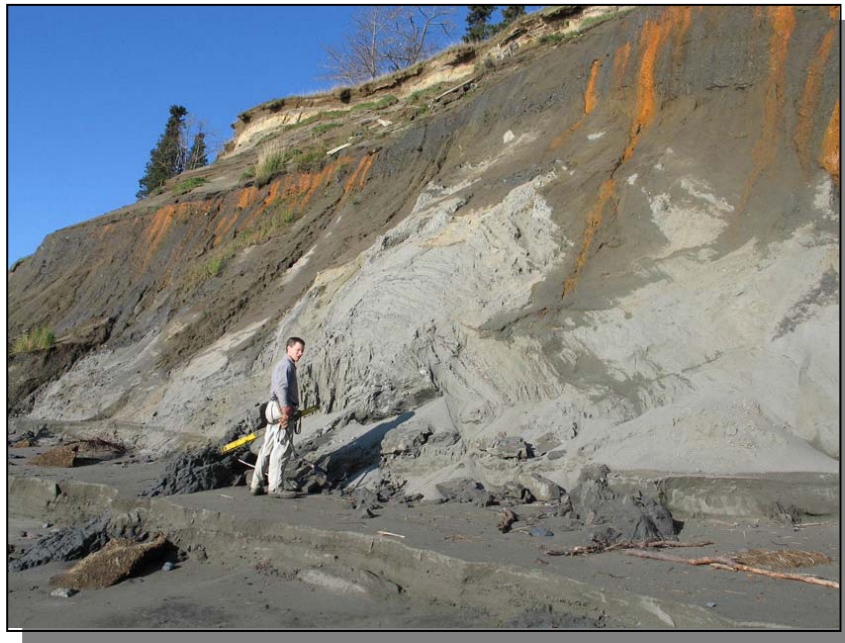
b. Light gray material in center of photo was part of a large
sand pocket observed west of Soil Profile SP-C. October, 2006.

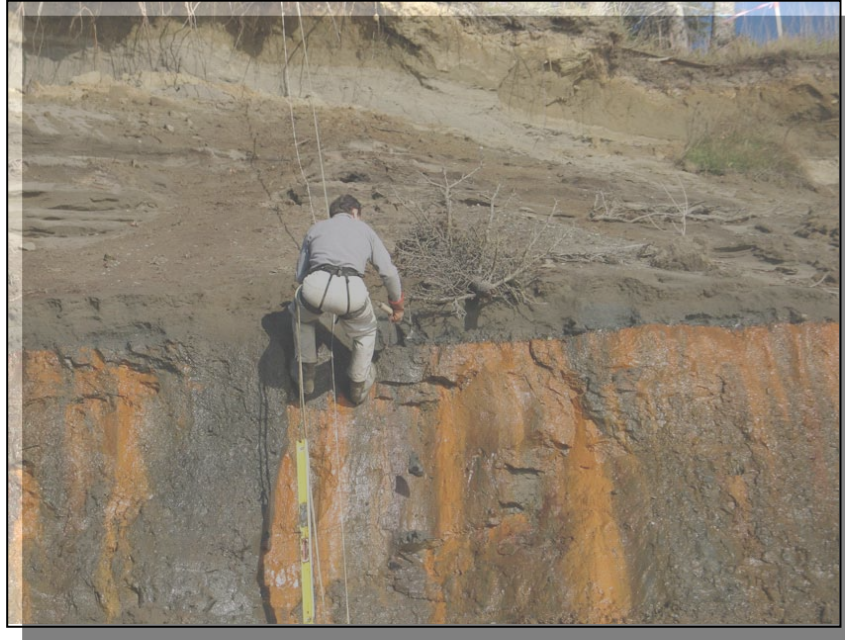
a. Groundwater seeping out of bluff at Soil Profile SP-D west of Ryan's Creek. October, 2006.

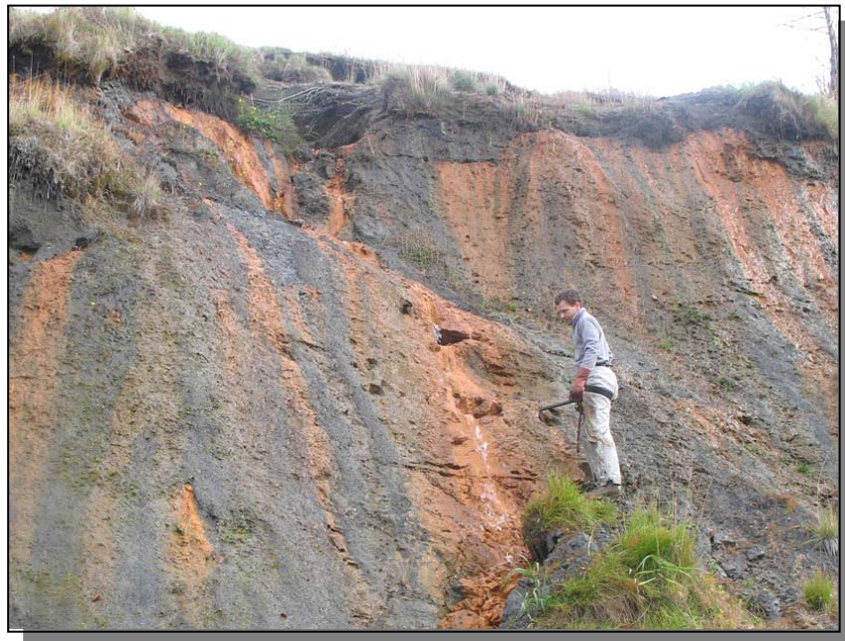
b. Small stream flowing out of bluff face near Soil Profile SP-I, east of Ryan's Creek. October, 2006.

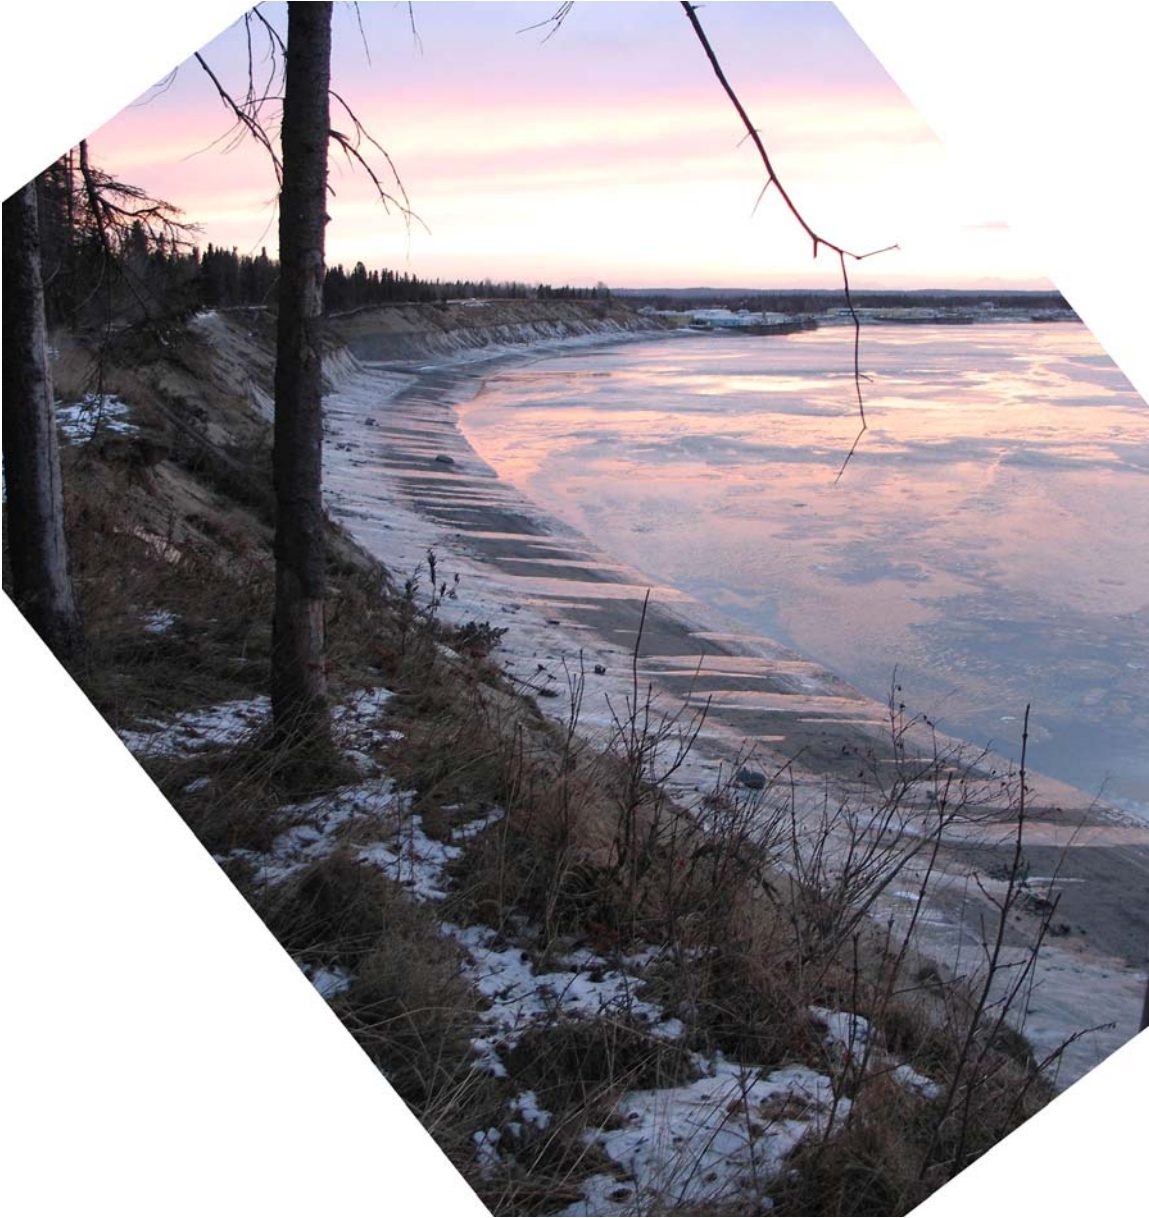
Looking east along tide flats from Group 2 test borings at low tide on one of the first cold days of the winter. Later in the winter the flats were completely covered by ice.

Note the high water line above (white area on left side of flats) and the frozen streams of fresh water as they flow into the river.
