Deering Streambank Protection

Condition of Improvements
31 December 2017
Deering Streambank Protection, Alaska
(CWIS No. 092906, 180355)

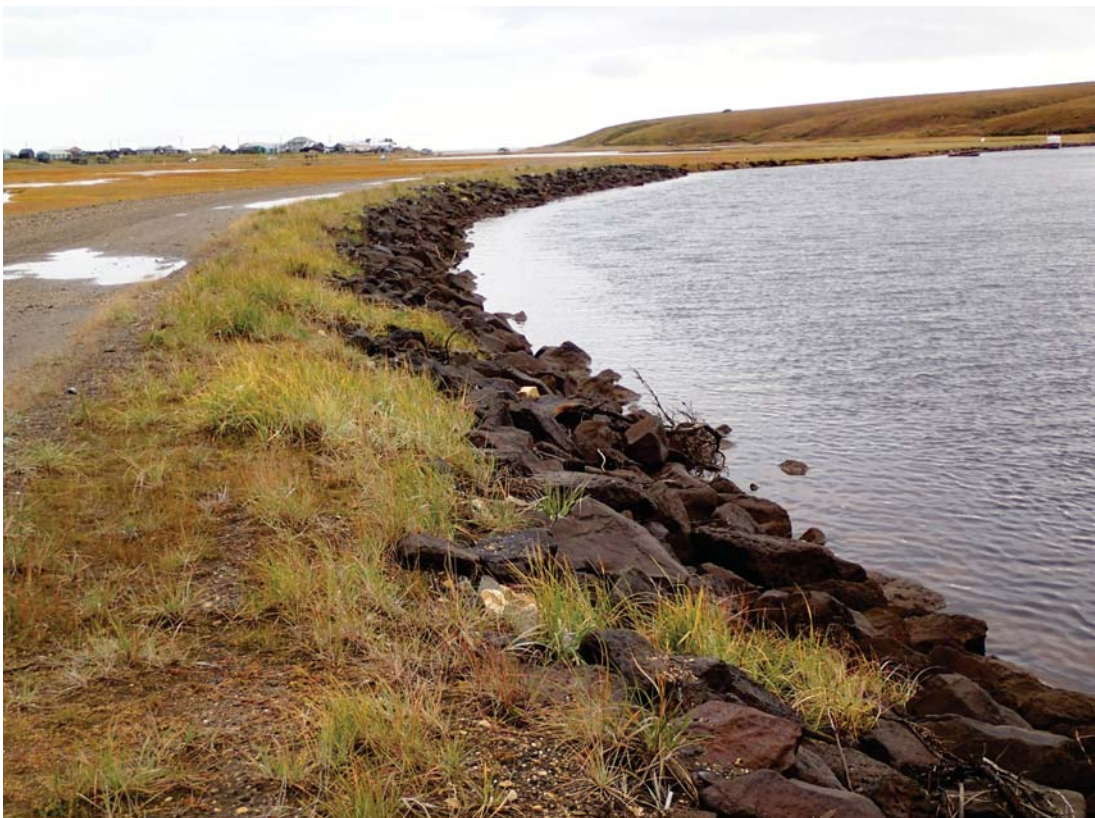
Looking downstream at the approximately 800-ft long revetment, September 2013

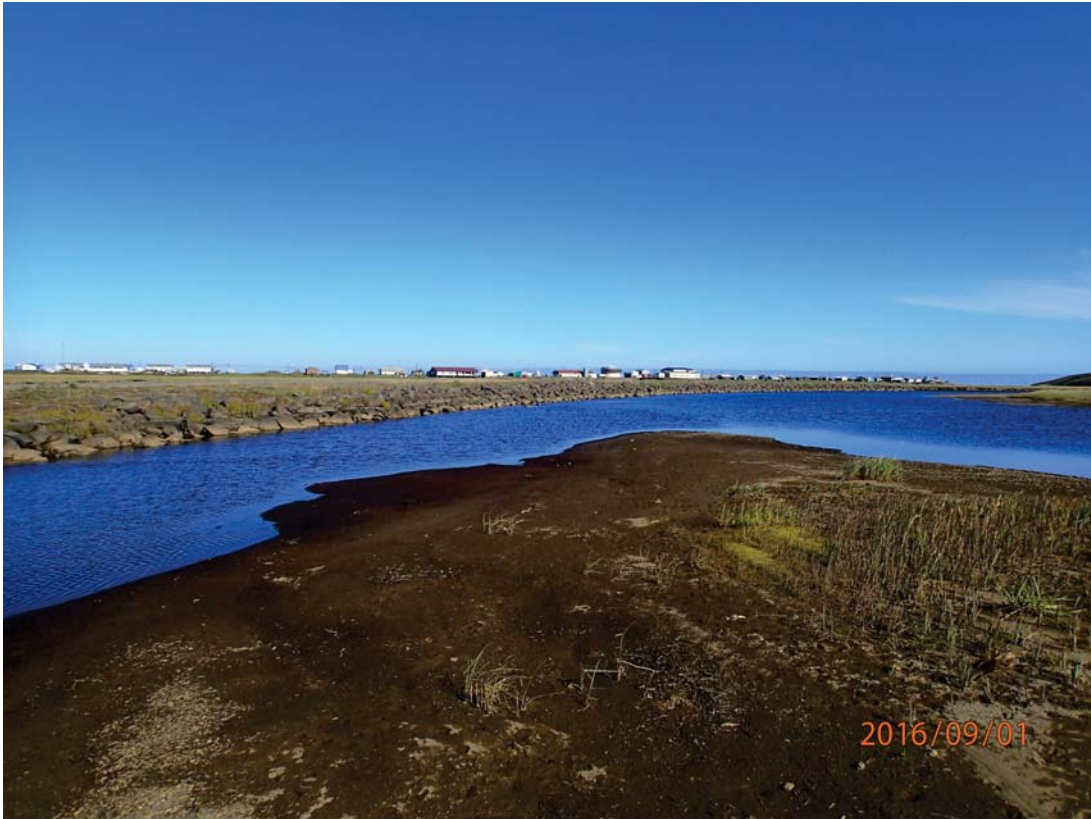
Looking at the revetment along the airport road, September 2016

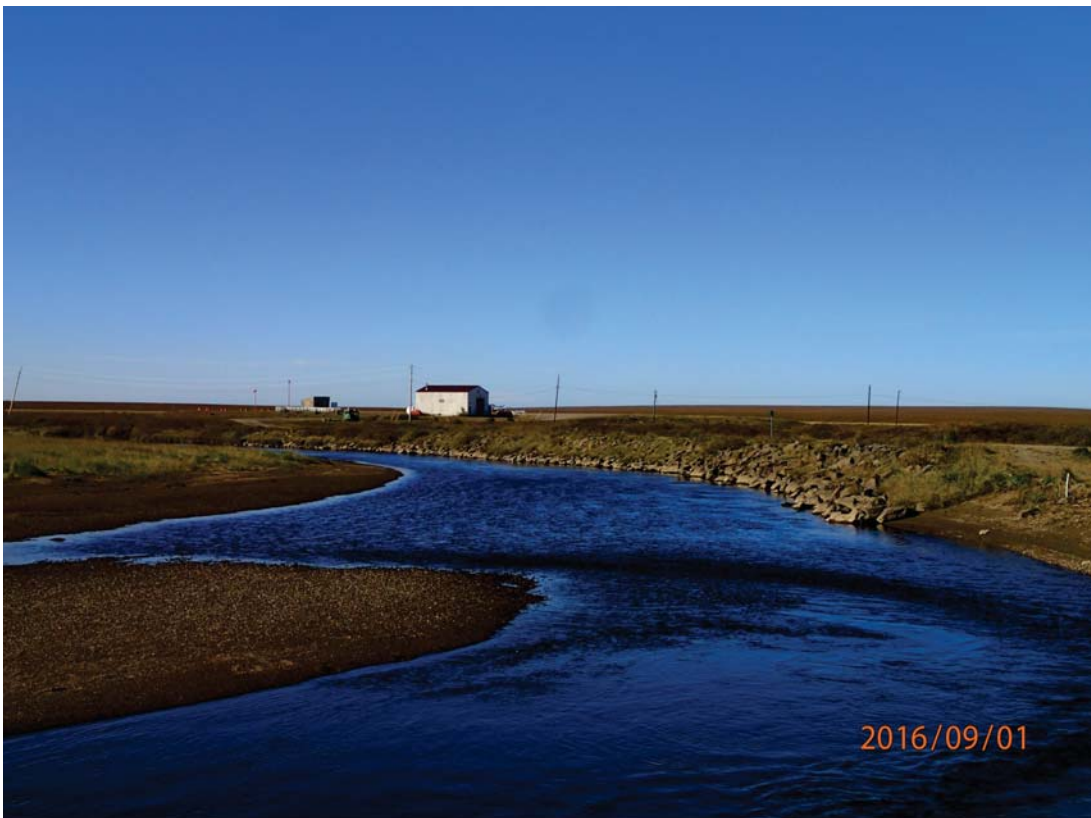
Revetment near the airport, September 2016
