Dillingham Bank Stabilization

Condition of Improvements

30 December 2015

(CWIS No. 075441)

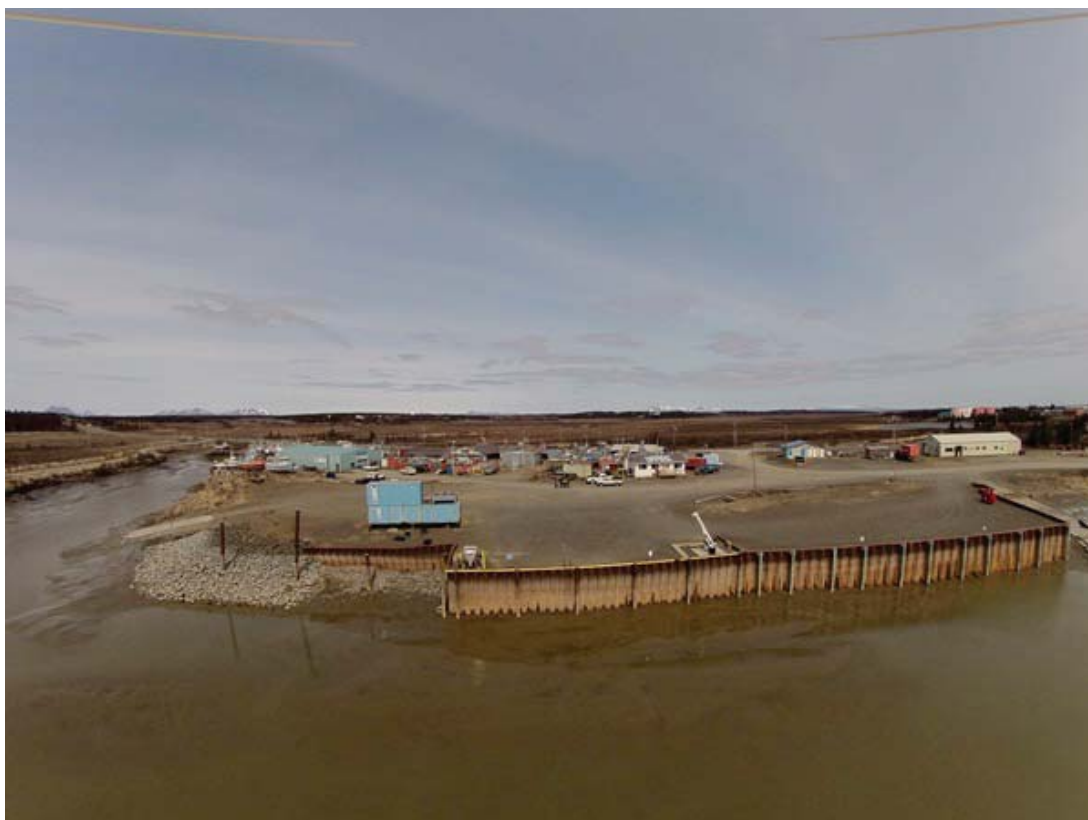
Riprap and sheetpile protection on the east side of the entrance channel, May 2014

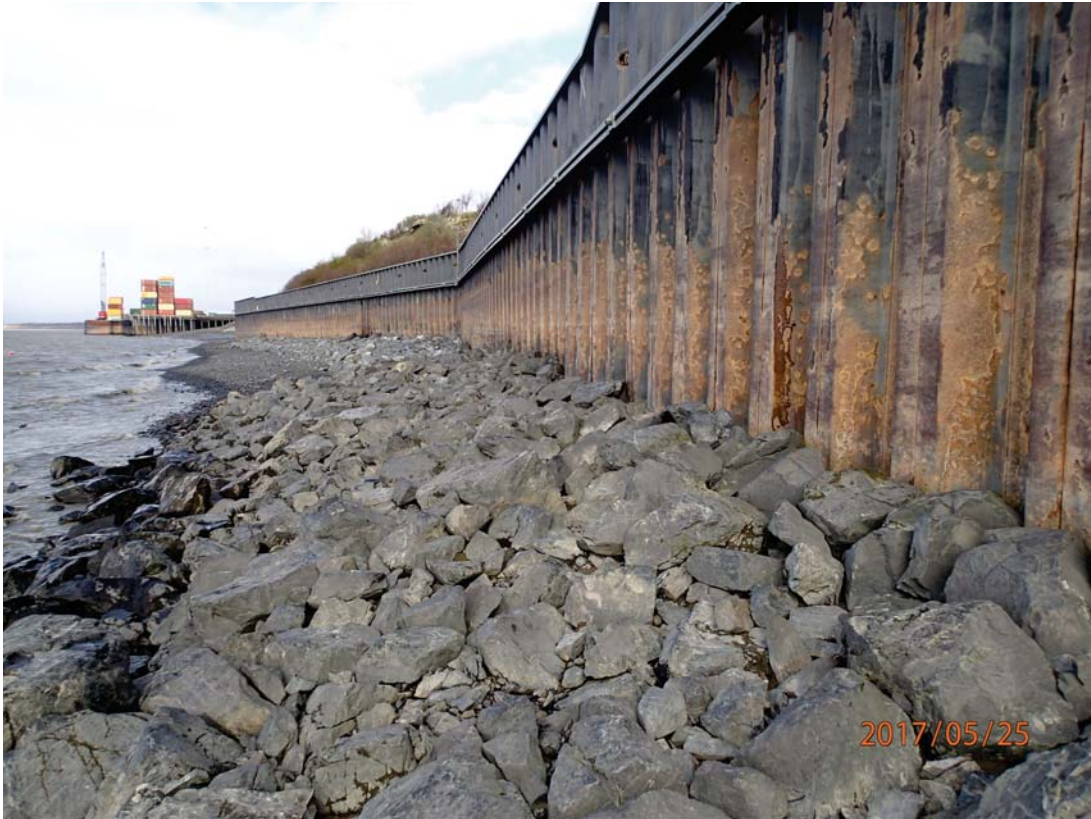
STA 21+00, Riprap @ Toe, Facing Downstream, May 2017

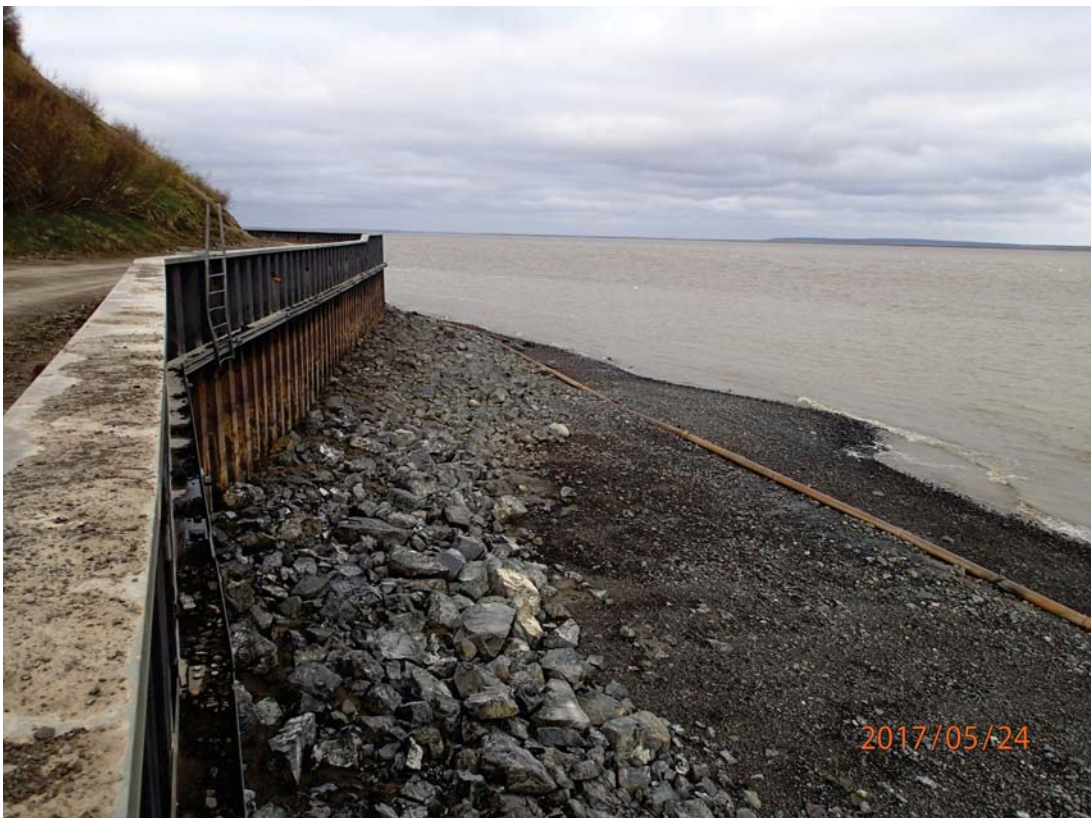
Top of Wall, STA 19+10, Riprap @ Toe, Facing Upstream, May 2017

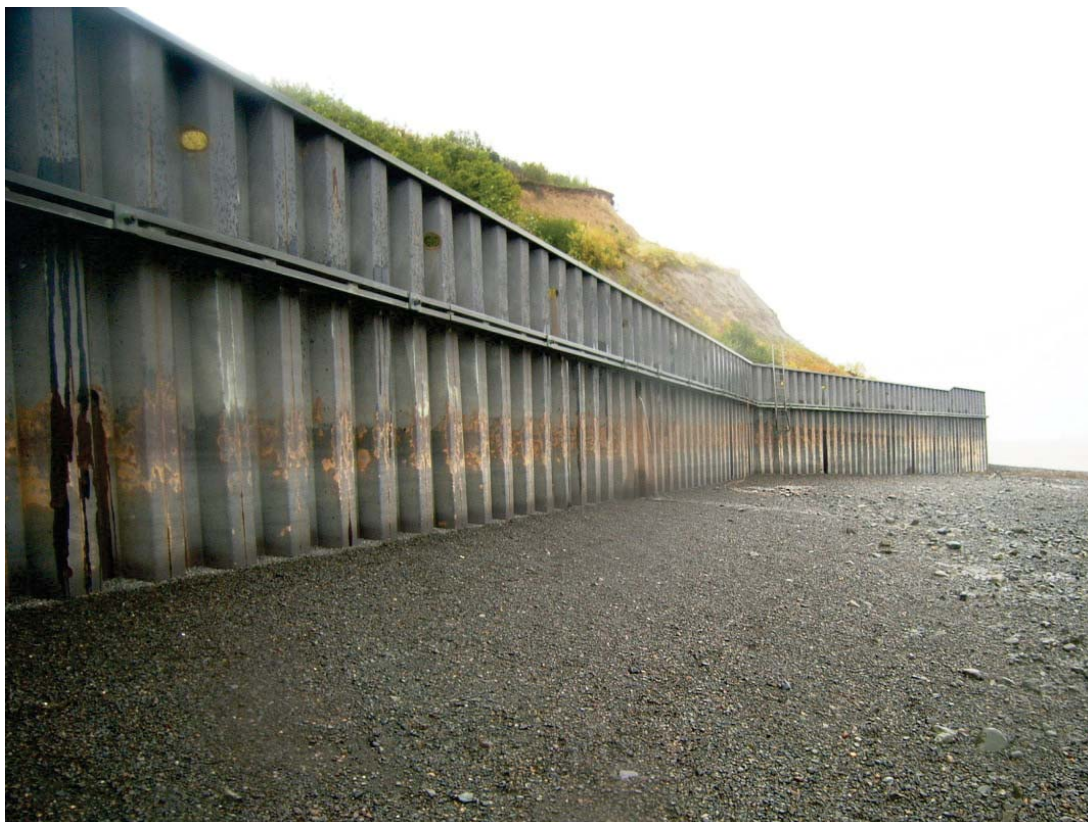
H-pile supported sheetpile bulkhead, September 2008

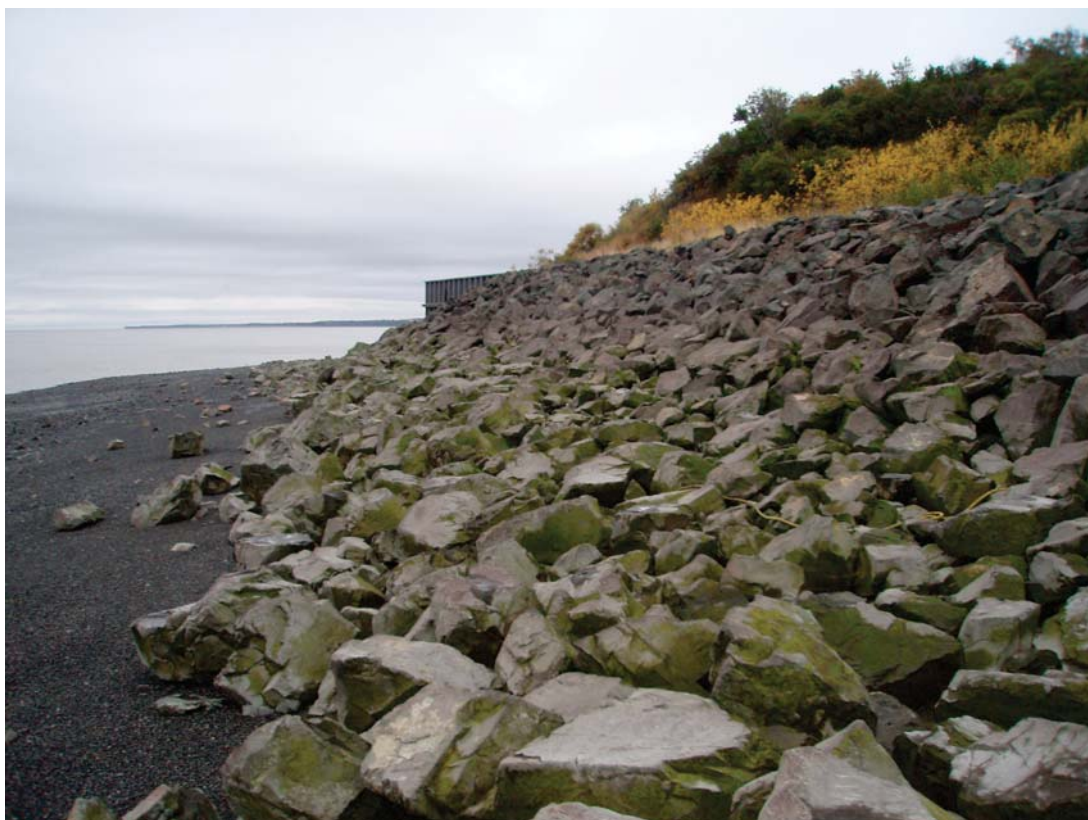
Rip-rap protection at the eastern extent of bank stabilization, 14 August 2008
