# **Emmonak Streambank Protection**

Condition of Improvements  
31 December 2017  
**Emmonak Streambank Protection, Alaska**  
(CWIS No. 092872, 325884)

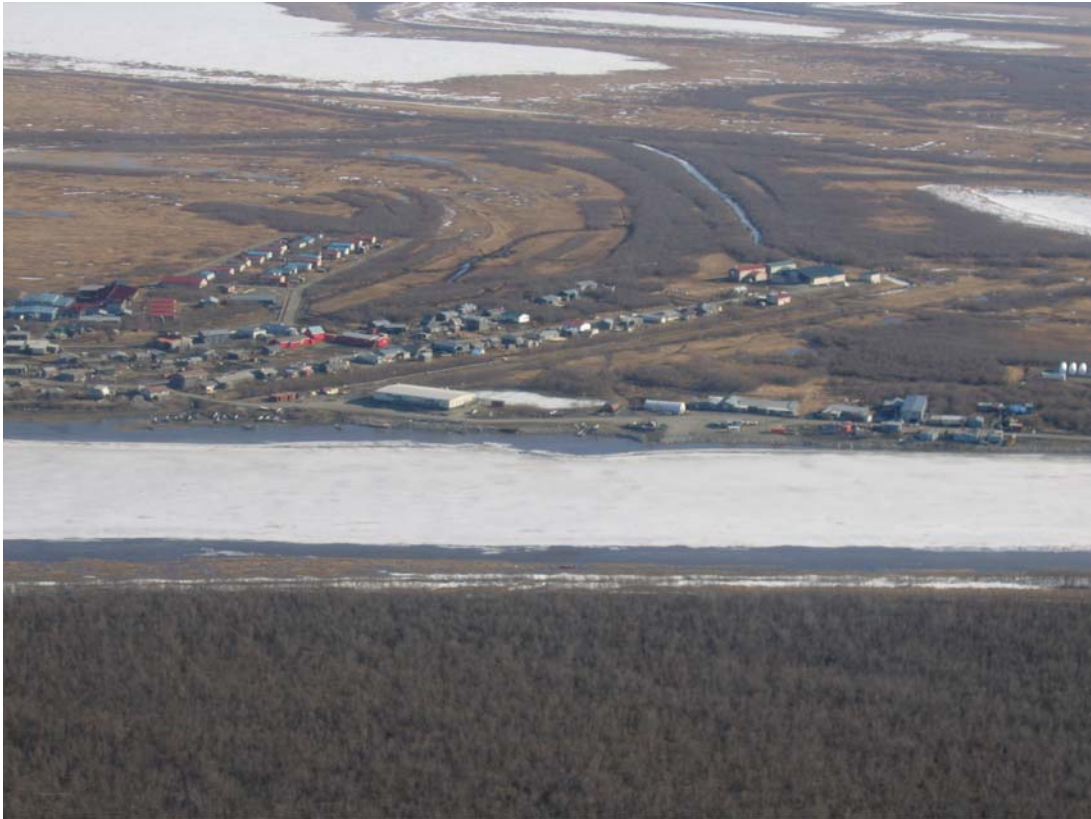
Oblique of the Emmonak streambank protection, May 2007

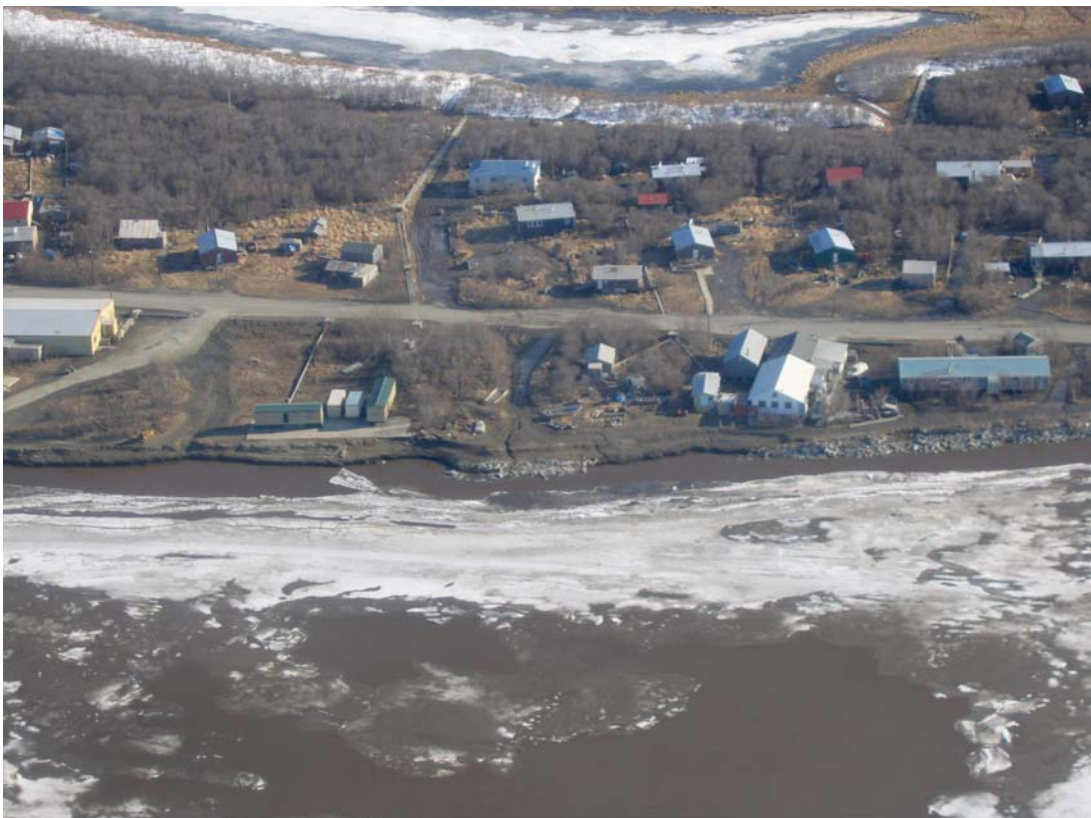
Oblique of the Emmonak streambank protection, May 2007

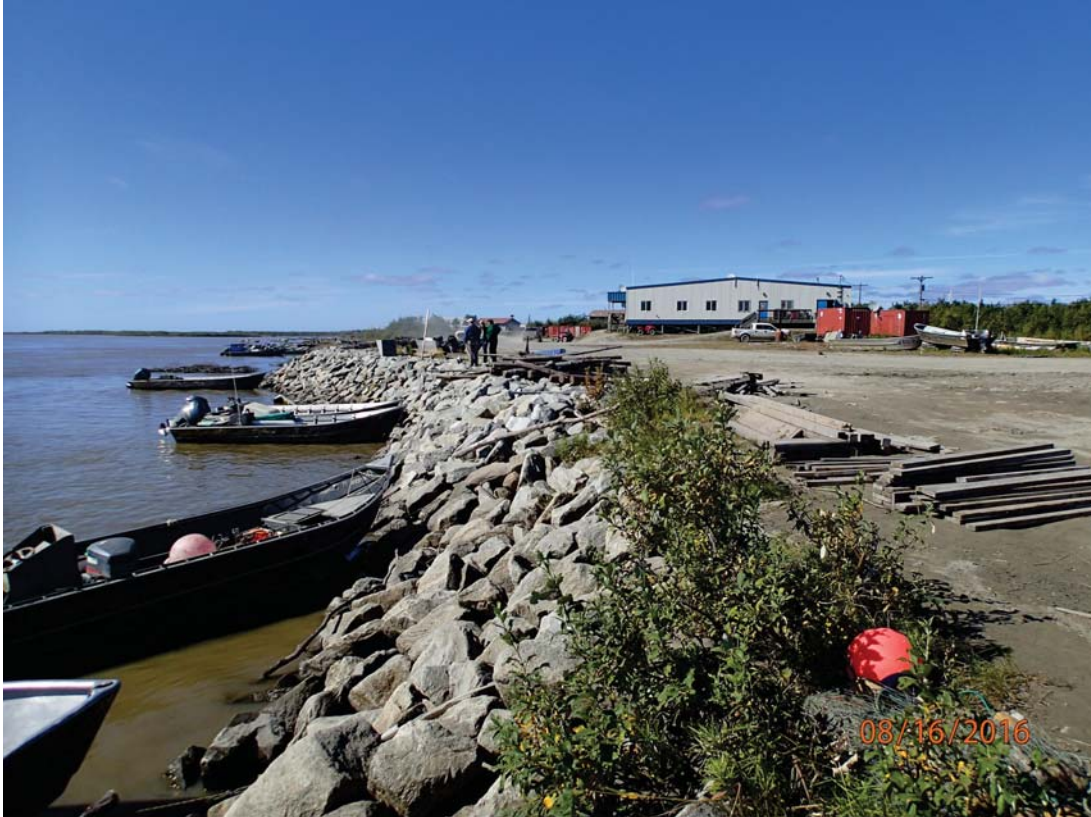
Emmonak revetment downstream of fish processor, August 2016

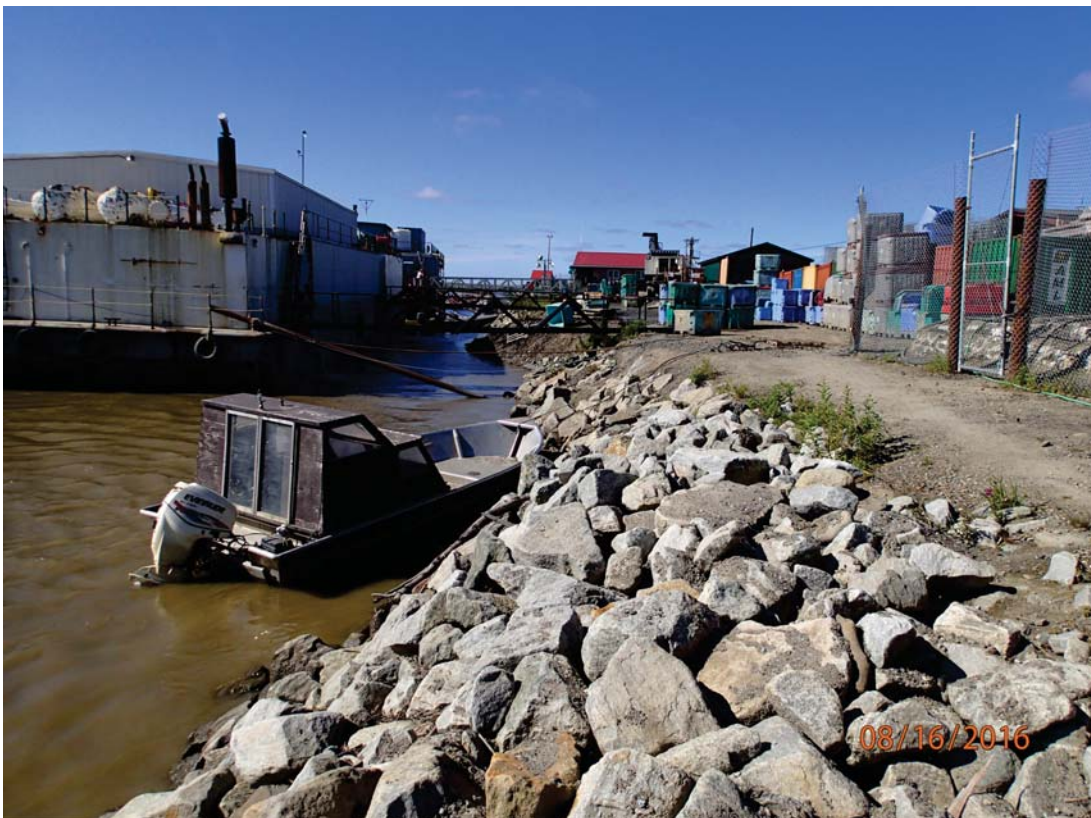
Emmonak revetment near fish processor, August 2016

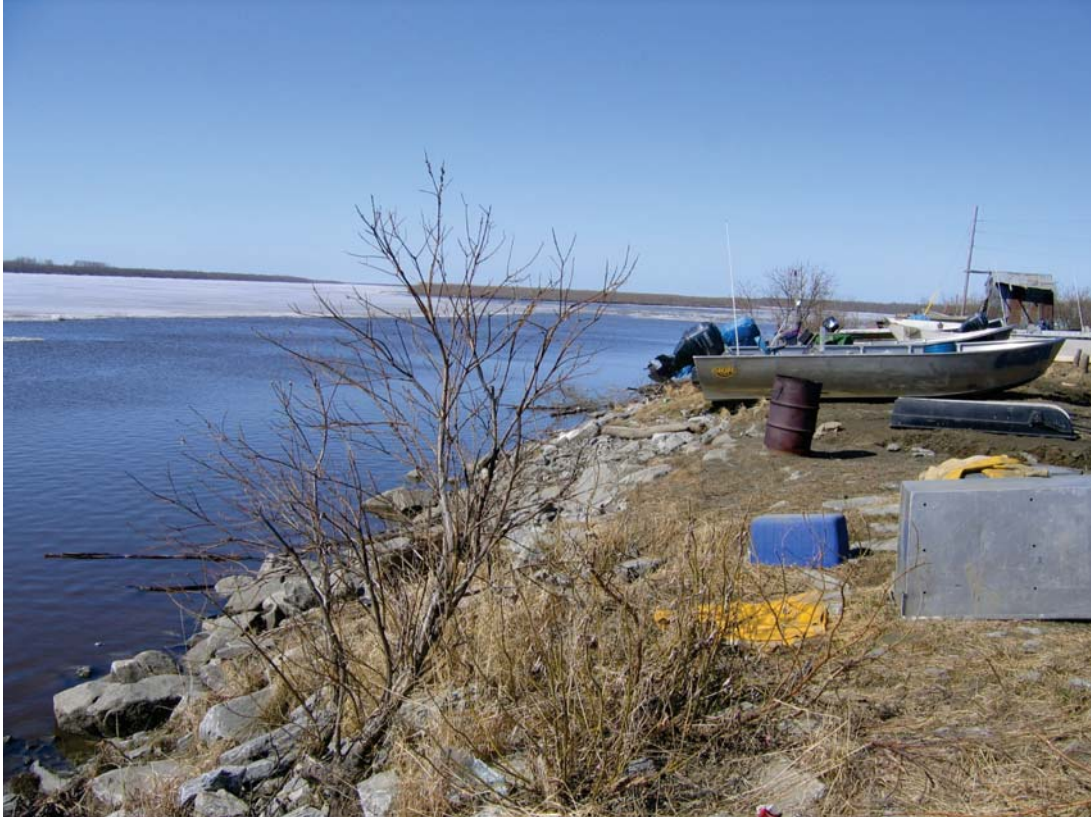
Emmonak streambank protection, 16 May 2007

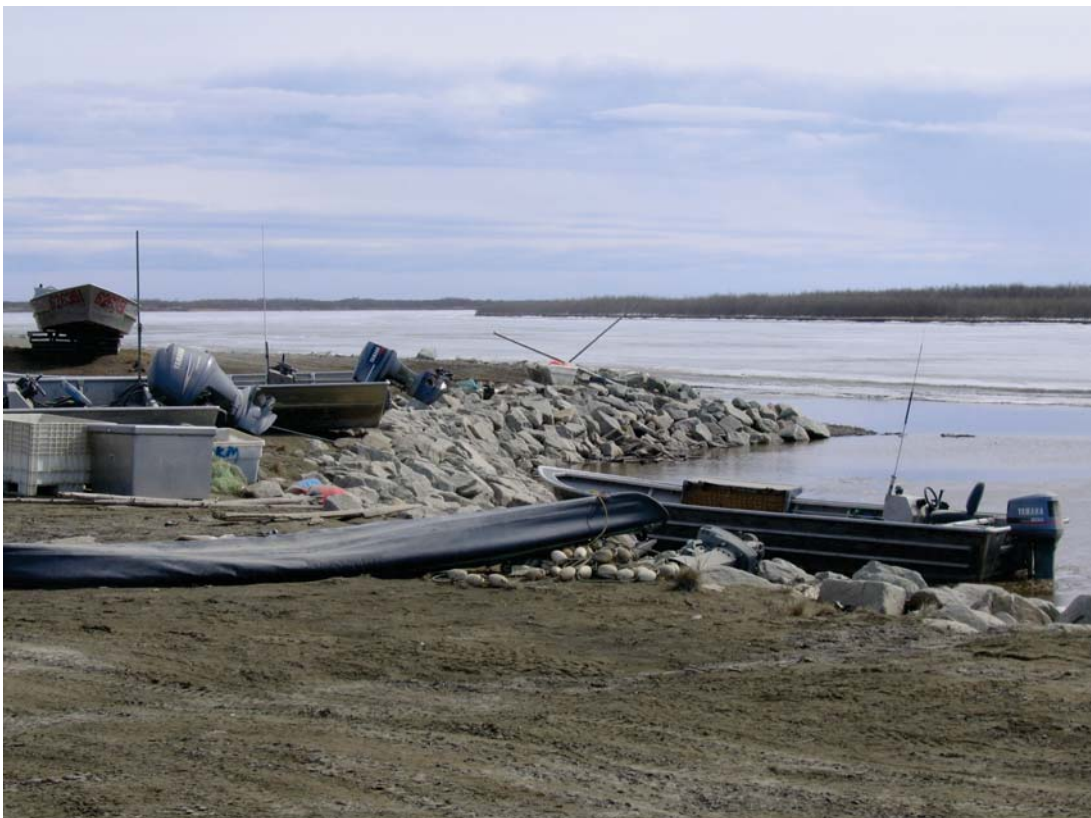
Emmonak streambank protection, 16 May 2007
