Gold Creek

Condition of Improvements
31 December 2017
Gold Creek, Alaska
(CWIS No. 006630, 150225)

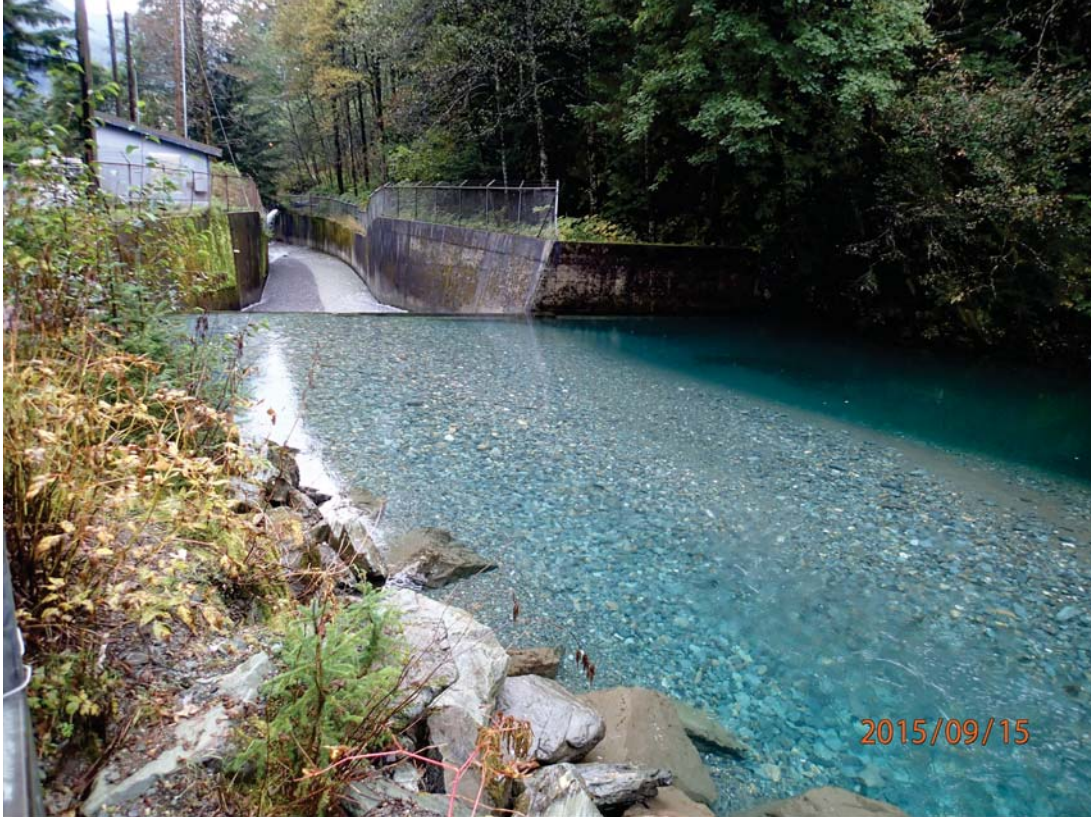
2016	The inspection found the channel in satisfactory condition, however a progression of concrete erosion was noted. The debris basin at the upstream end of the project was found to be full of rocks and gravel.
2017	The channel was inspected by walking the invert in April. Numerous damaged concrete areas not seen from the top of the channel were identified, notably under the Willoughby Street Bridge.

Weir and debris basin at upstream end of channel, September 2015

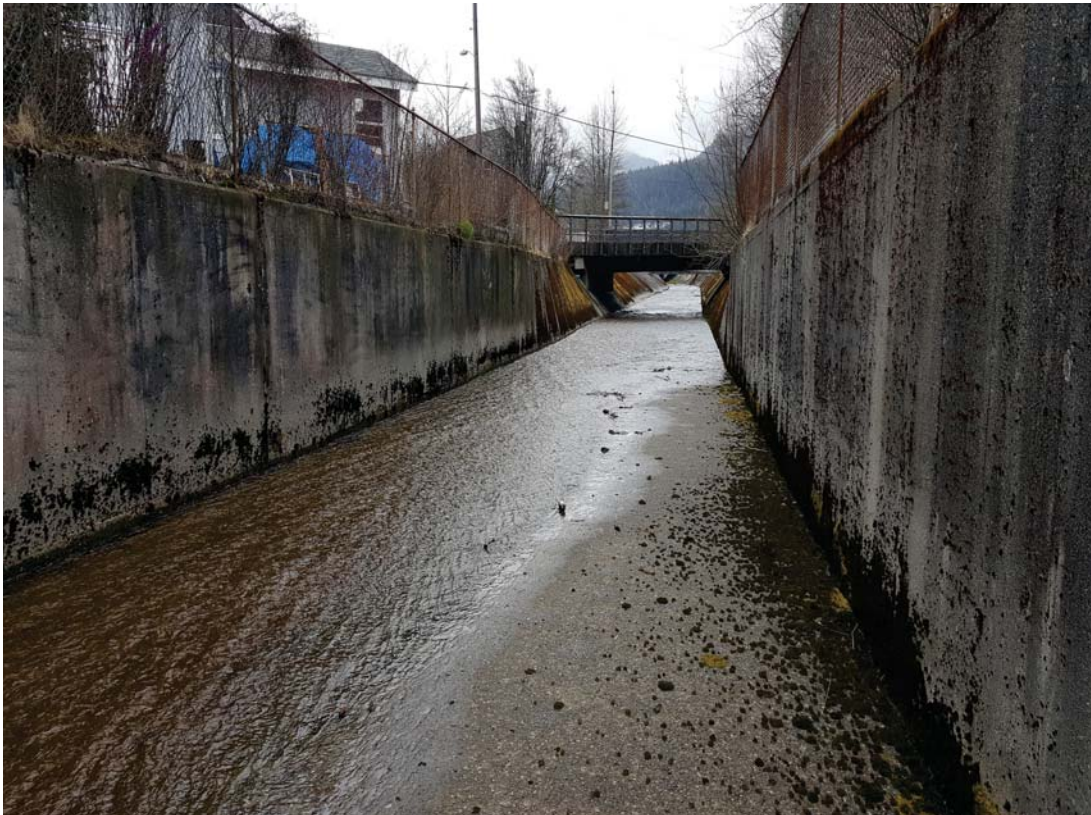
Concrete channel near 9th Street, 2017
