Klutina River

Condition of Improvements
31 December 2017
Klutina River at Copper Center, Alaska
(CWIS No. 003830)

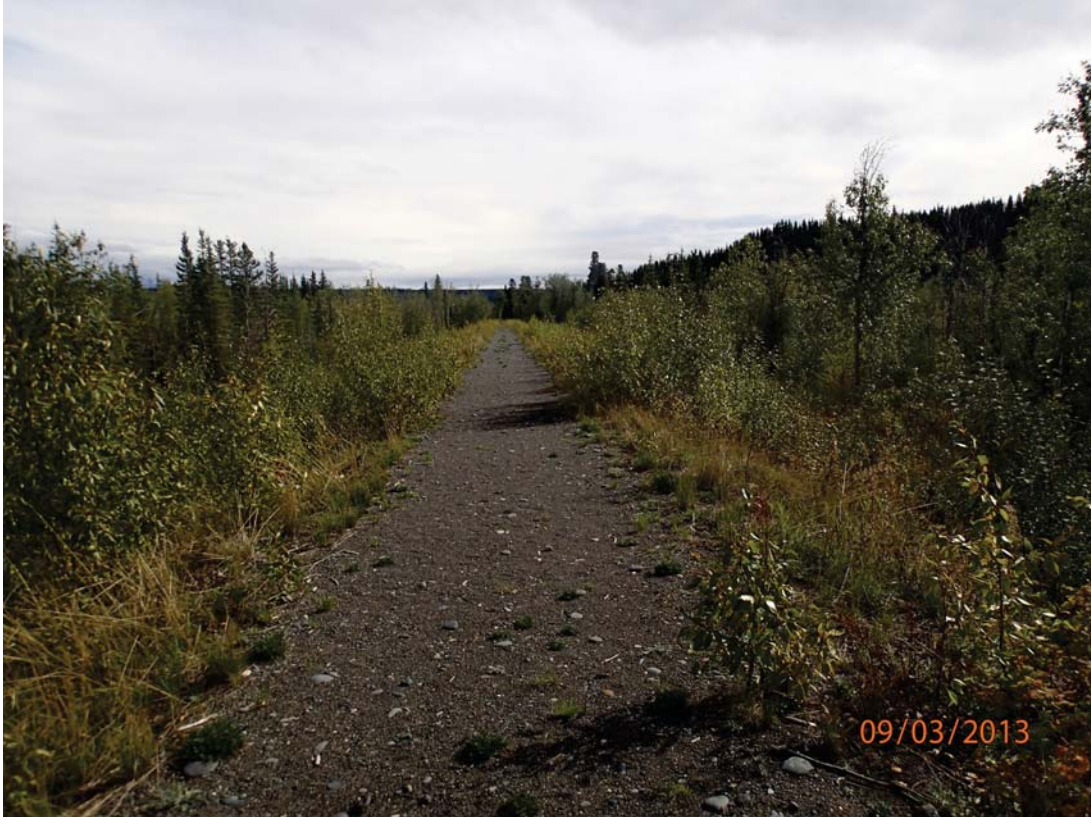
Klutina River Levee, September 2013

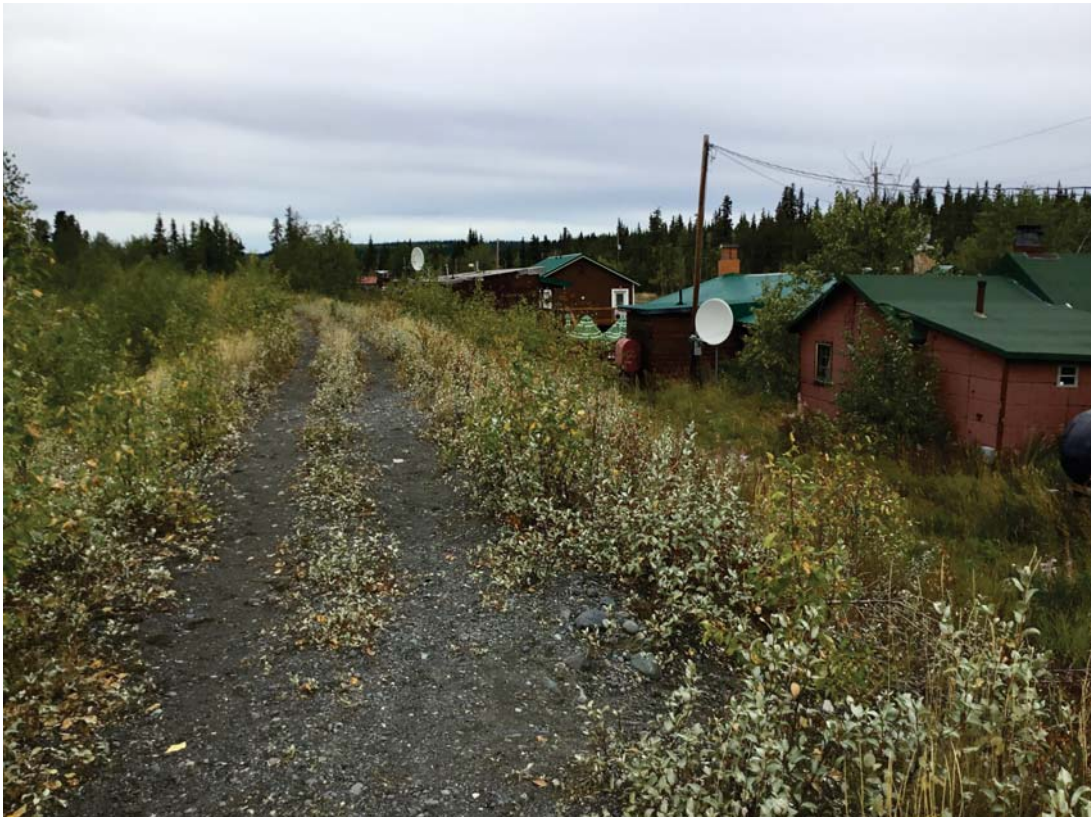
Encroachments within the levee footprint, August 2017
