# **Metlakatla Erosion Protection**

Condition of Improvements  
31December 2017  
**Metlakatla Erosion Protection, Alaska**  
Cemetery and Fuel Tank Facility  
(CWIS No. 092796, 092830)

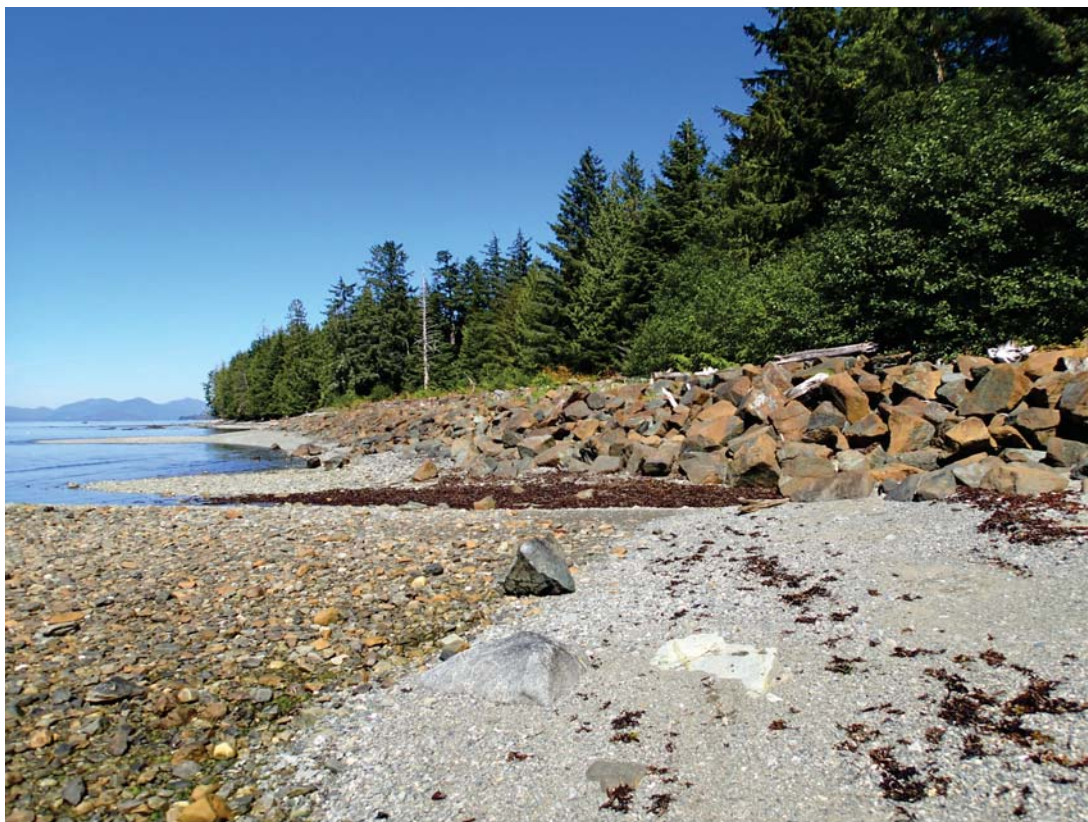
The cemetery rock revetment , August 2017

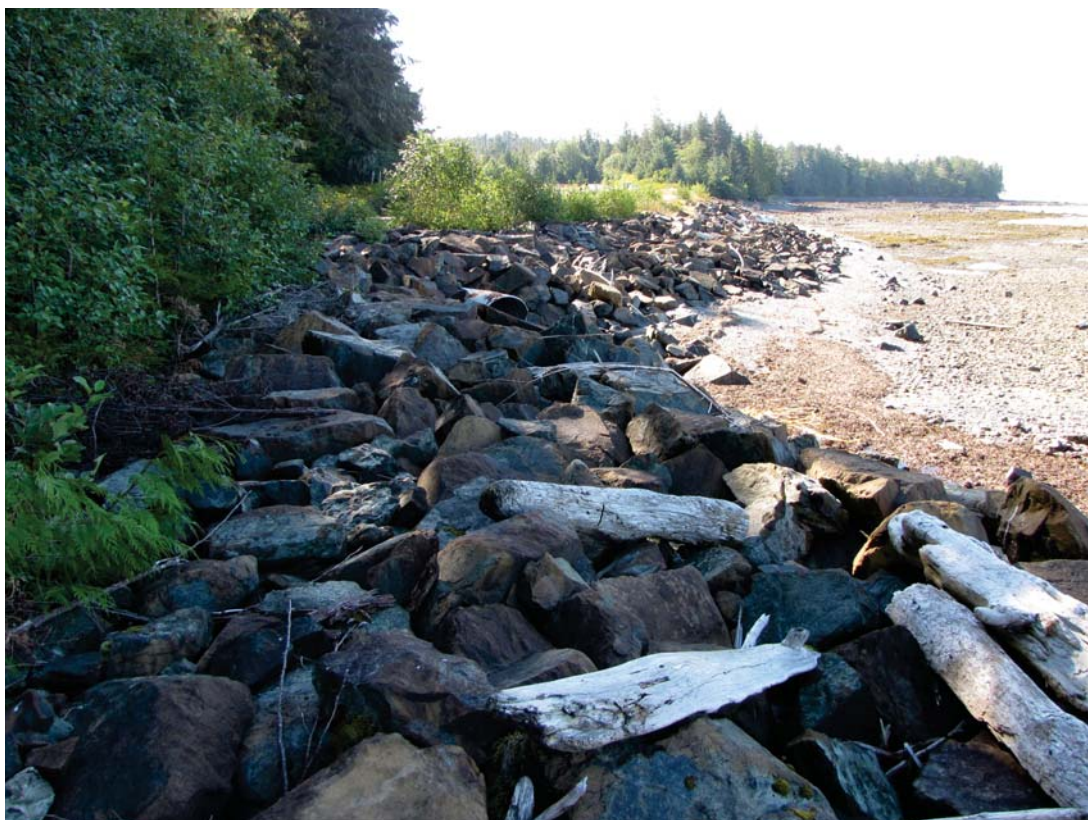
The cemetery rock revetment , September 2010

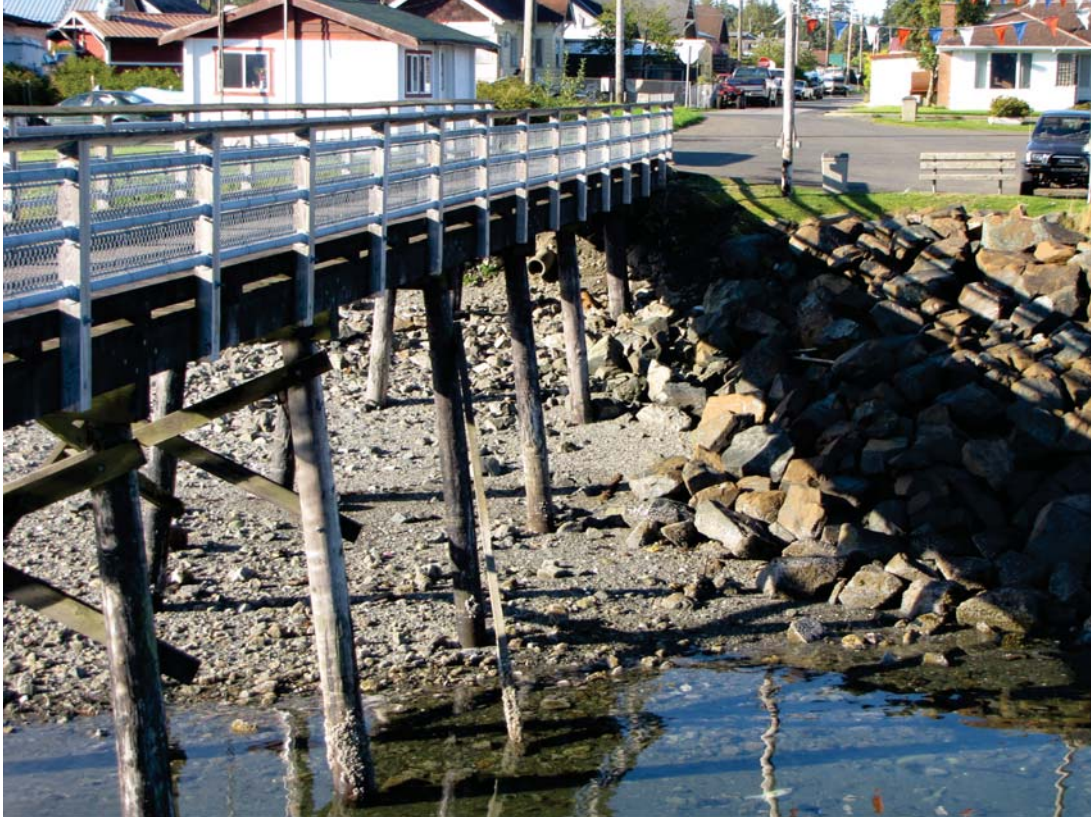
The east extent of the tank farm rock revetment , September 2010

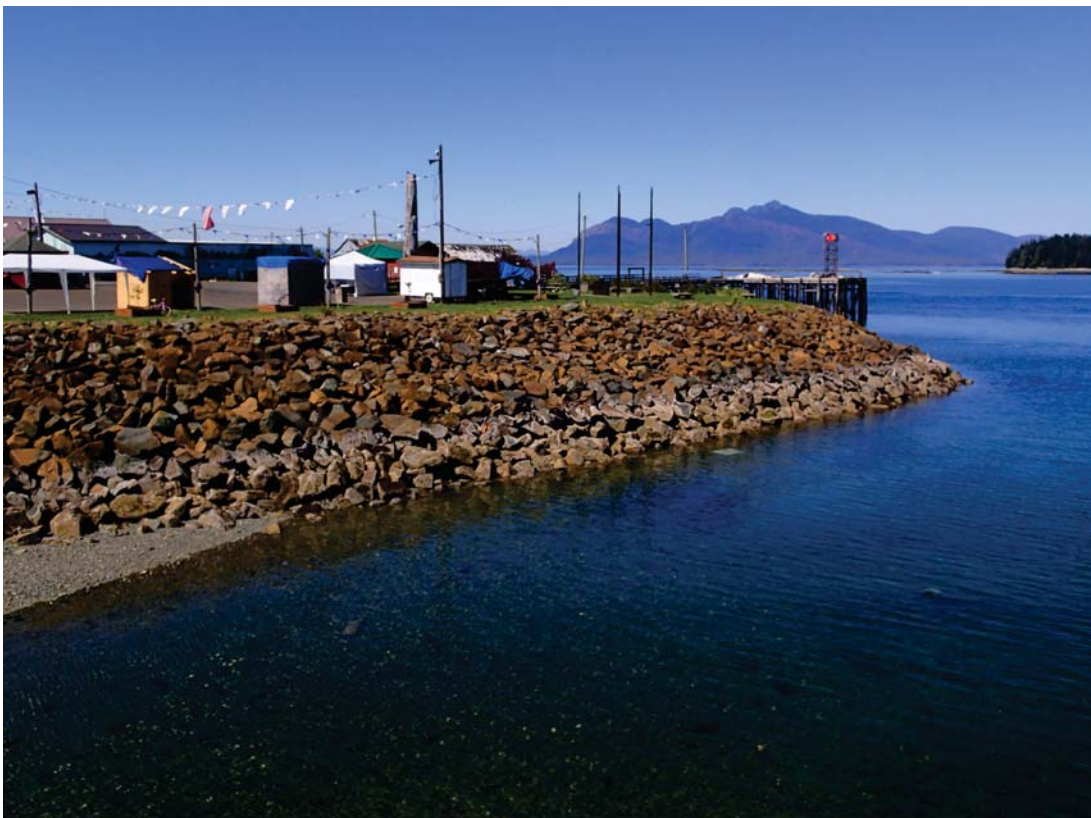
City Park rock revetment, August 2017
