# **Deering Streambank Protection**

Condition of Improvements  
31 December 2019  
**Deering Streambank Protection, Alaska**  
(CWIS No. 092906, 180355)

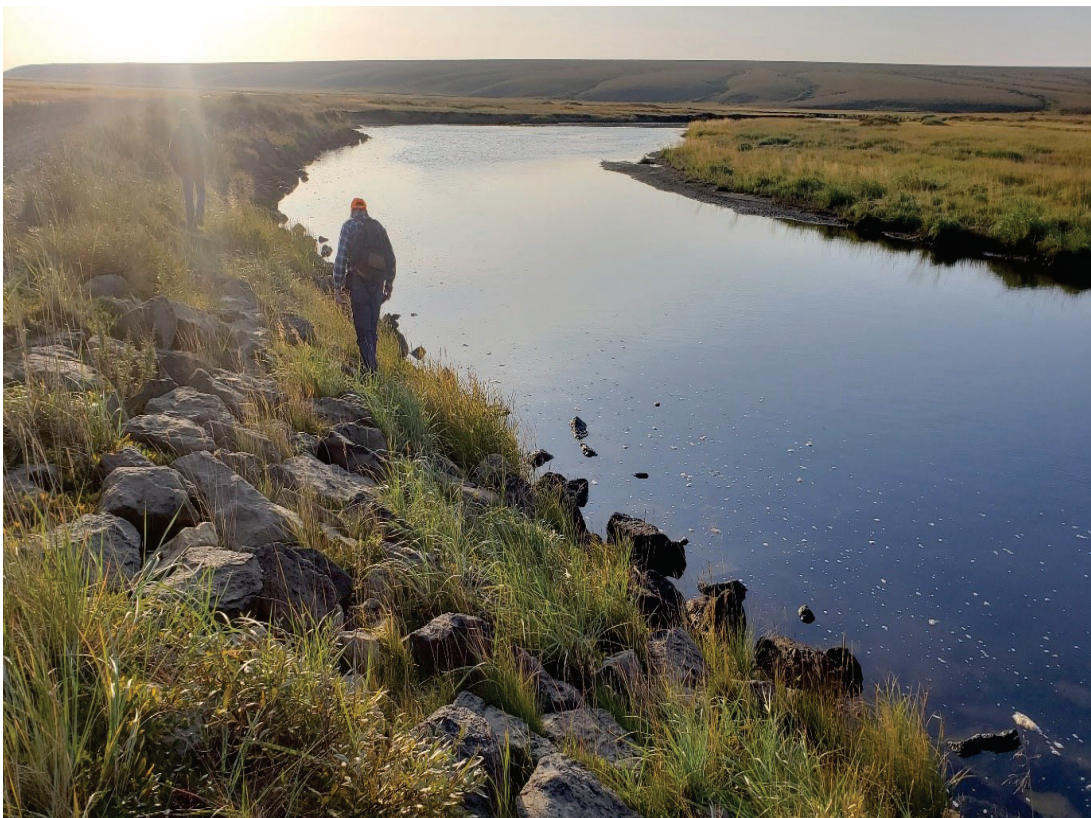
2014	The project is inspected in September: evidence of fracturing of the revetment rock is apparent throughout, some erosion of the stream banks downstream of the revetments is on-going and some stones are not keyed well, but both sections appear to be in good overall condition.
2015	The project is inspected in September: Erosion was noted at the downstream end of the Area 2 revetment near the airport and a sandbar formation was noted at the upstream end of the Area 1 revetment along the airport road.
2016	The project is inspected in September: No significant changes were noted from previous inspections.
2017	The project is inspected in August: No significant changes were noted from previous inspections.
2018	The project is inspected in August: No significant changes were noted from previous inspections.
2019	The project is inspected in August: No significant changes were noted from previous inspections.

Looking downstream at the approximately 800-ft long revetment, August 2019

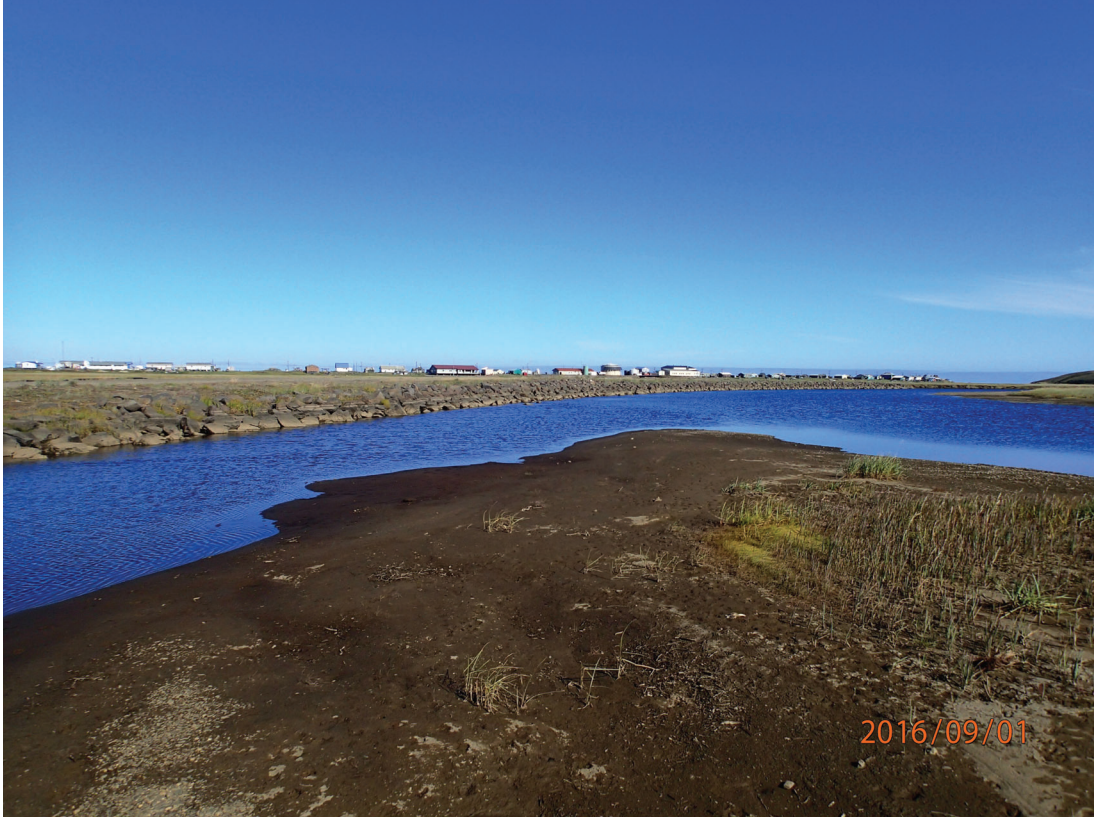
Looking at the revetment along the airport road, September 2016

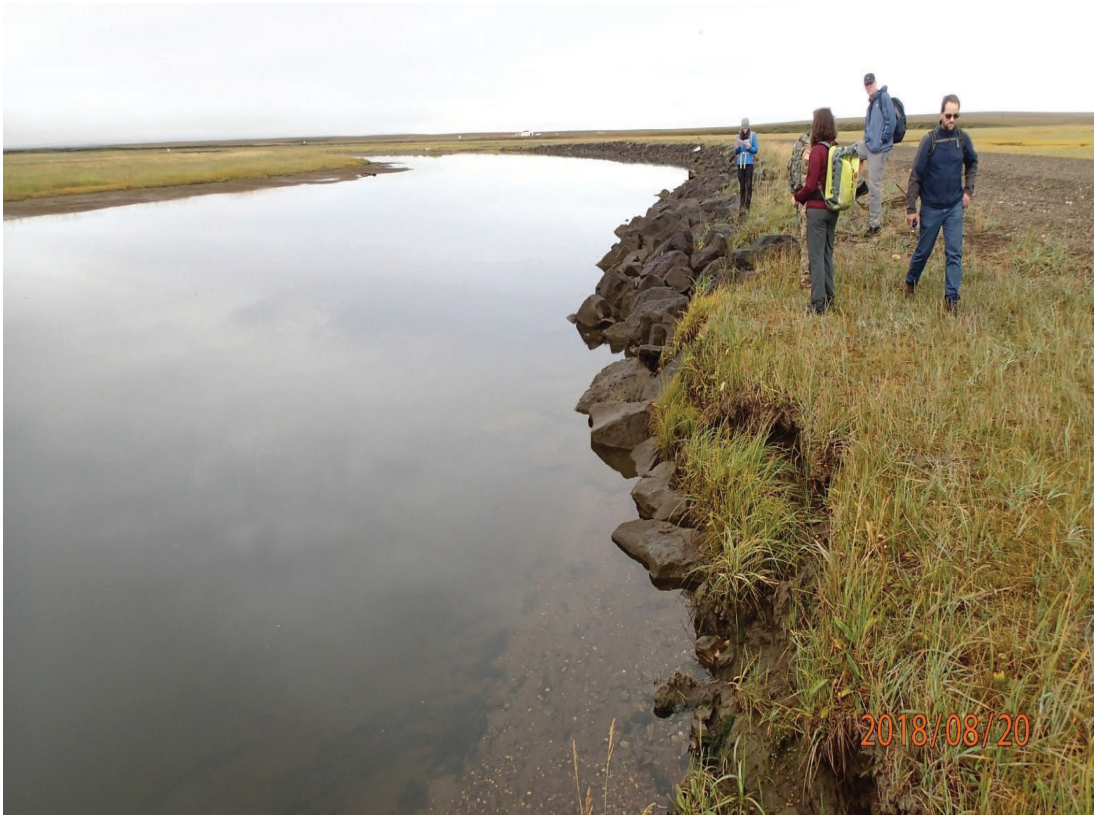
Revetment near the airport, August 2018
