# **Dillingham Bank Stabilization**

Condition of Improvements  
31 December 2019  
**Dillingham Bank Stabilization, Alaska**  
(CWIS No. 075441)

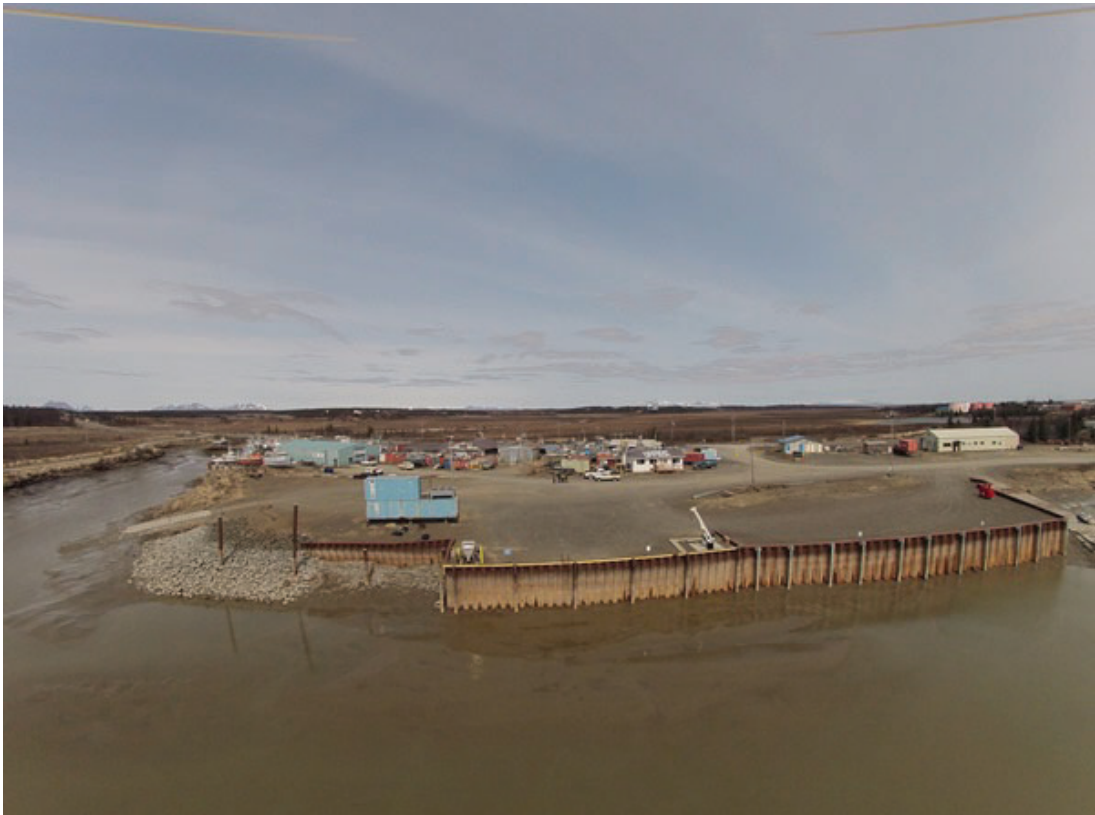
Riprap and sheetpile protection on the east side of the entrance channel, May 2014

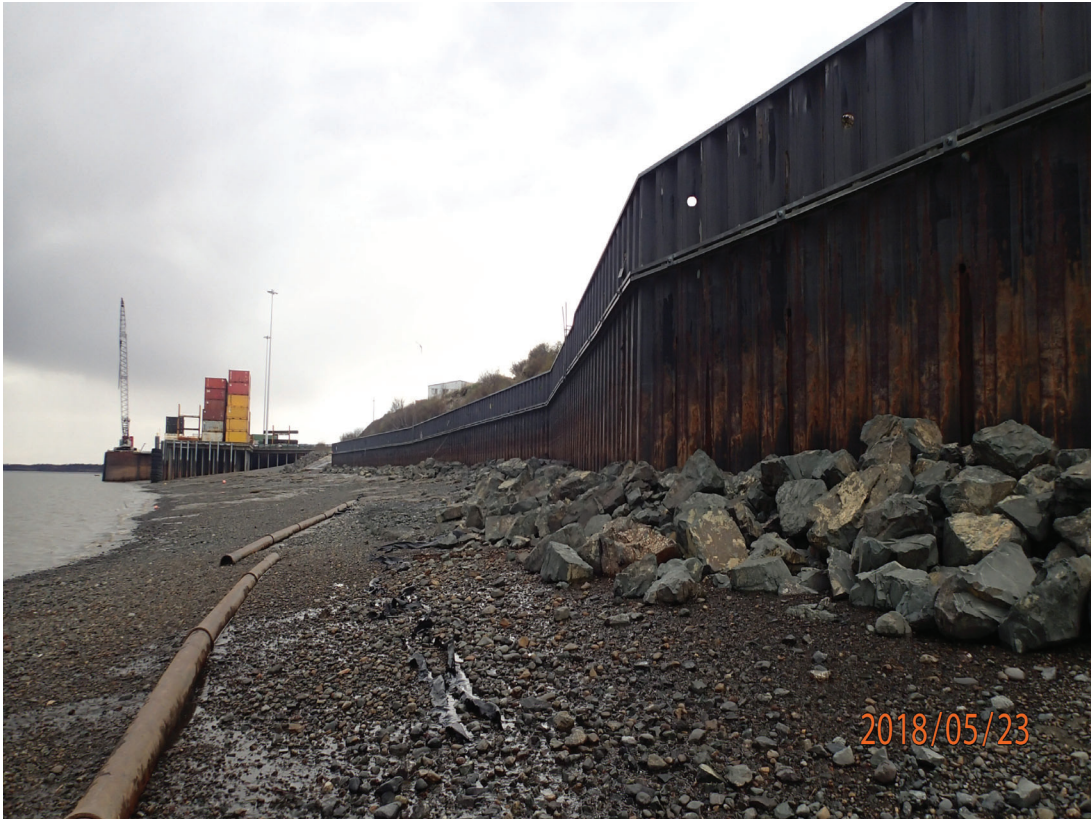
STA 17+00 Riprap @ Toe, Facing Downstream, May 2018

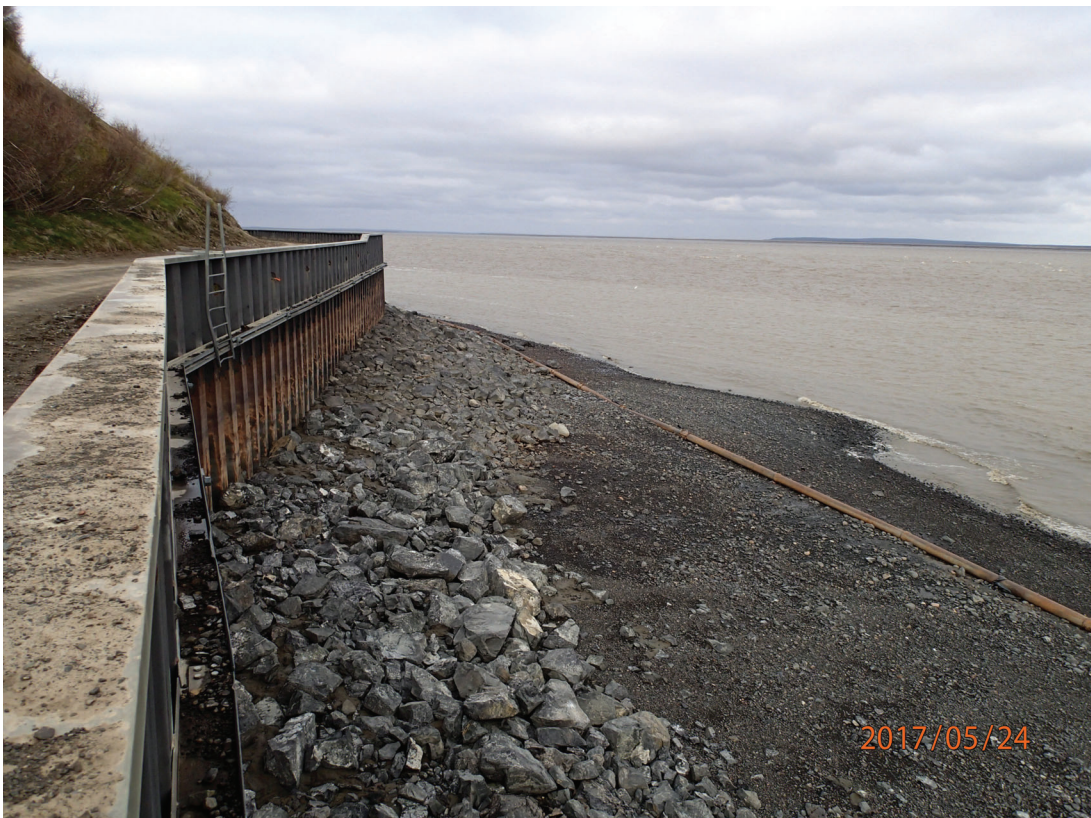
Top of Wall, STA 19+10, Riprap @ Toe, Facing Upstream, May 2017

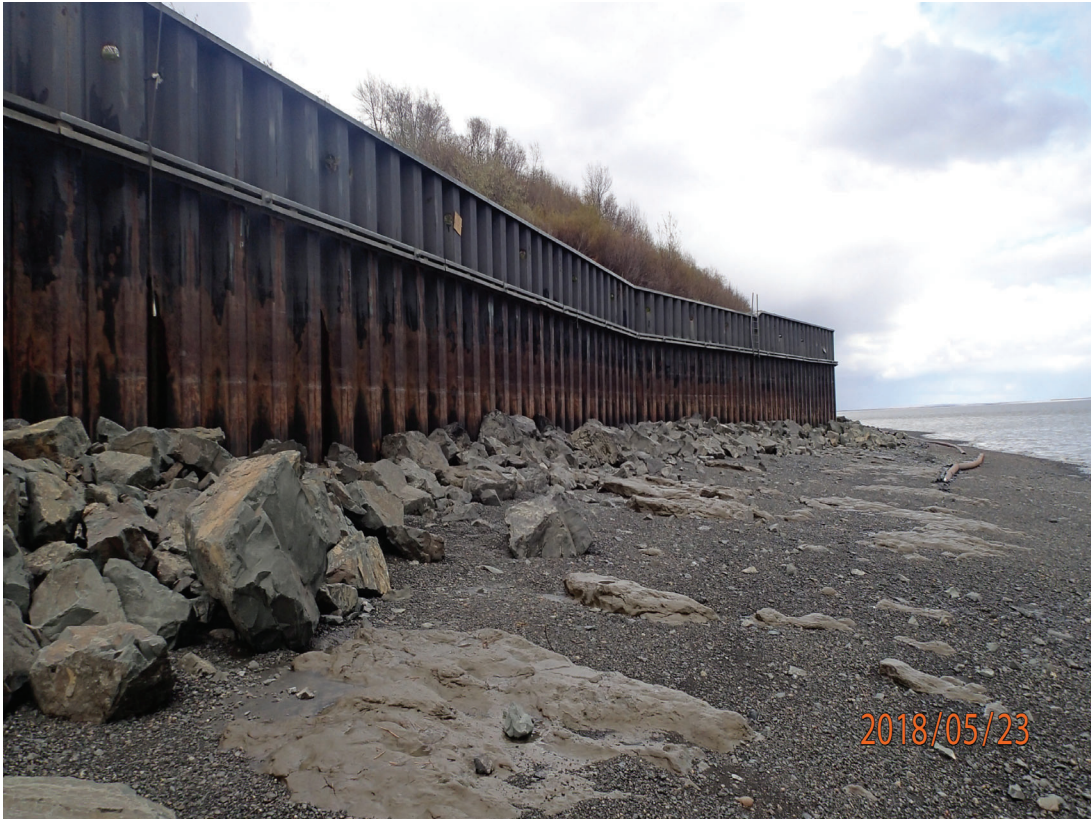
H-pile supported sheetpile bulkhead, May 2018

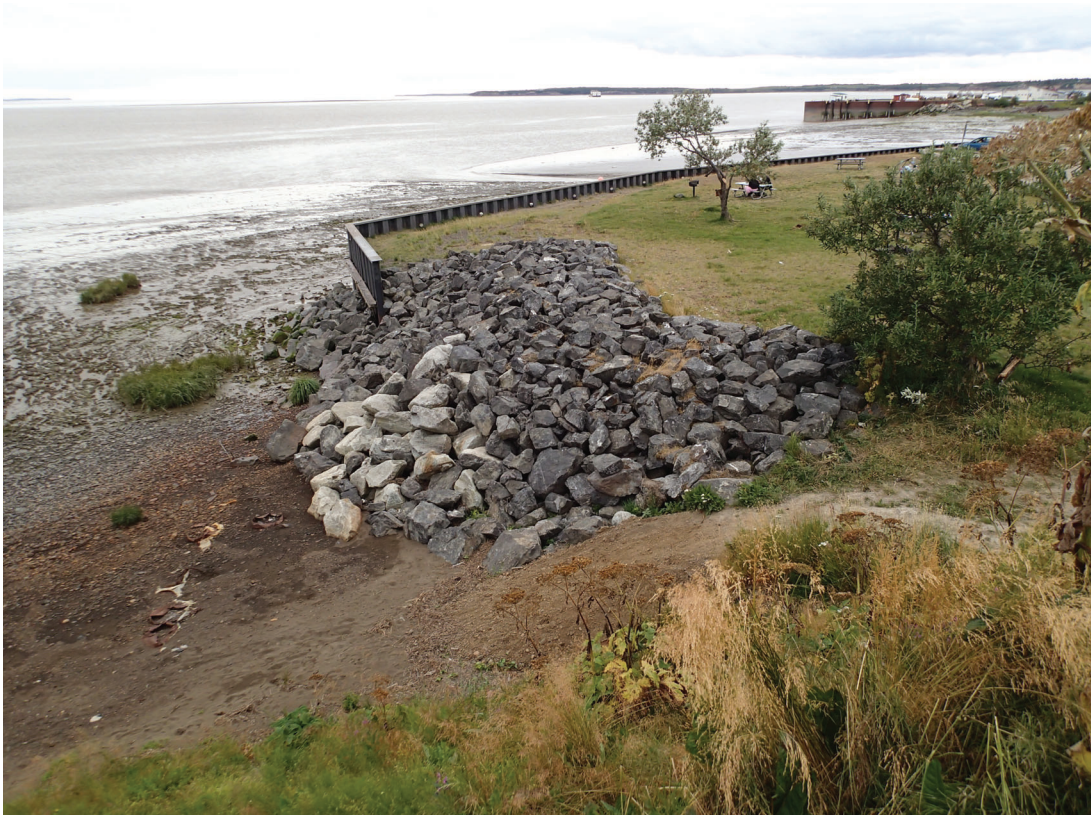
Rip-rap protection at the eastern extent of bank stabilization, August 2019
