# **Emmonak Streambank Protection**

Condition of Improvements  
31 December 2019  
**Emmonak Streambank Protection, Alaska**  
(CWIS No. 092872, 325884)

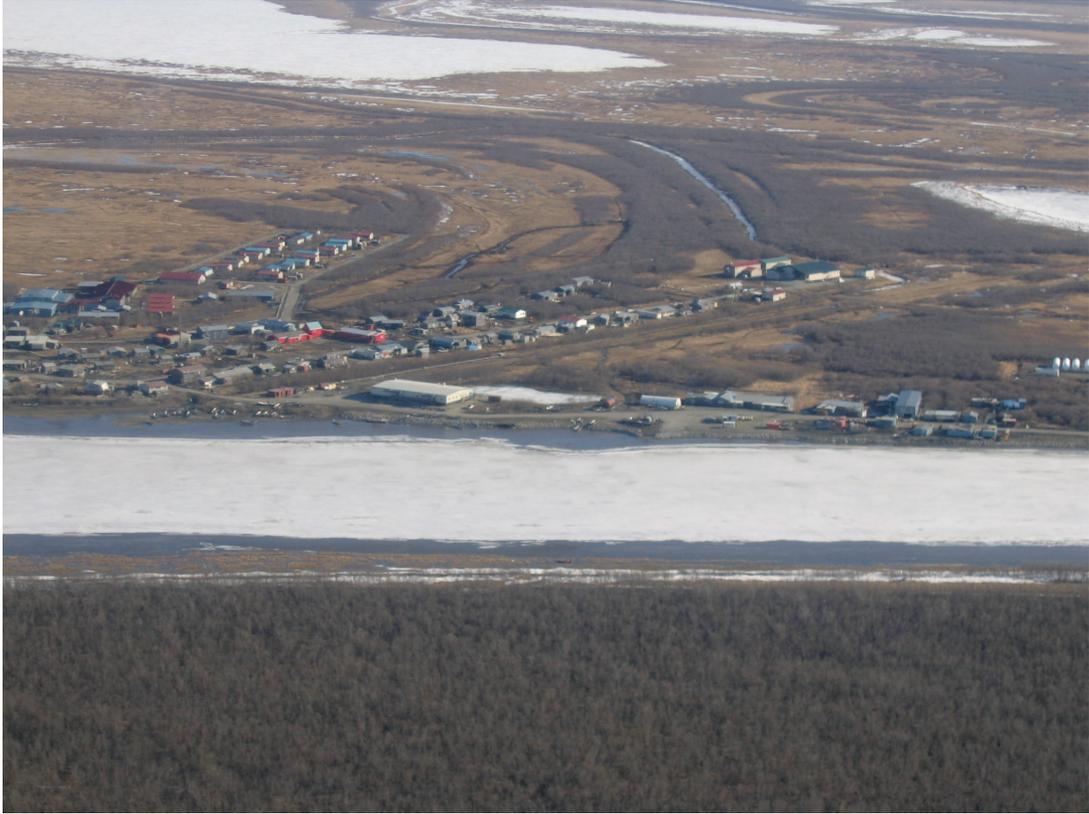
Oblique of the Emmonak streambank protection, May 2007

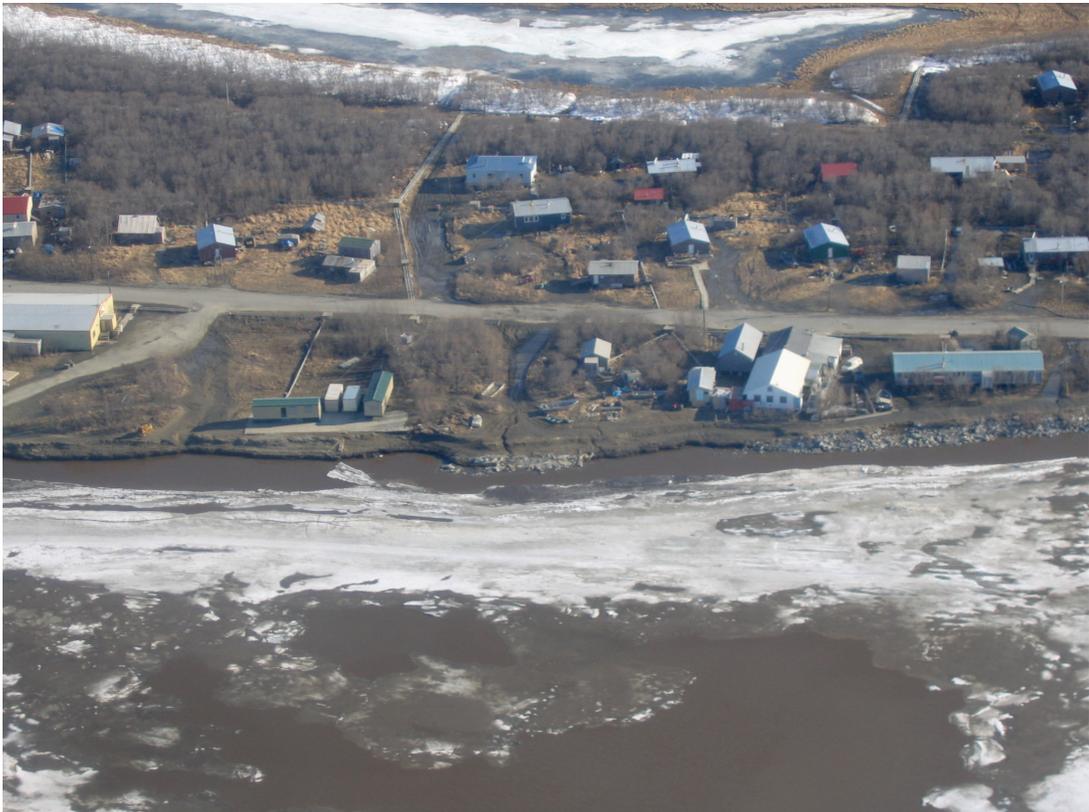
Oblique of the Emmonak streambank protection, May 2007

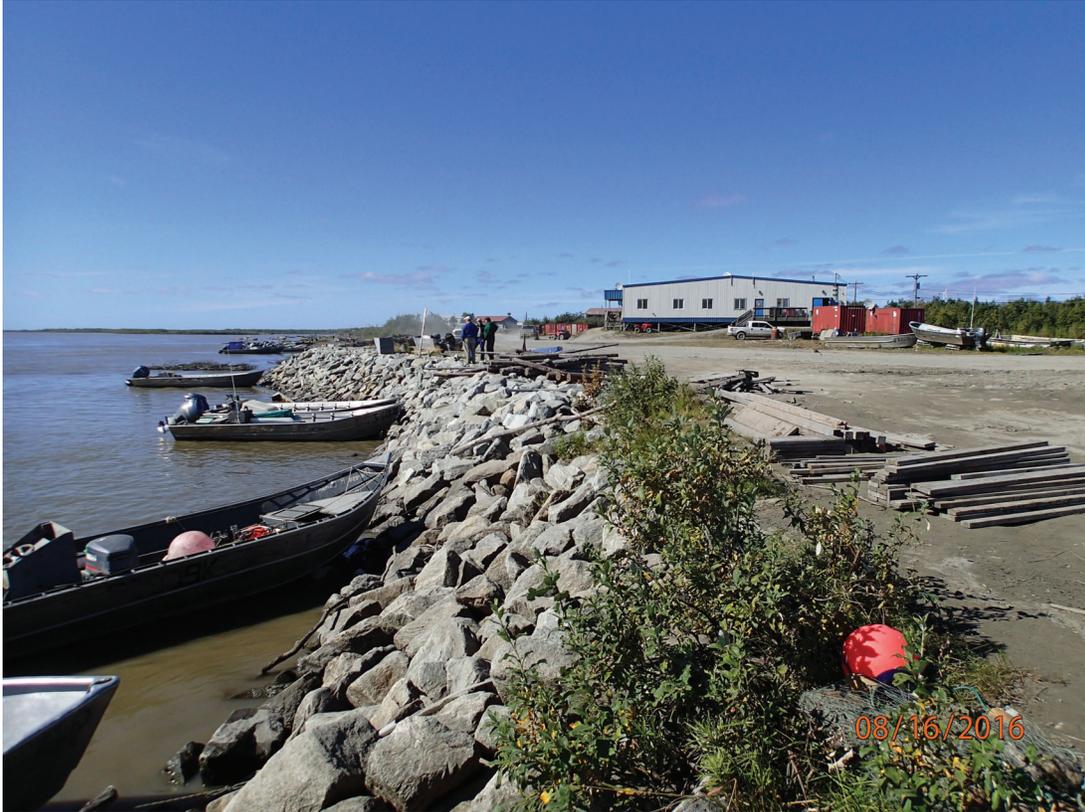
Emmonak revetment downstream of fish processor, August 2016

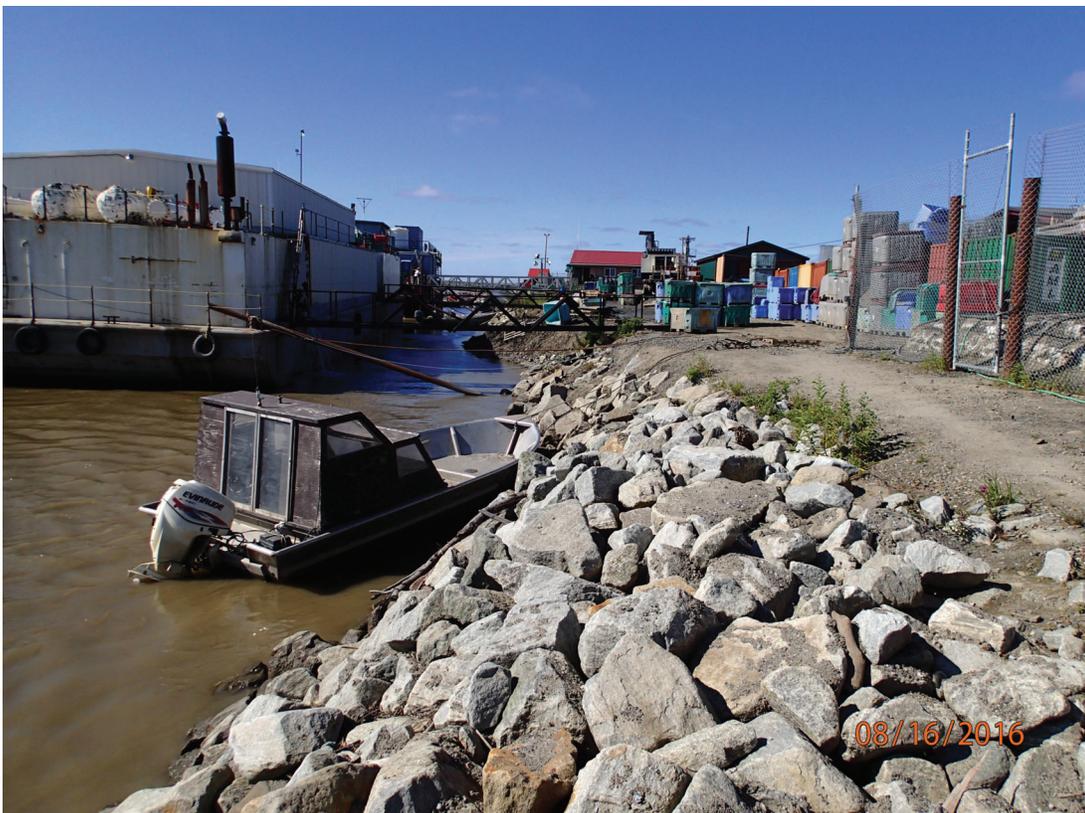
Emmonak revetment near fish processor, August 2016

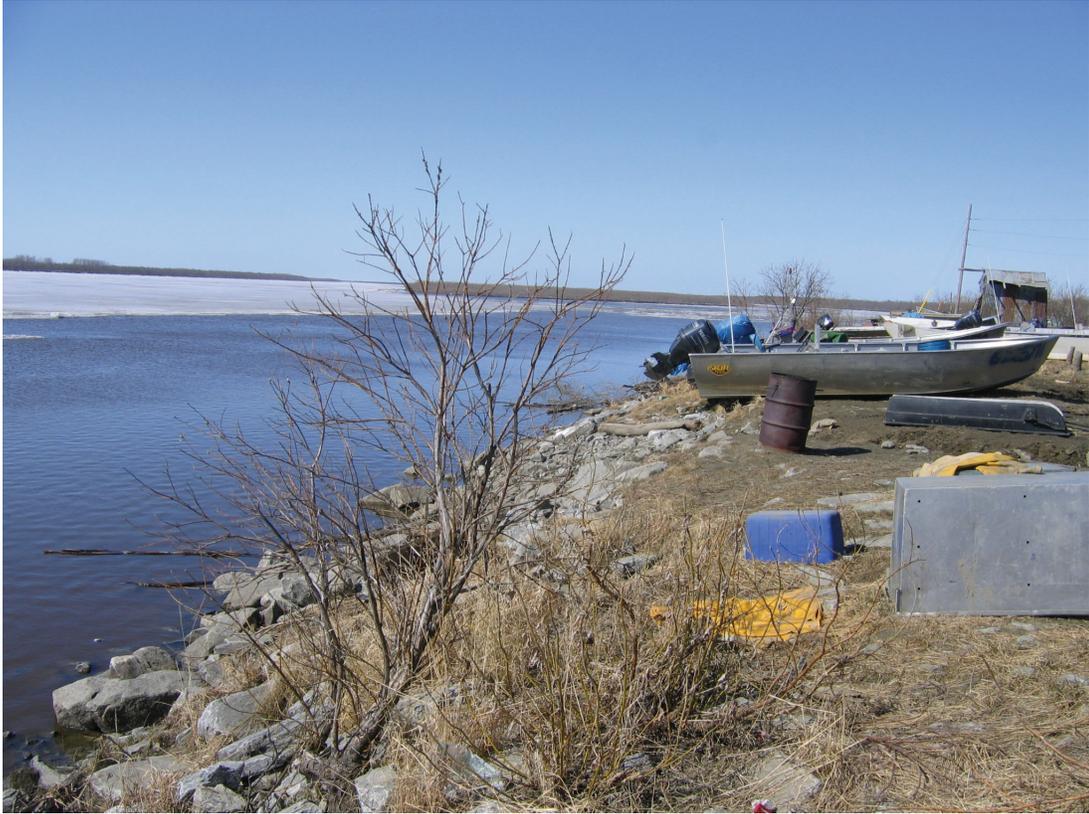
Emmonak streambank protection, 16 May 2007

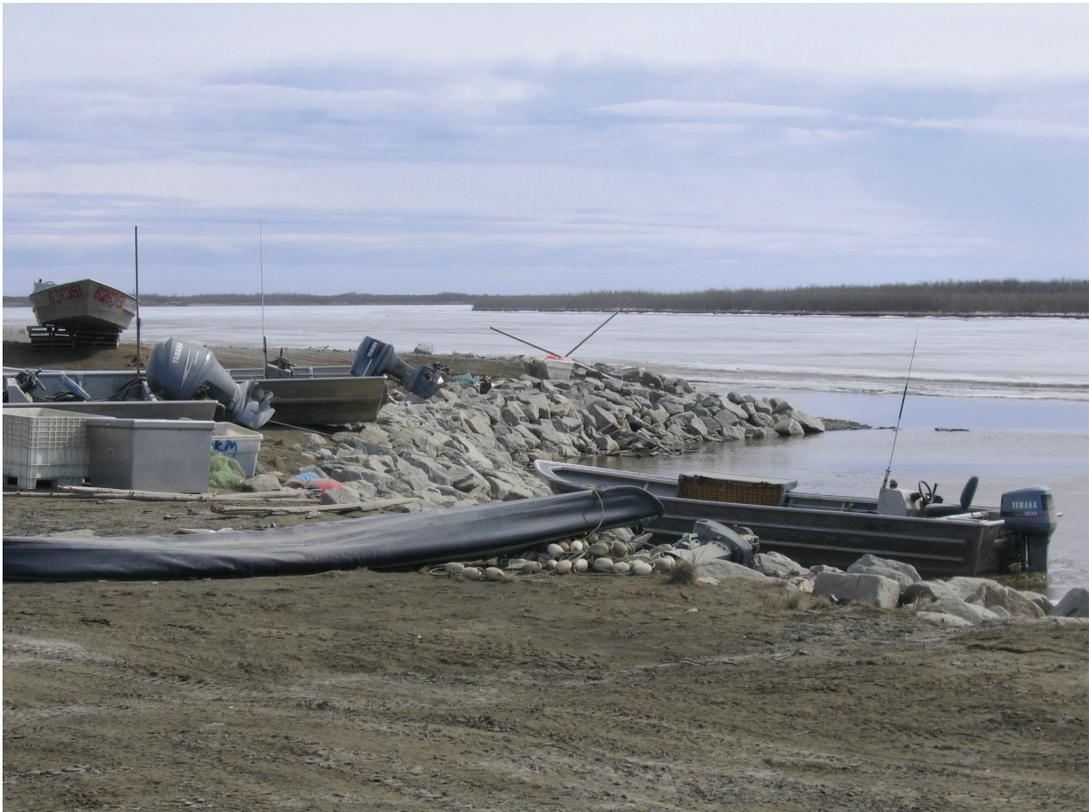
Emmonak streambank protection, 16 May 2007
