# **Galena Emergency Bank Stabilization**

Condition of Improvements  
31 December 2019  
**Galena Emergency Bank Stabilization, Alaska**  
(CWIS No. 075442)

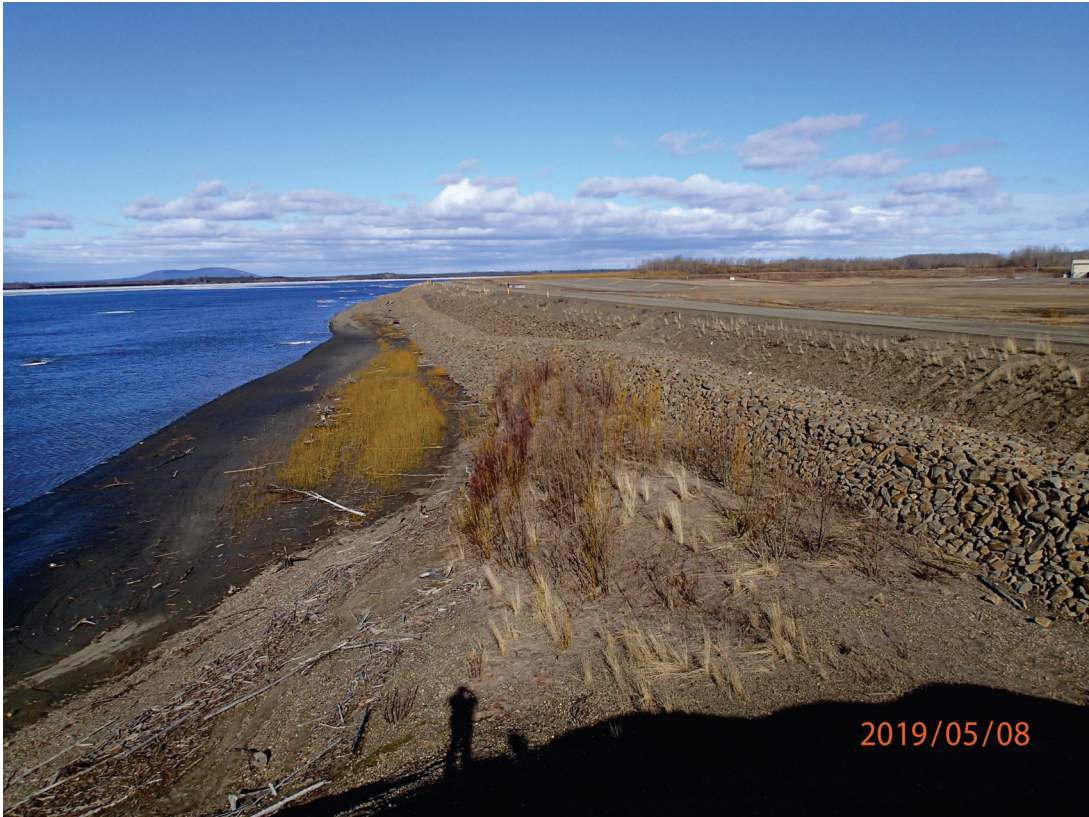
Revetment looking downstream, May 2019

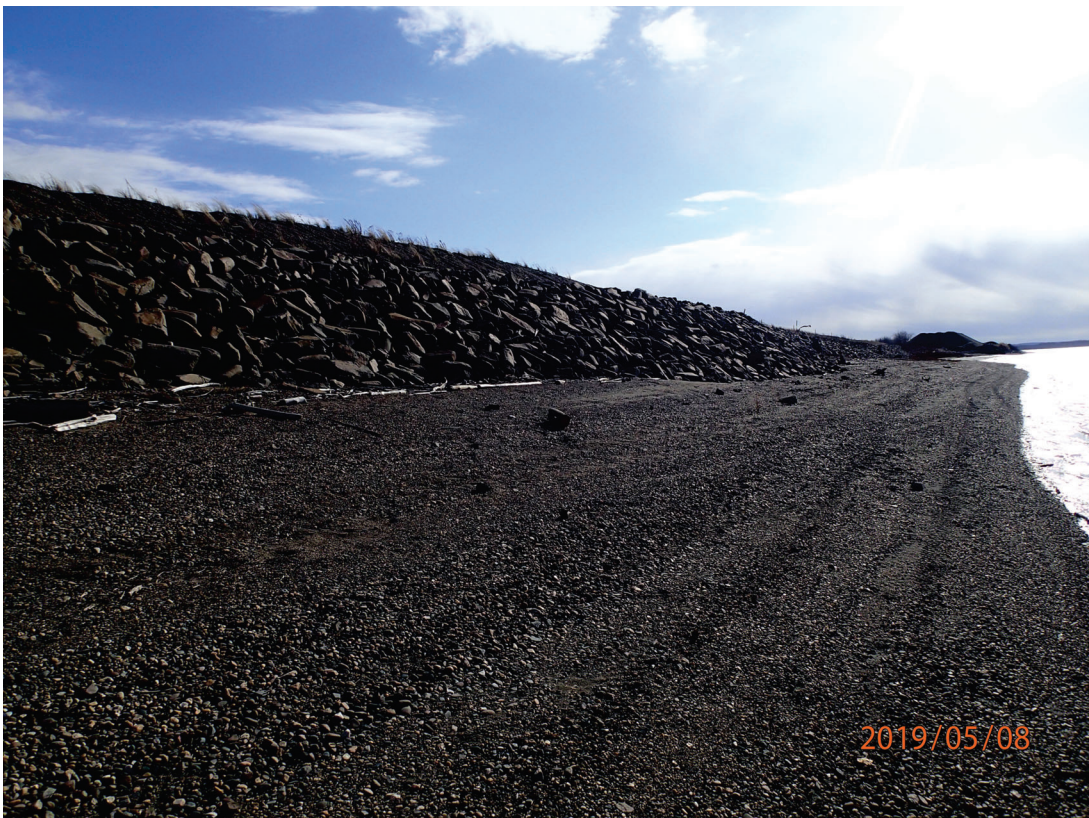
Revetment near downstream end, looking upstream, May 2019
