Gold Creek

Condition of Improvements
31 December 2019
Gold Creek, Alaska
(CWIS No. 006630, 150225)

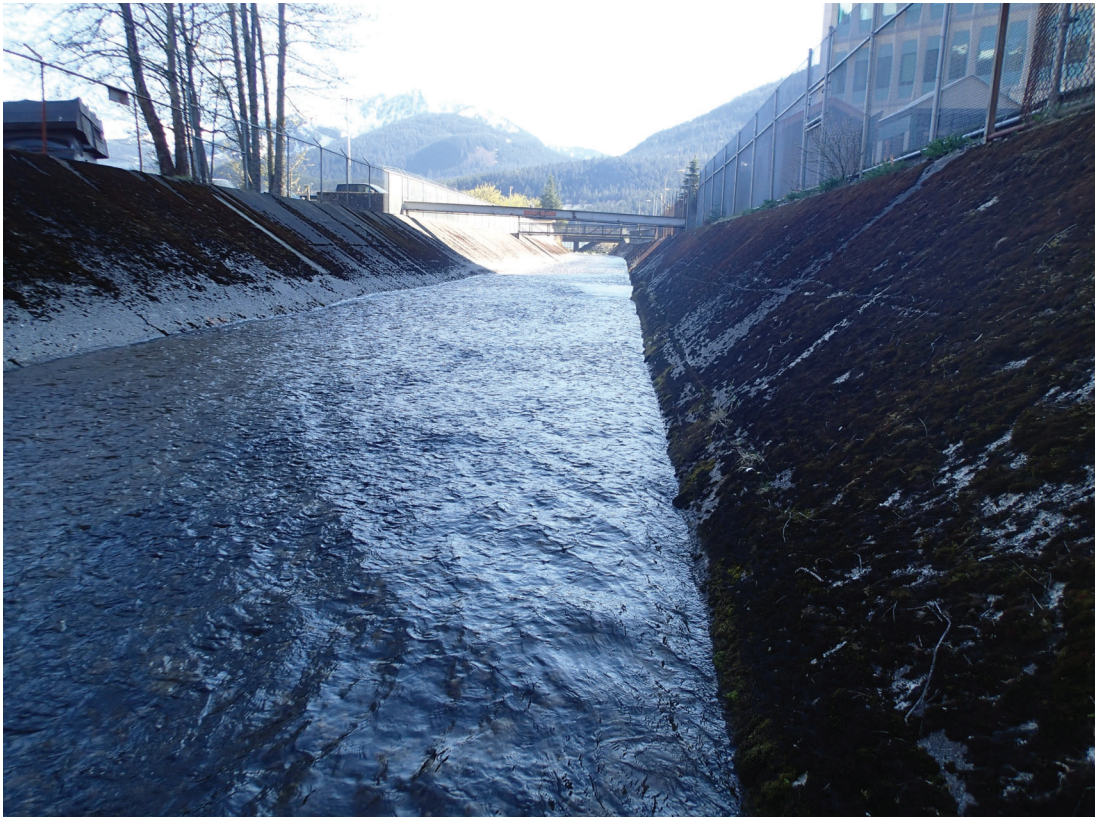
Concrete channel downstream from 9th Street, April 2019
