# **Klutina River**

Condition of Improvements  
31 December 2019  
**Klutina River at Copper Center, Alaska**  
(CWIS No. 003830)

# Klutina River Levee, Copper Center, Alaska

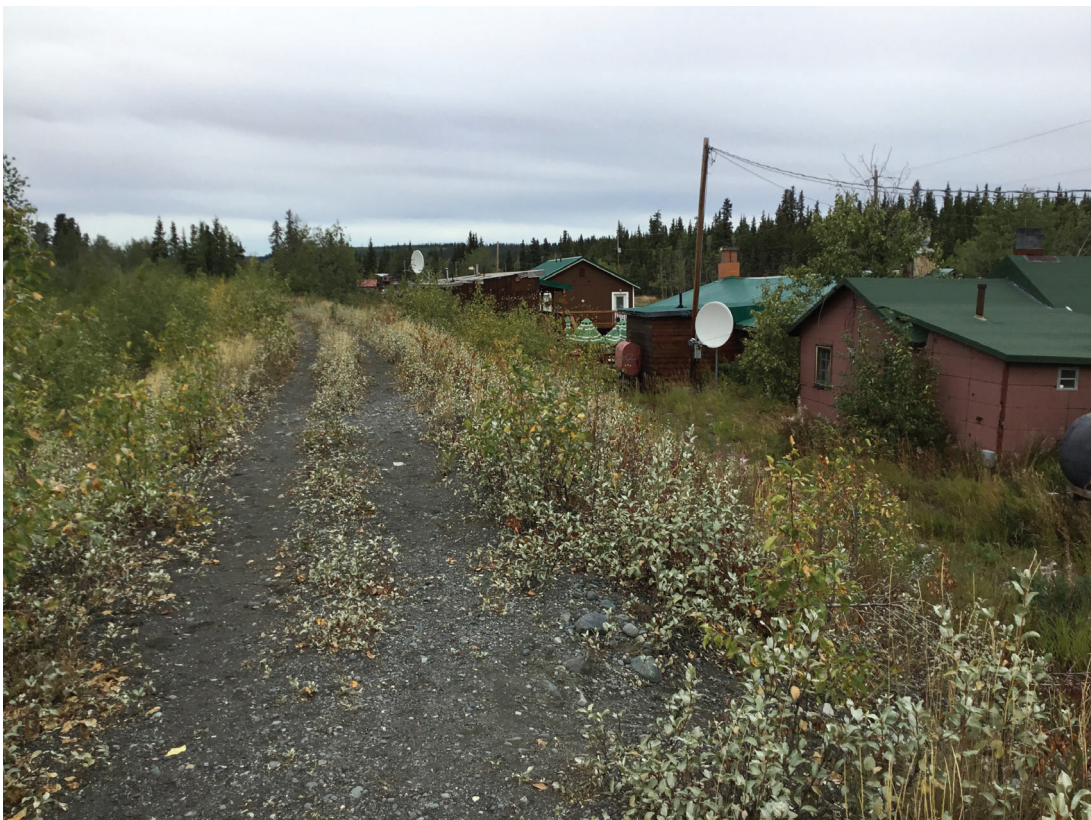
Encroachments within the levee footprint, August 2017
