Metlakatla Erosion Protection

Condition of Improvements
 31 December 2019
Metlakatla Erosion Protection, Alaska
 Cemetery and Fuel Tank Facility
 (CWIS No. 092796, 092830)

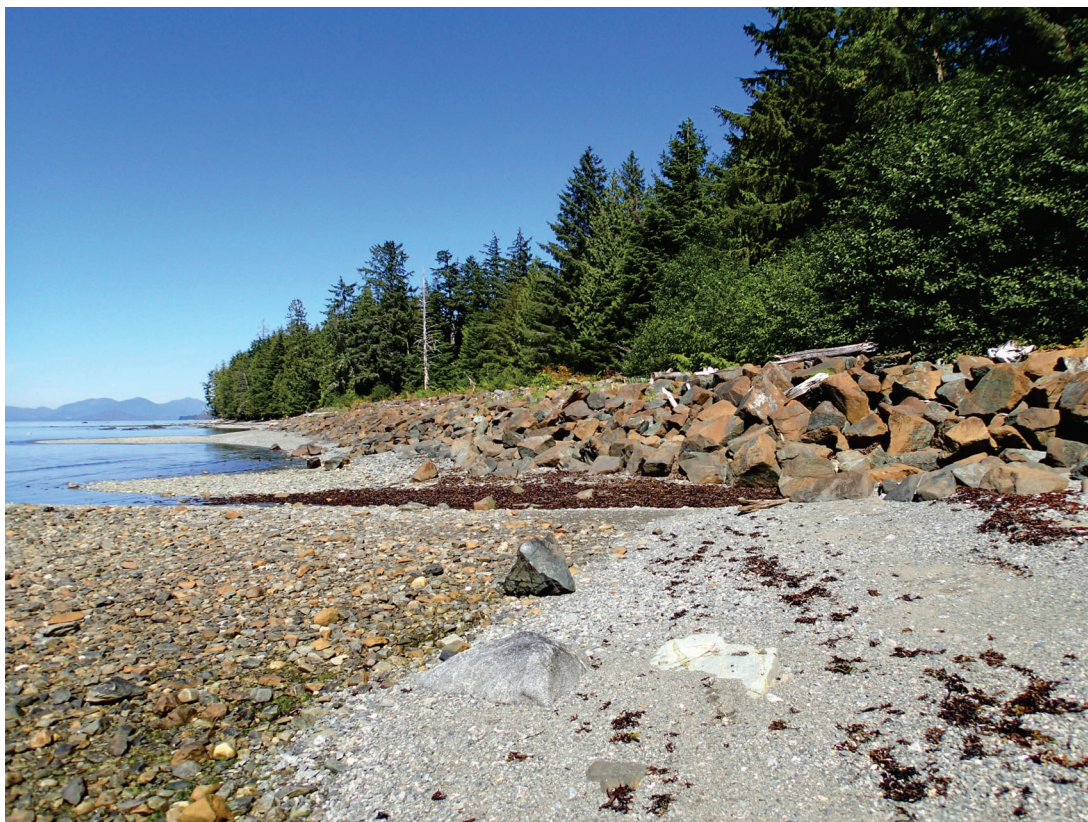
The cemetery rock revetment , August 2017

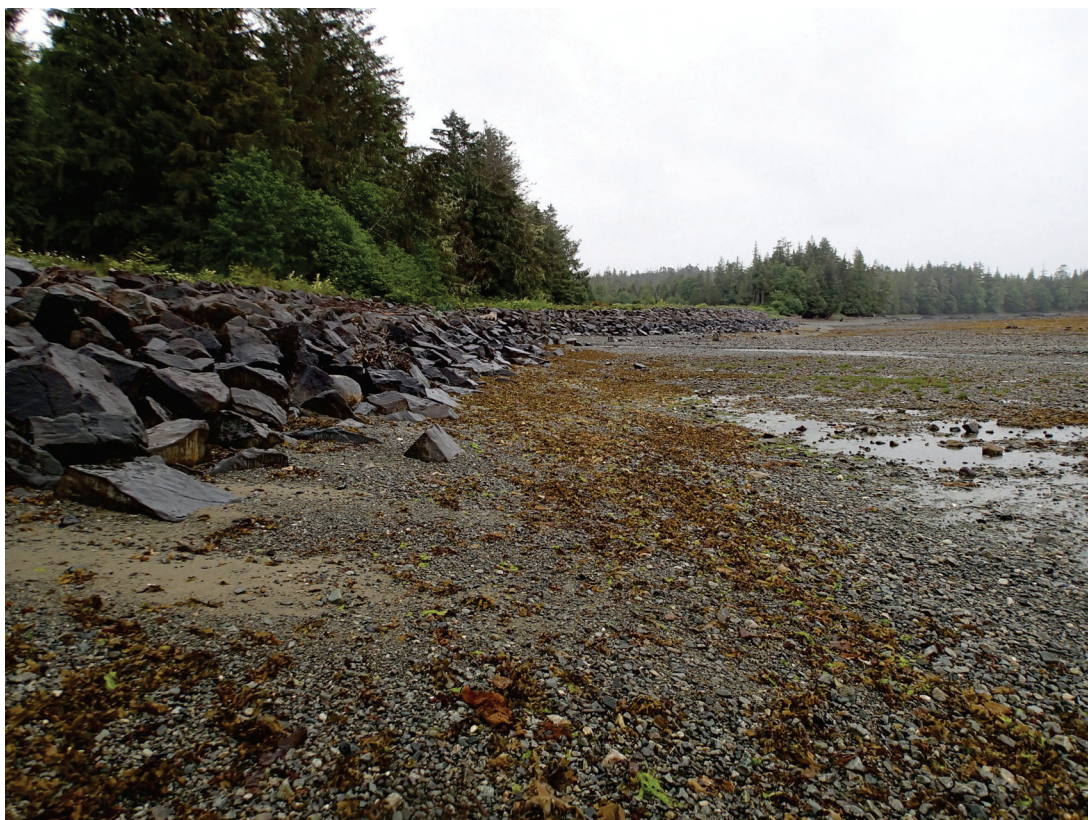
The cemetery rock revetment , June 2019

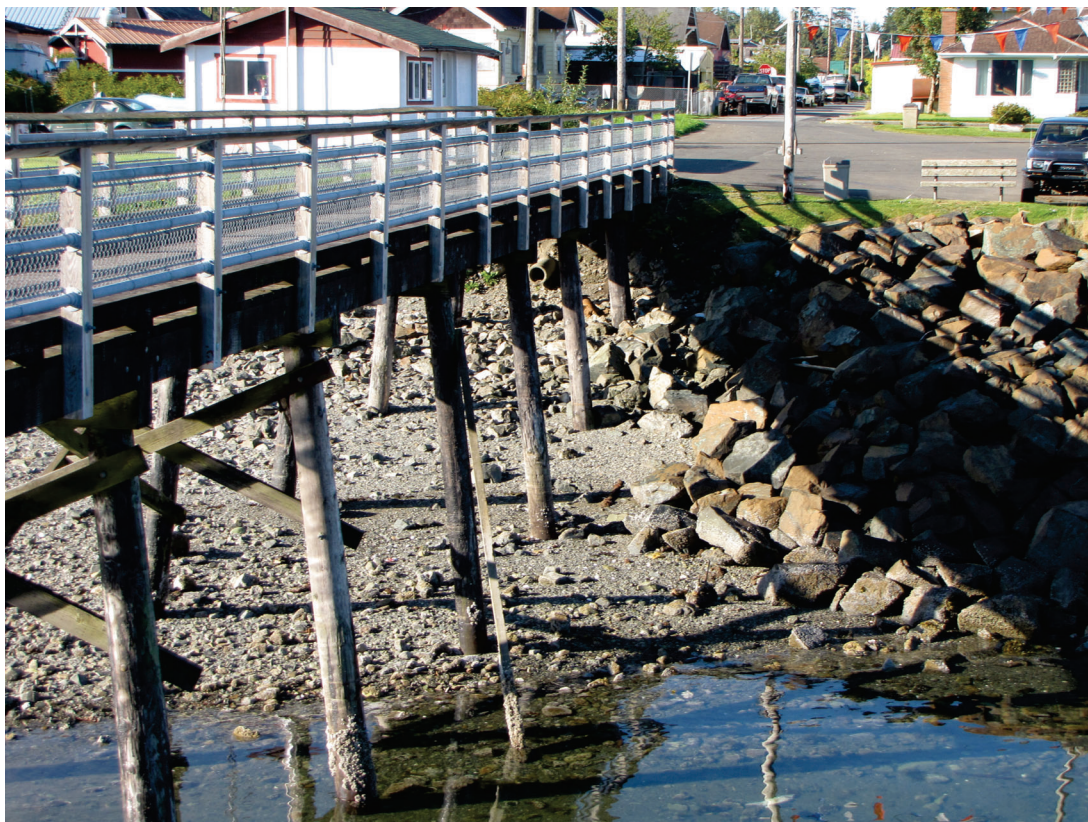
The east extent of the tank farm rock revetment , September 2010

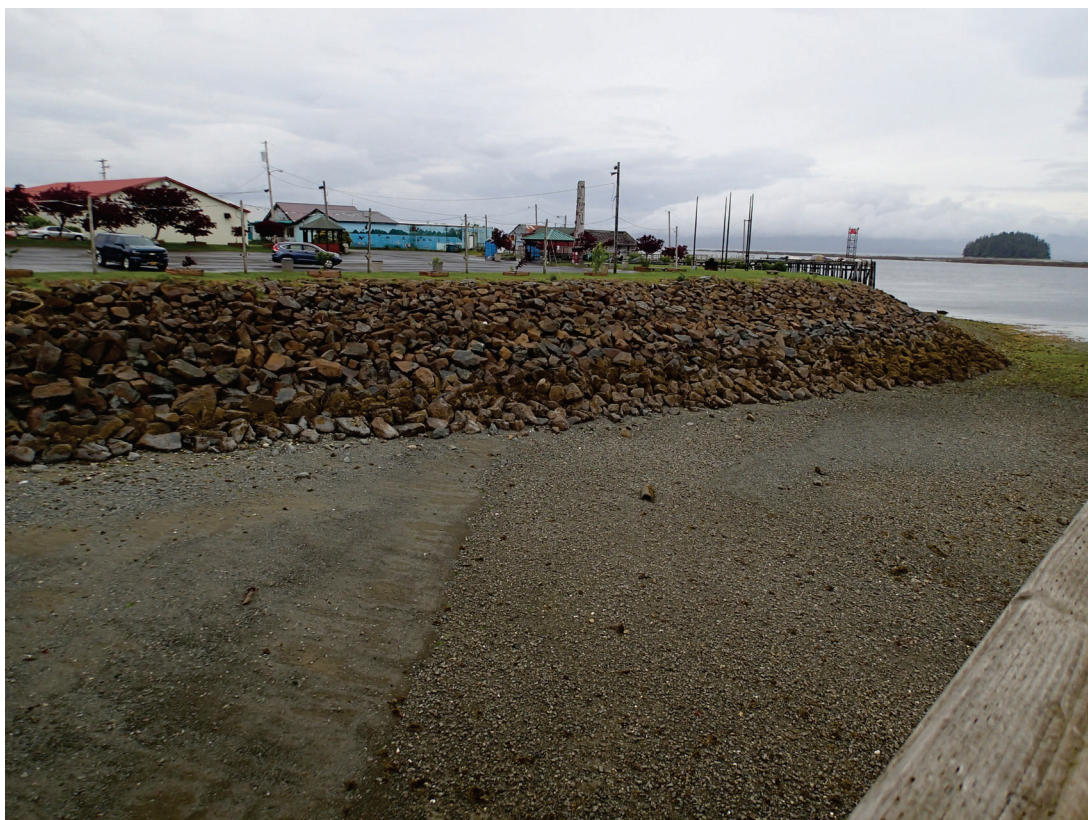
City Park rock revetment, June 2019
