Nome Seawall

Condition of Improvements
31 December 2019
Nome Seawall, Nome, Alaska
(CWIS No. 010422 & 012770)

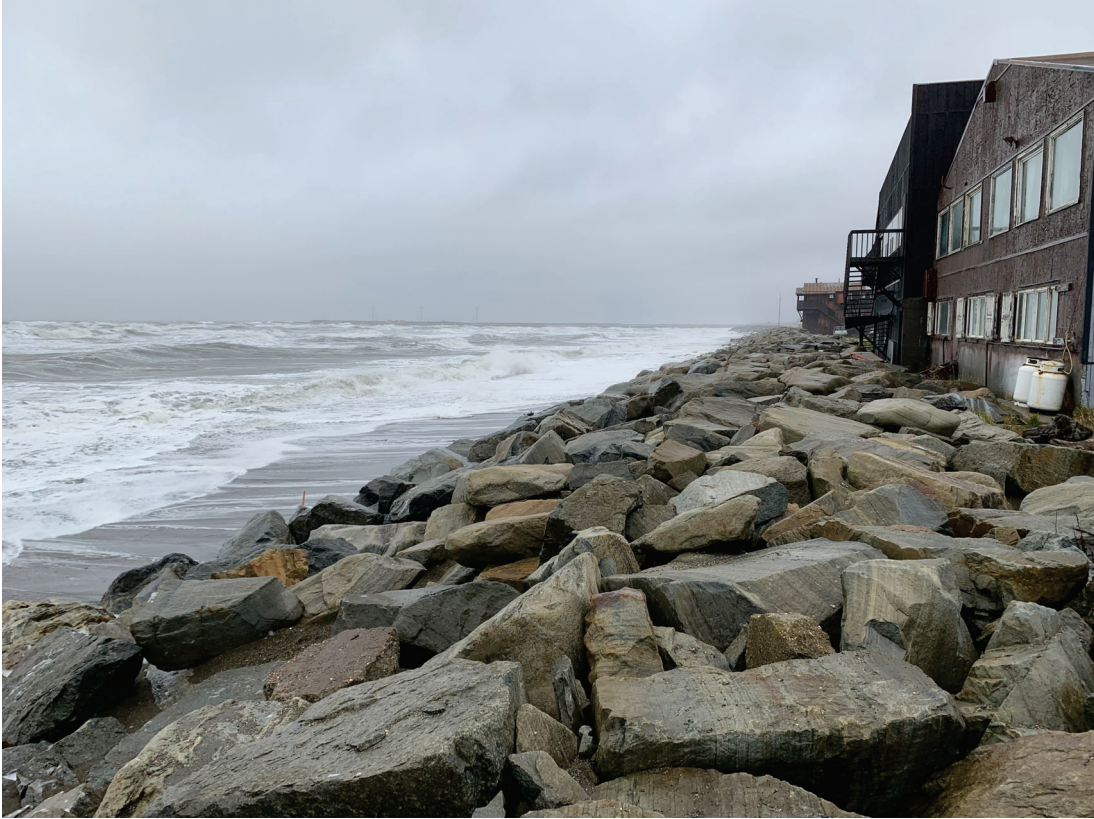
Nome Seawall, September 2019

2017	Project inspection reveals no significant change from previous year.
2018	Project inspection reveals the sea wall to be in overall good condition. Sand has accumulated around many of the armor stone in the lower portion of the sea wall, filling in void spaces between stones.
2019	Project inspection completed in August, The sea wall appears to be in overall good condition. Conditions at the time of the inspection were a minor storm event, however the variation in toe conditions along the length of the project was evident due to the amount of spray
