# Salmon River

Condition of Improvements  
31 December 2019  
**Salmon River, Hyder, Alaska**  
(CWIS No. 072857)

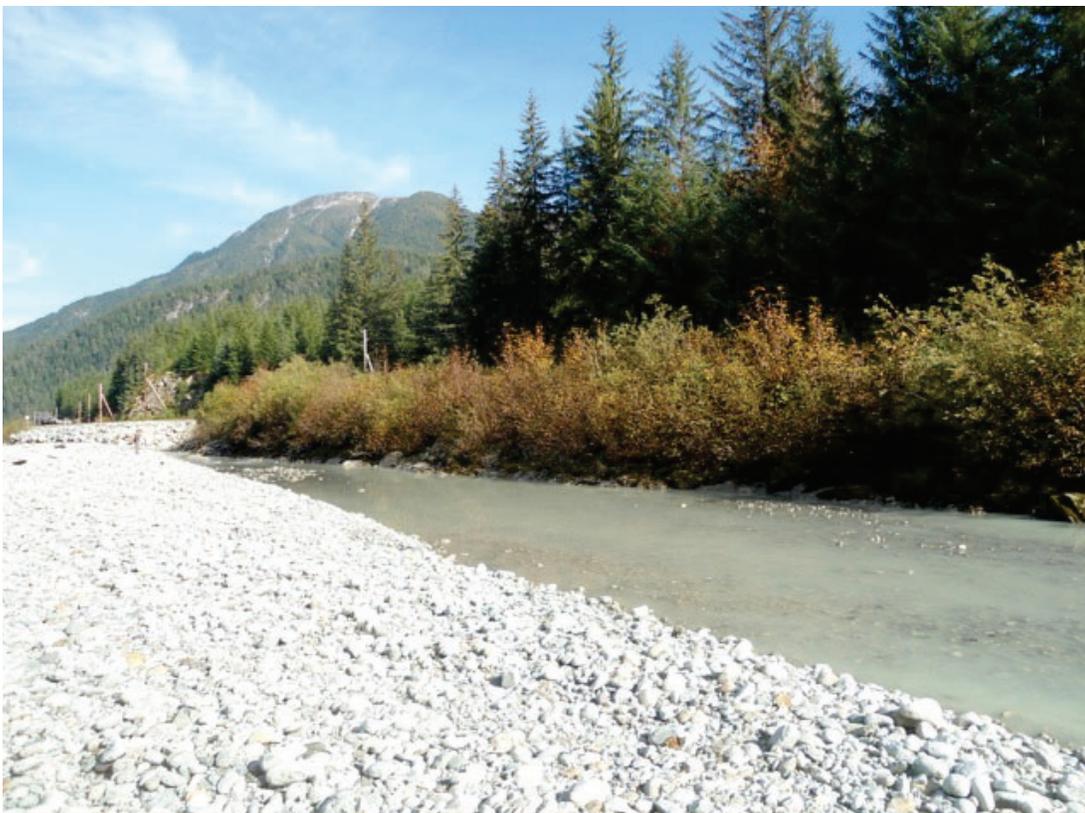
Salmon River Dike , September 2014

2014	The dike was inspected in September and found to be in "poor" condition.
2018	A periodic inspection found the levee to be in an unacceptable condition, primarily due to erosion of riprap revetments and unwanted vegetation on the levee embankment slopes and crown. The extent of vegetation limited the inspection team's ability to identify and assess issues with the levee. The team recommended clearing vegetation in accordance with EM 1110-2-301.
