Skagway River

Condition of Improvements 31 December 2019 **Skagway River, Alaska** (CWIS No. 000013, 016900, 091000)

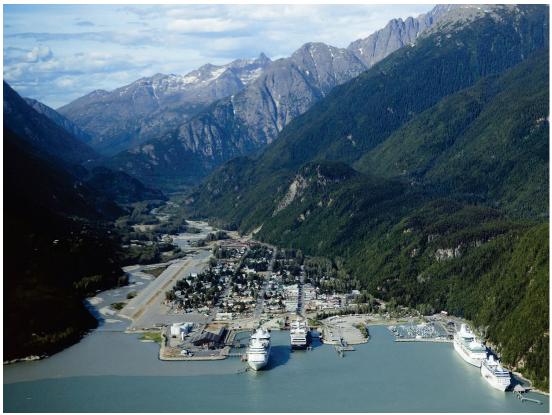
Oblique of Skagway, 2009

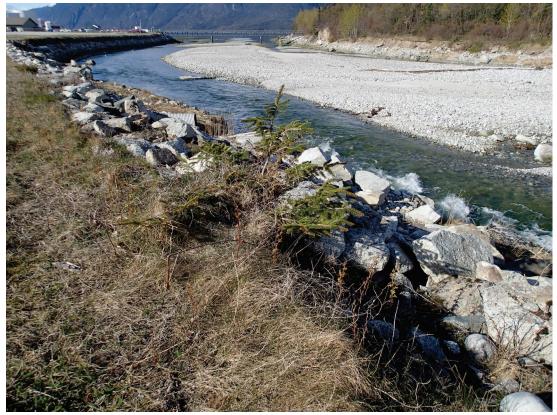
Downstream view of the Skagway River Levee, April 2019

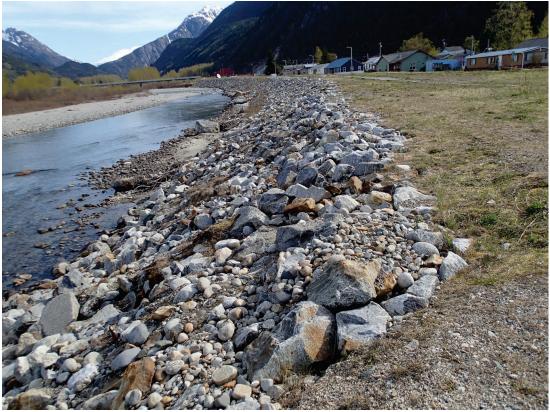
Skagway River Levee near Klondike Highway Bridge, April 2019

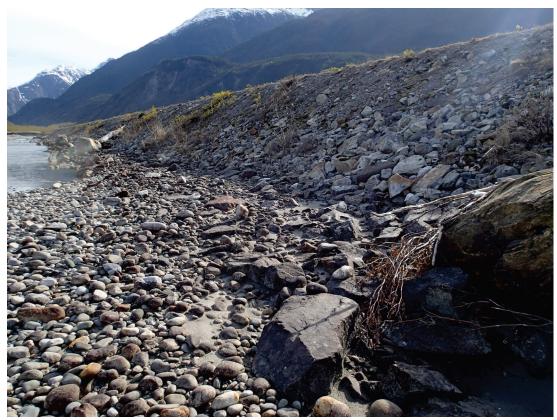
Upstream view of the Skagway River Levee along the runway, April 2019
