Chignik Harbor

Condition of Improvements
31 December 2019
Chignik Harbor, Alaska
(CWIS No. 010375, 087214, 087394)

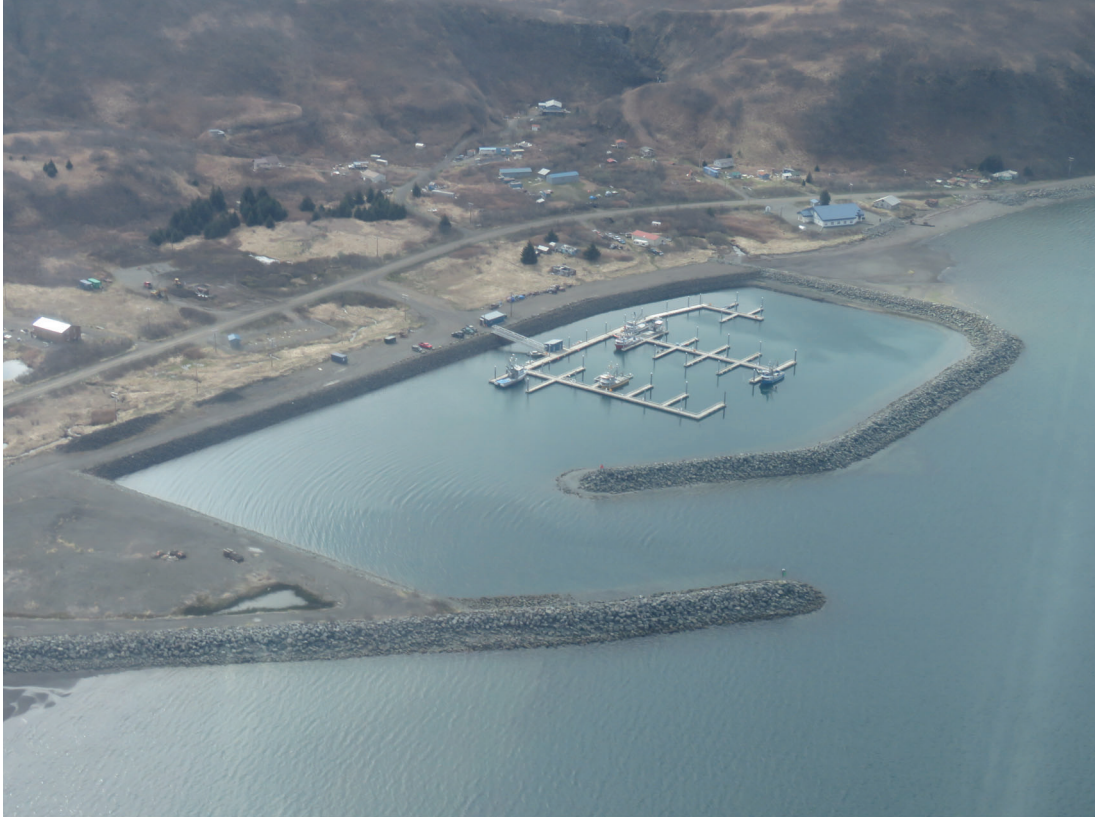
Oblique photo of Chignik Harbor, May 2017

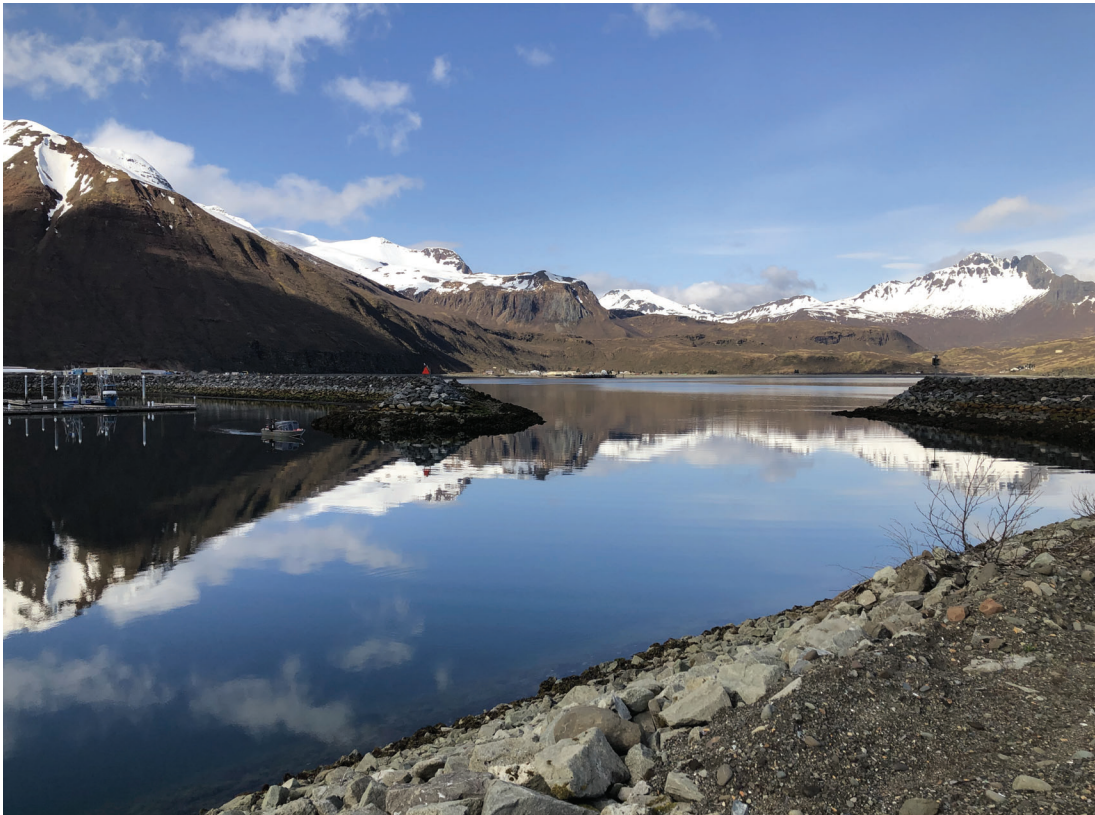
Controlling Depth Based on the May 2019 survey the majority of the entrance channel meets or exceeds project depth. The northwest boundary along the toe of the north breakwater has a shoal to -18.9 feet MLLW. In the inner part of the entrance channel, the controlling depth is -19.5 feet MLLW in the middle of the channel.

Chignik Harbor Entrance Channel, May 2019

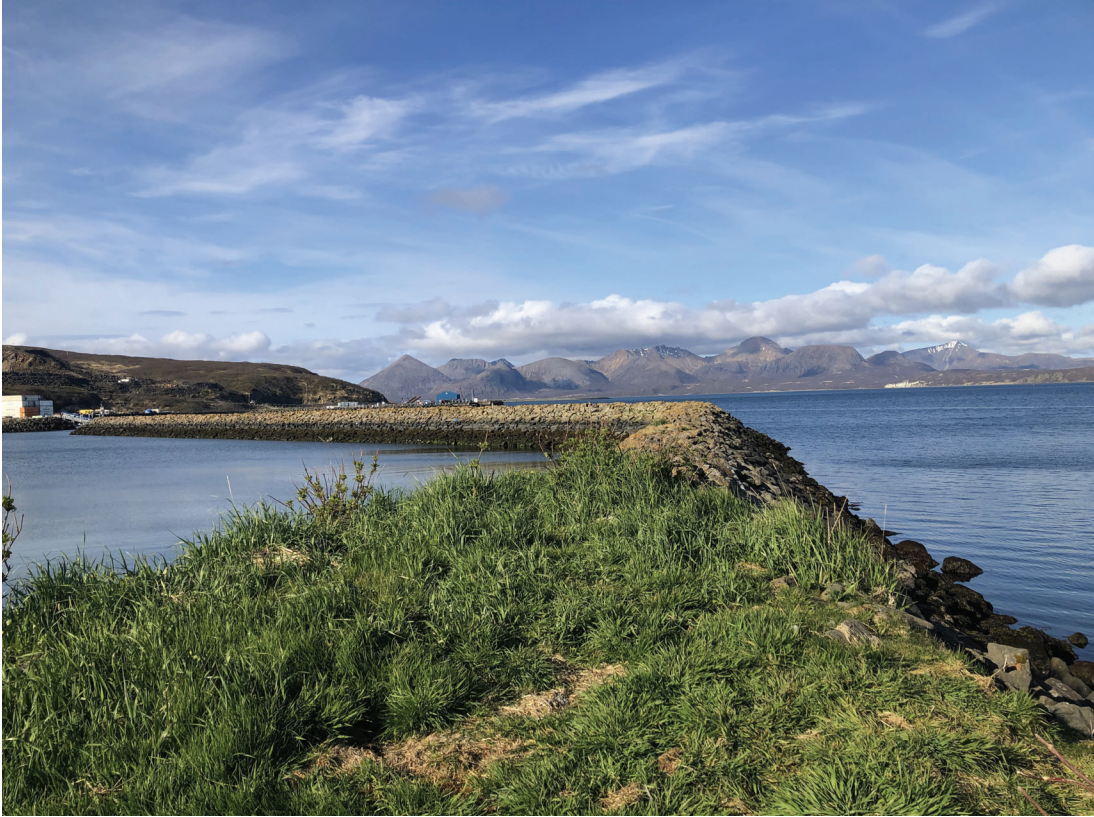
| 2015 | A project condition survey of the harbor entrance channel was conducted in May. An Operational Condition Assessment (OCA) of the north and south breakwaters was conducted in August due to deterioration of the armor stone. The breakwaters were rated as "D" for Condition and "A" for Function. Although there is currently no loss of function for the harbor, 30-40% of the armor stone is disintegrating and repairs to the breakwaters will be needed in order to preserve their integrity and to prevent accelerated future damages. |

Chignik Breakwater May 2019

| 2018 | Western Marine completes reconstruction of the north and south breakwaters between May and August. Prior to the start of construction, a contract modification is issued to change the repair method from the original plan to place two layers of armor stone on top of the existing breakwaters to totally removing and replacing the existing armor stone and "B" rock. The final contact amount is \$6,990,000. Armor stone removed from the breakwaters is placed to create a bench, visible at low tide, on the seaward side of each breakwater. The placement of the disposed rock in this area eliminated a navigation hazard caused by submerged rock. |

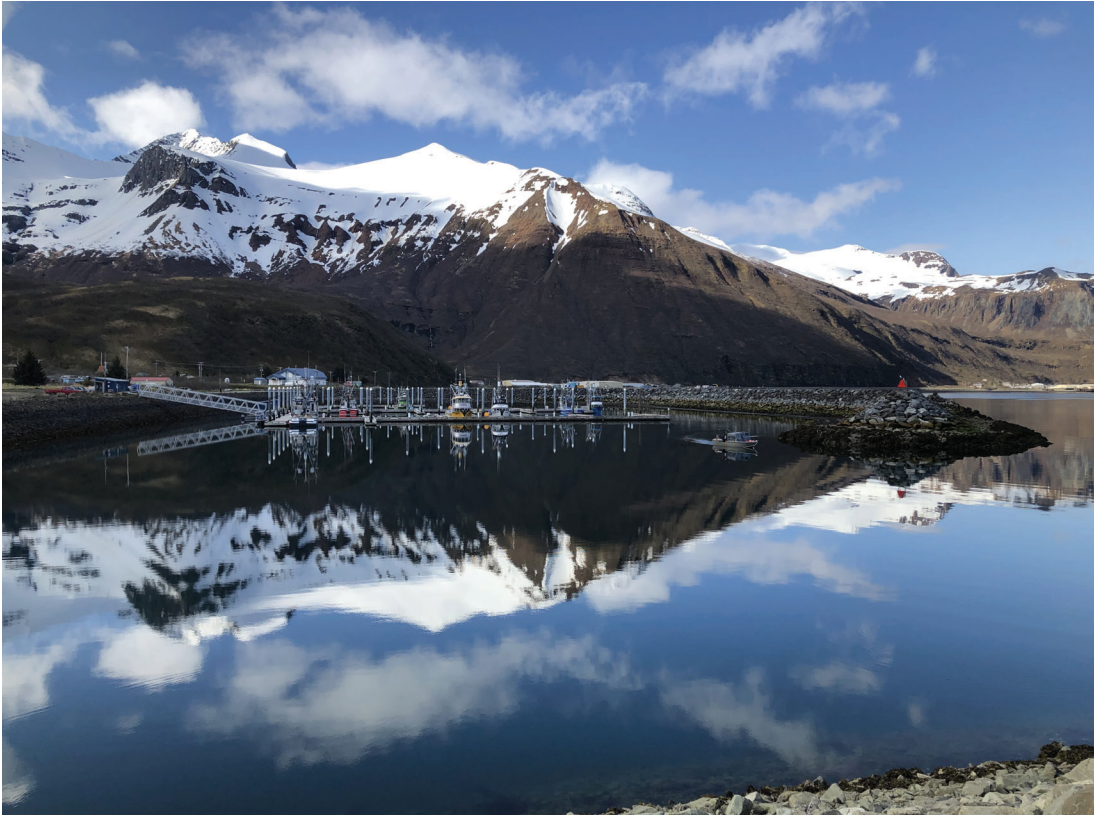
Chignik Harbor, May 2019
