Ketchikan Bar Point Harbor

Condition of Improvements
 31 December 2019
Bar Point Harbor
 Ketchikan, Alaska
 (CWIS No. 087071)

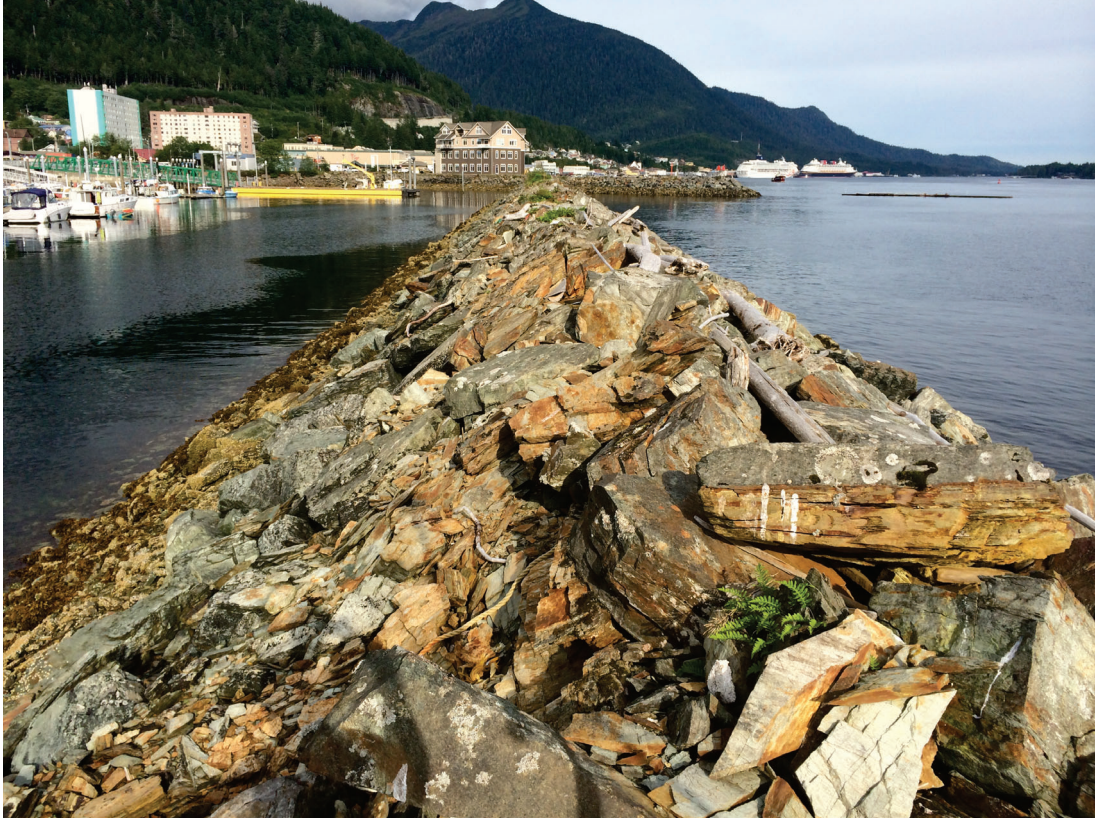
Looking Southeast from the West breakwater, August 2015

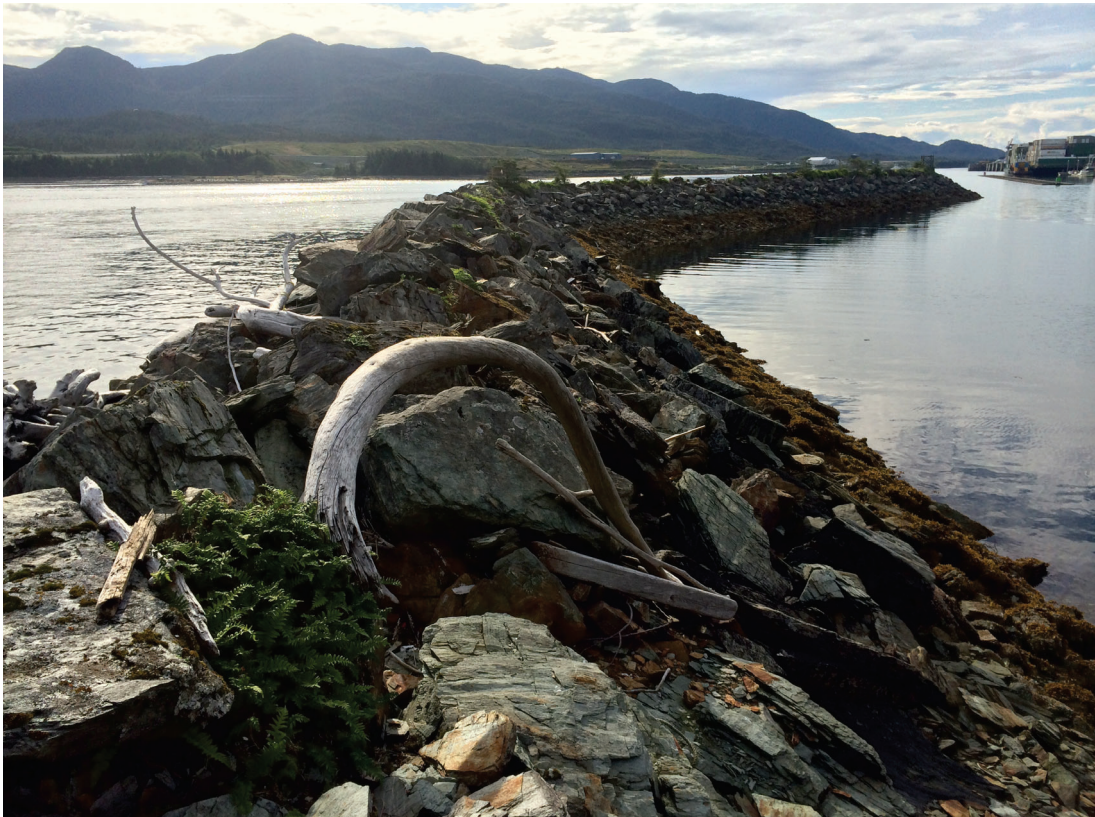
Looking Northwest from the West breakwater, August 2015

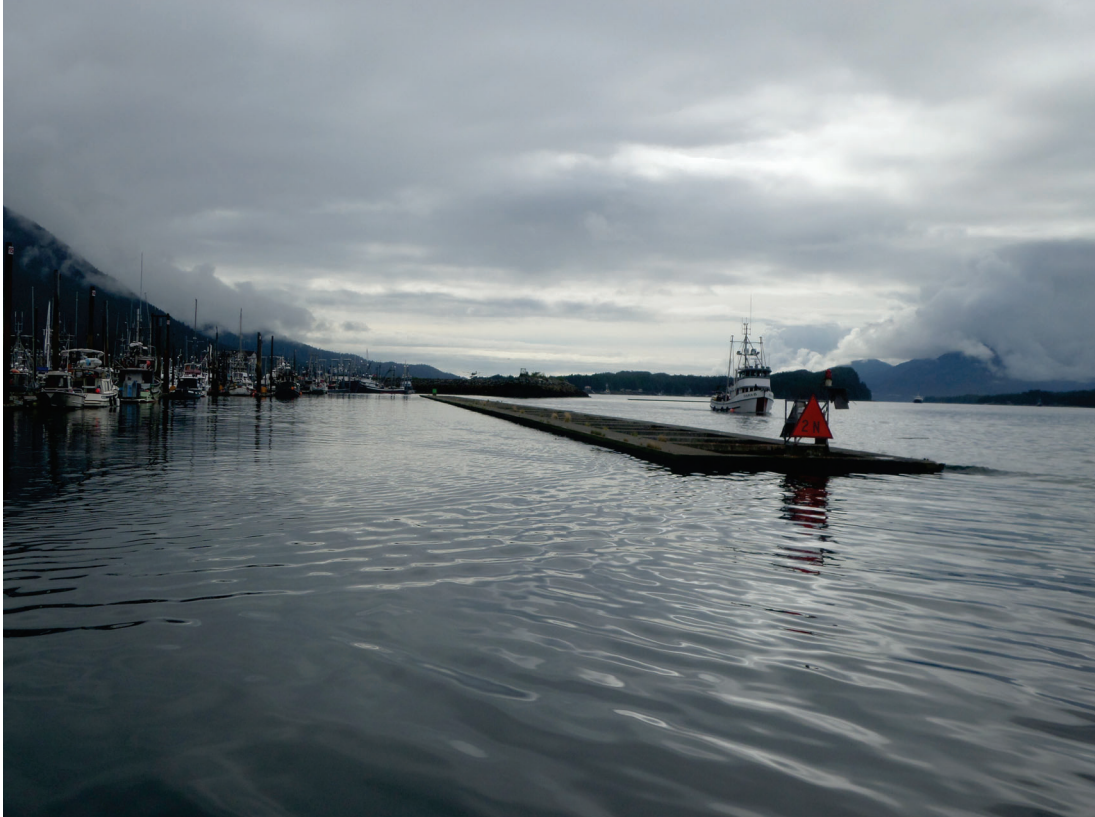
Large floating breakwater protecting the expanded harbor, August 2015

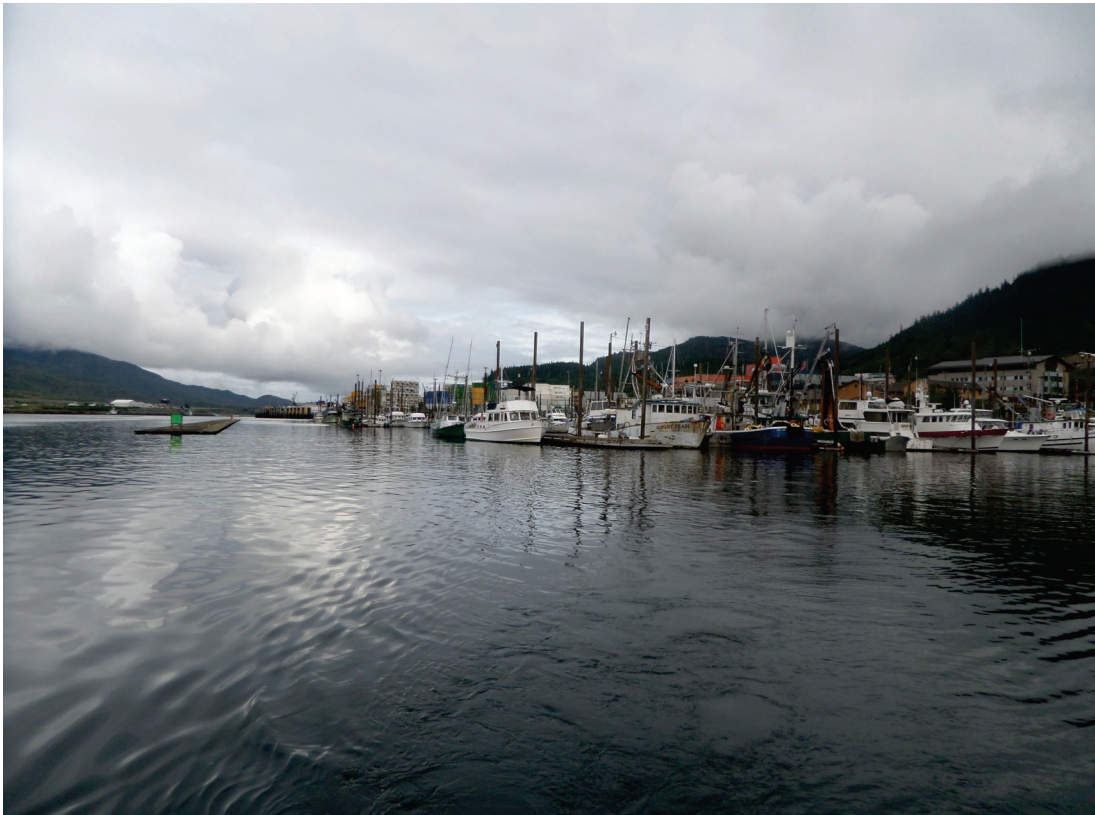
Looking Northwest across the expanded harbor, August 2015
