Port Lions Harbor

Condition of Improvements
31 December 2019
Port Lions Harbor, Alaska
(CWIS No. 087202, 087744, 010599)

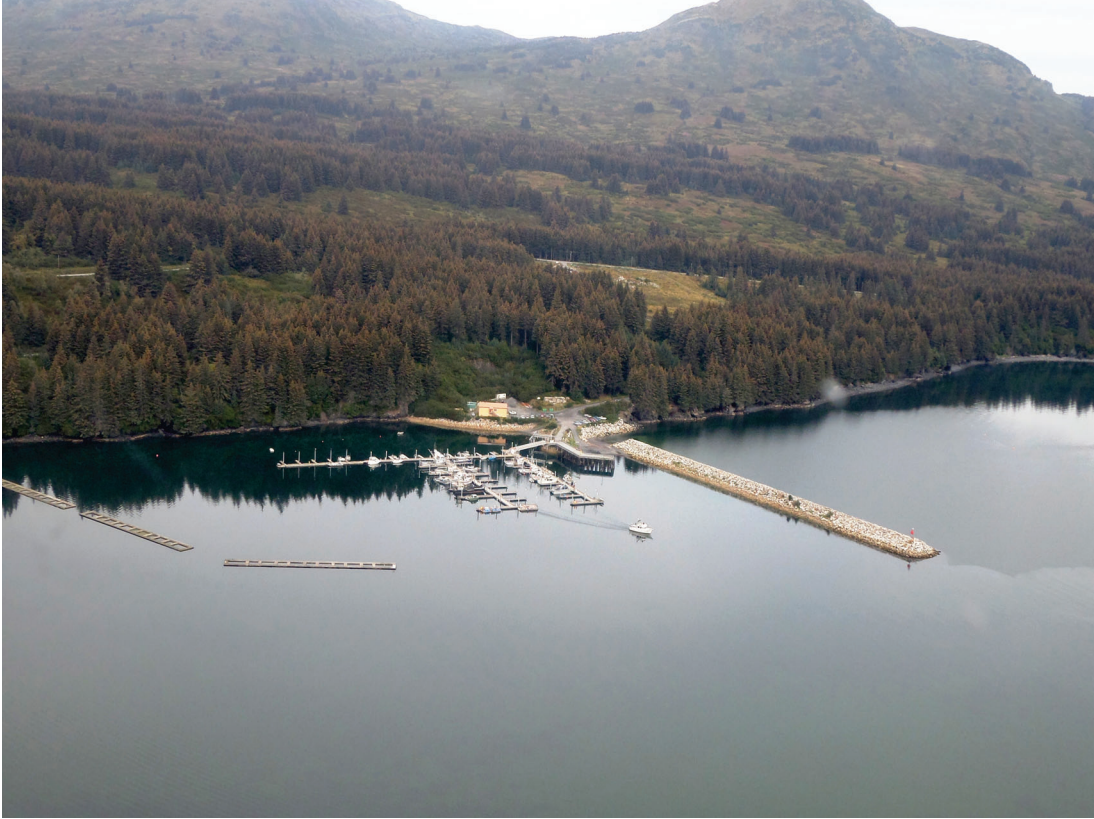
Northwest oblique of Port Lions Harbor, 24 September 2014.

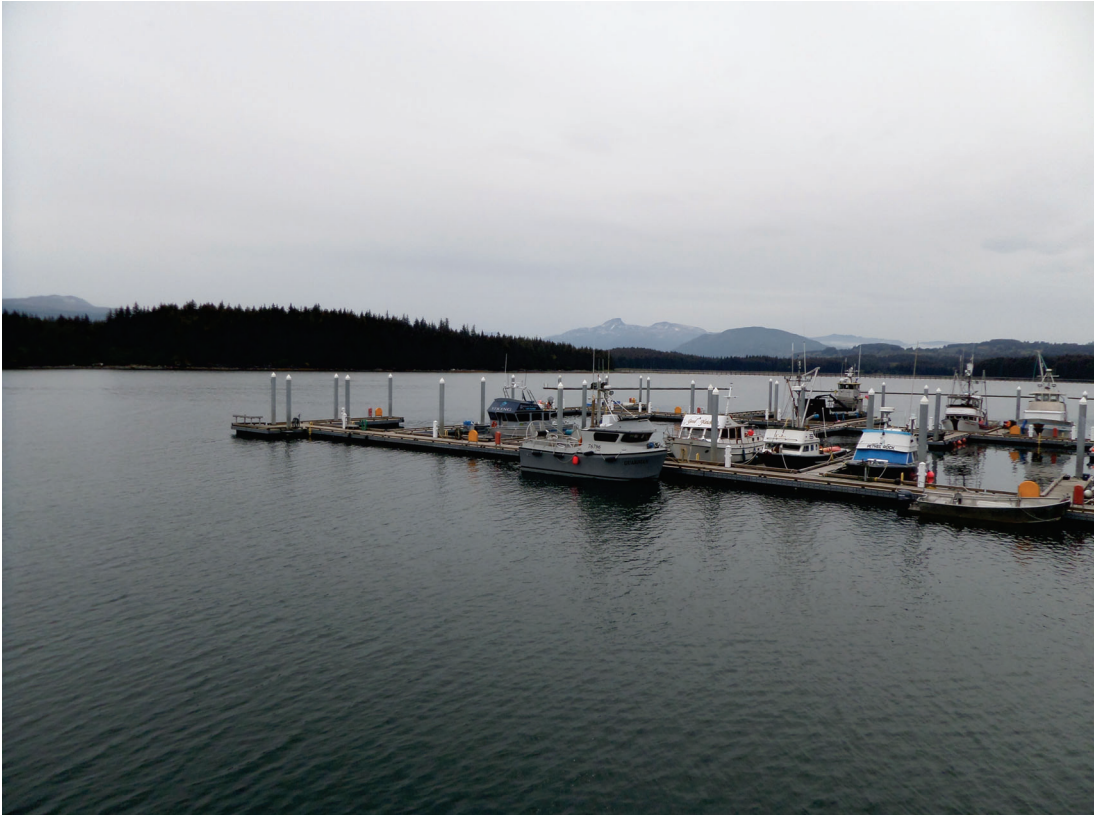
Port Lions Harbor, 3 September 2014.

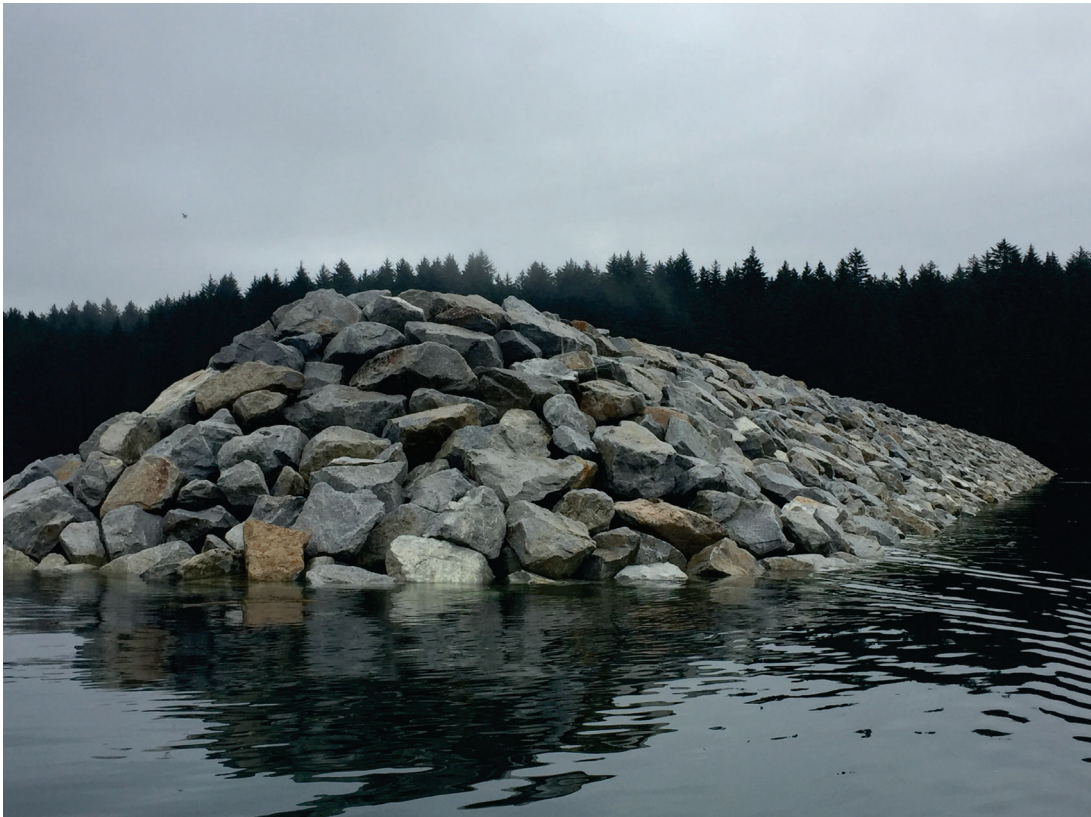
North End of New Breakwater, May 2018
