**St Paul Island**  
**St Paul Harbor**

**Condition of Improvements**  
**31 December 2019**  
**St Paul Harbor**  
**St Paul Island, Alaska**  
**(CWIS Nos. 010169, 010429 & 080526)**

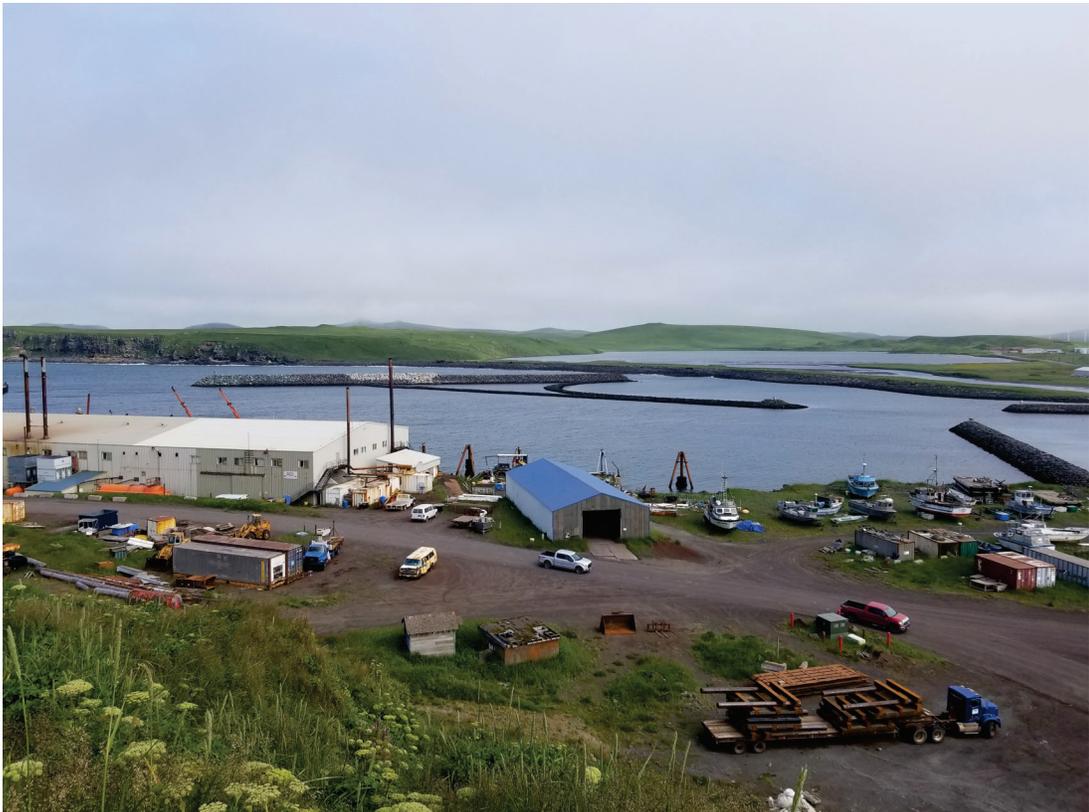
St. Paul Harbor, Detached Breakwater and Spending Beach, July 2019

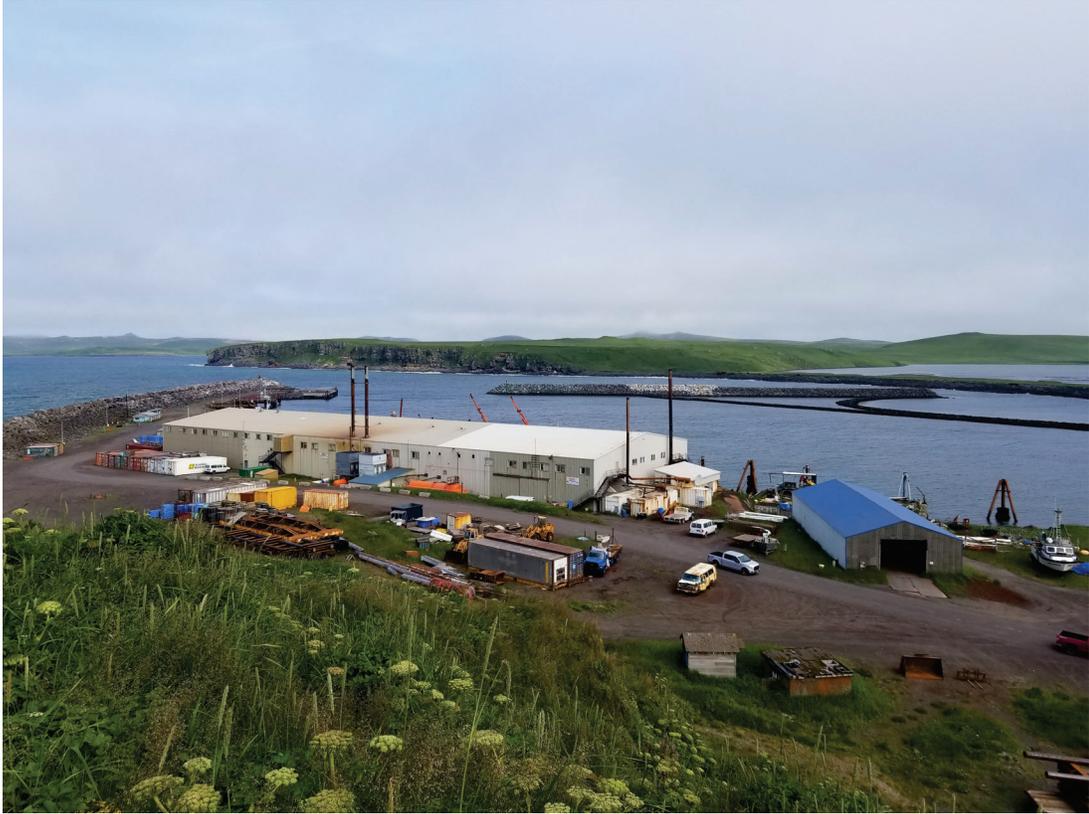
**Controlling Depth** In July 2019, project depth of -30 feet MLLW can be found throughout most of the main entrance channel, the eastern boundary of the main entrance channel has shoaled to a controlling depth of -15.0 feet MLLW. A depth of -27.6 feet MLLW controls the northern end of the federally maintained maneuvering basin. The majority of the small boat harbor entrance channel is above the project depth of -16.5 MLLW with points as shallow as -10.2 feet MLLW along the southern boundary. Project depth of -12 feet MLLW can be found throughout 80% of the small boat harbor mooring area, a controlling depth of -3.6 feet MLLW can be found along the northern limits. Project depth of -8 feet MLLW can be found throughout most of the small boat harbor maneuvering area, a controlling depth of -6.8 feet MLLW can be found at the very southeasterly corner.

St. Paul Harbor Entrance Channel, July 2019

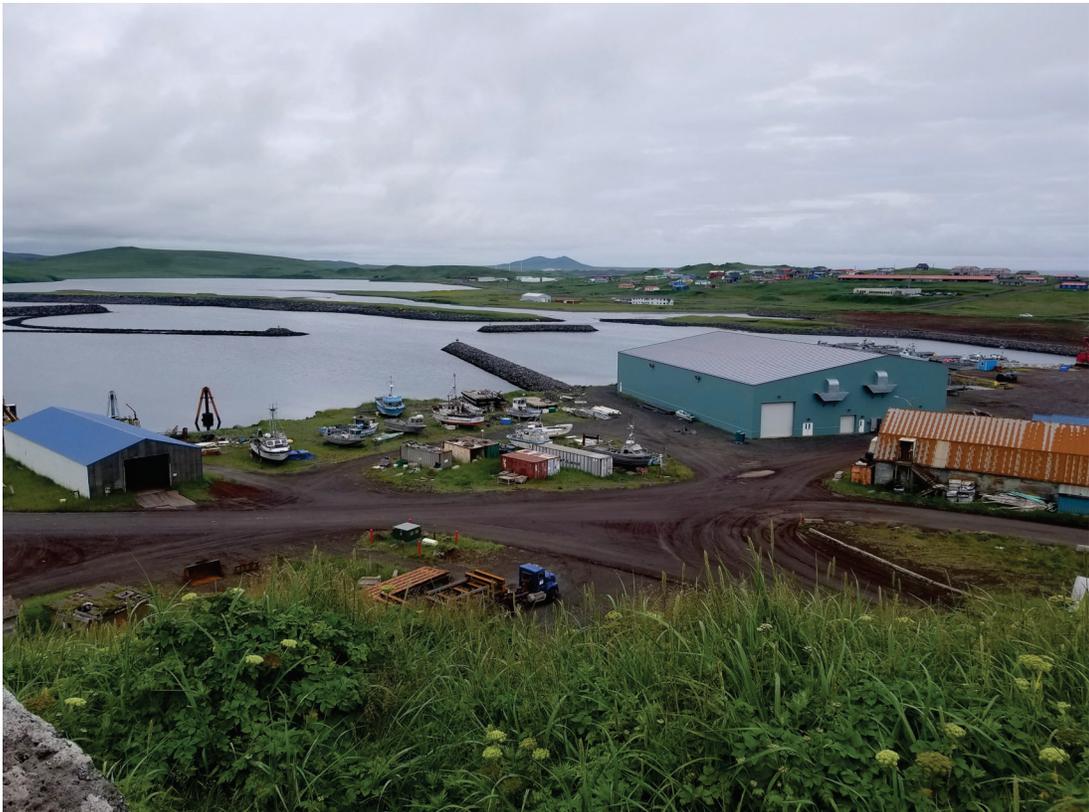
2019 A project condition survey was conducted in July. A severe storm in mid-October (remnants of Typhoon Hagibis) causes overtopping of the main breakwater. There appears to be increased scour off the nose of the attached breakwater in the small boat harbor.

St. Paul Harbor Small Boat Harbor, July 2019
