Geotechnical Feasibility Report Craig Harbor Navigation Improvements

Craig, Alaska, Alaska District, Pacific Ocean Division

November 2014

SUBJECT: Geotechnical Feasibility Report for Craig Harbor Navigation Improvements, Craig, Alaska

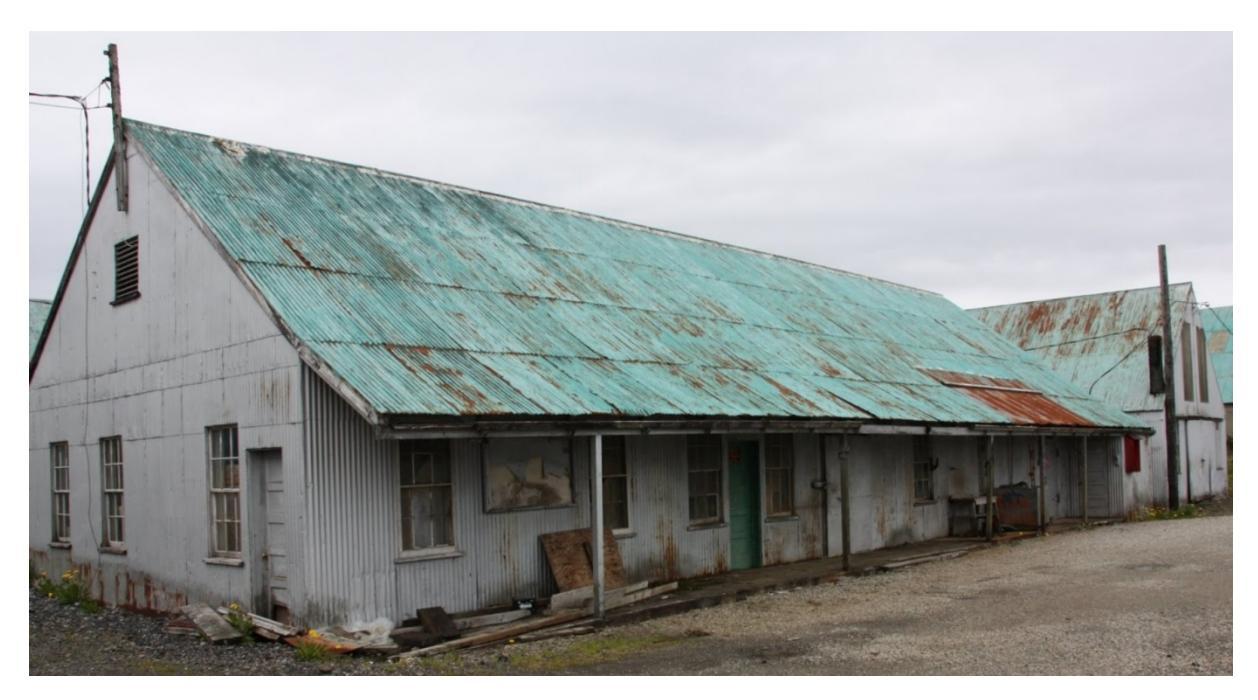
The primary problem is current moorage demand at Craig, Alaska exceeds supply. The City of Craig and the surrounding area is heavily dependent upon access to protected moorage in order to safely and efficiently engage in commercial, recreational, and subsistence fishing activities. The Navigation Improvements Feasibility Study selected a project site that had been used by Wards Cove Packing Company. Many of the company's structures remain along the north shore of Wards Cove. The machinist shop, cannery, freezer house, seine net lofts and boilers are shown in Figure 1 and 2.

Figure 1. Old machinists shop at the old Wards Cove Packing Company Cannery site. Building next to it was the freezer house and the seine net lofts.

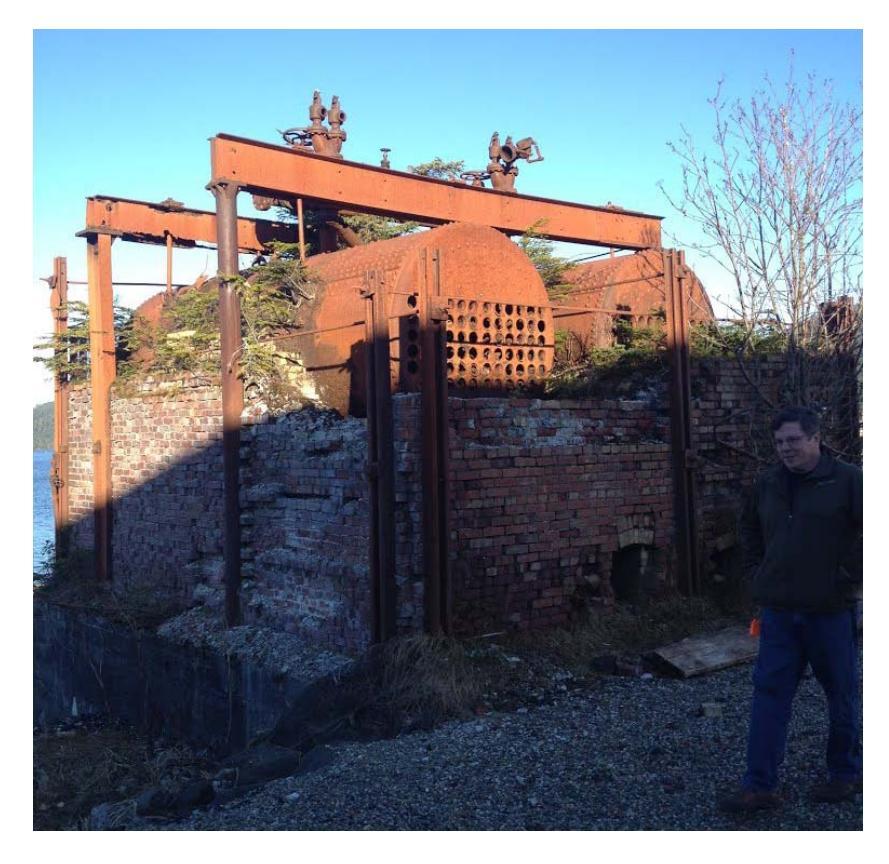
Figure 2. Photograph is to the northeast of Words Cove Packing Company Cannery old boilers.

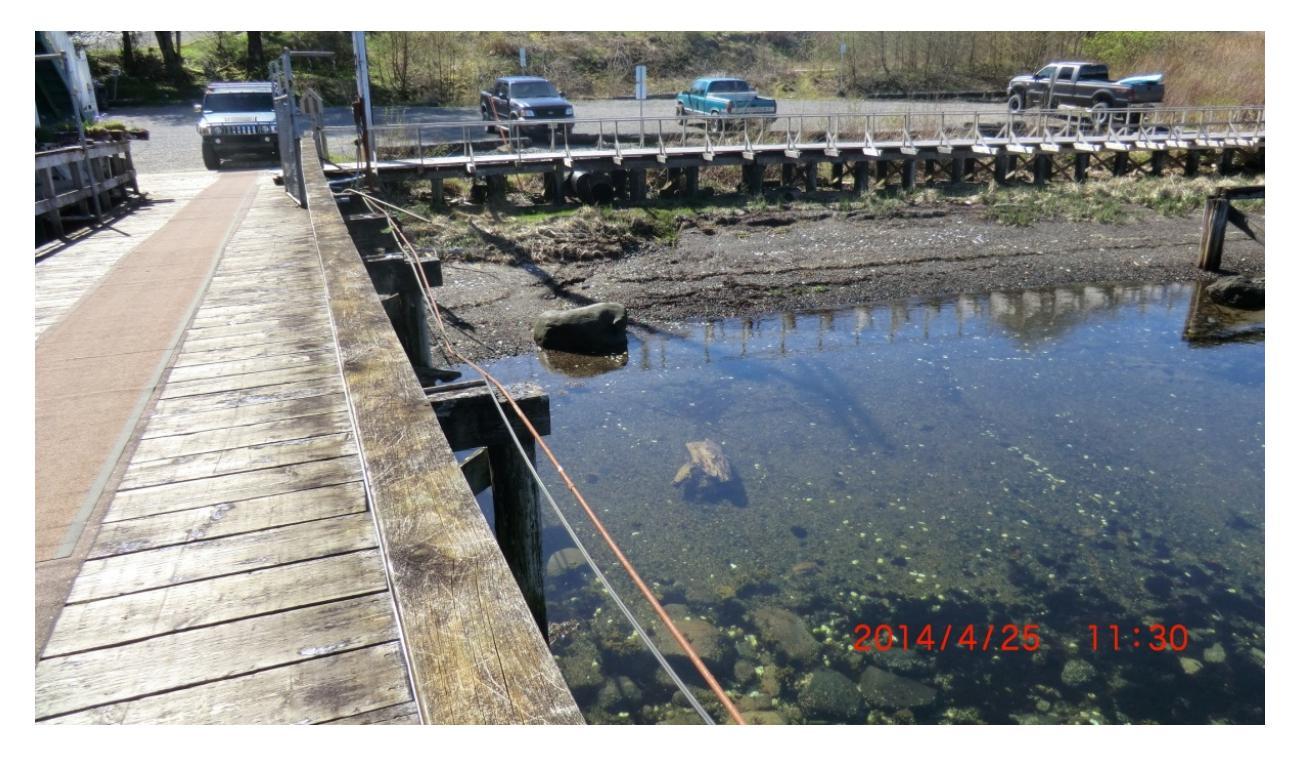
The project site has an approximate 13 percent grade sloping down from plus five feet to minus 20 feet MLLW to the north and shallows to an approximate six percent grade to minus 45 feet MLLW. The surface is composed of sand with some fines, gravel, and an abundance of cobbles and boulders; Figure 3 and 4. Remains of the Wards Cove Packing Company timber dock are littered over a large portion of the project site. This includes remnants of the dilapidated timber dock; scattered timber piles are protruding out of the water as well as lying on the sea floor, and large iron rigging, equipment and/or machinery; Figure 4 though 6.

Figure 3. Large boulders can be seen in the photograph near the eastern project limits.

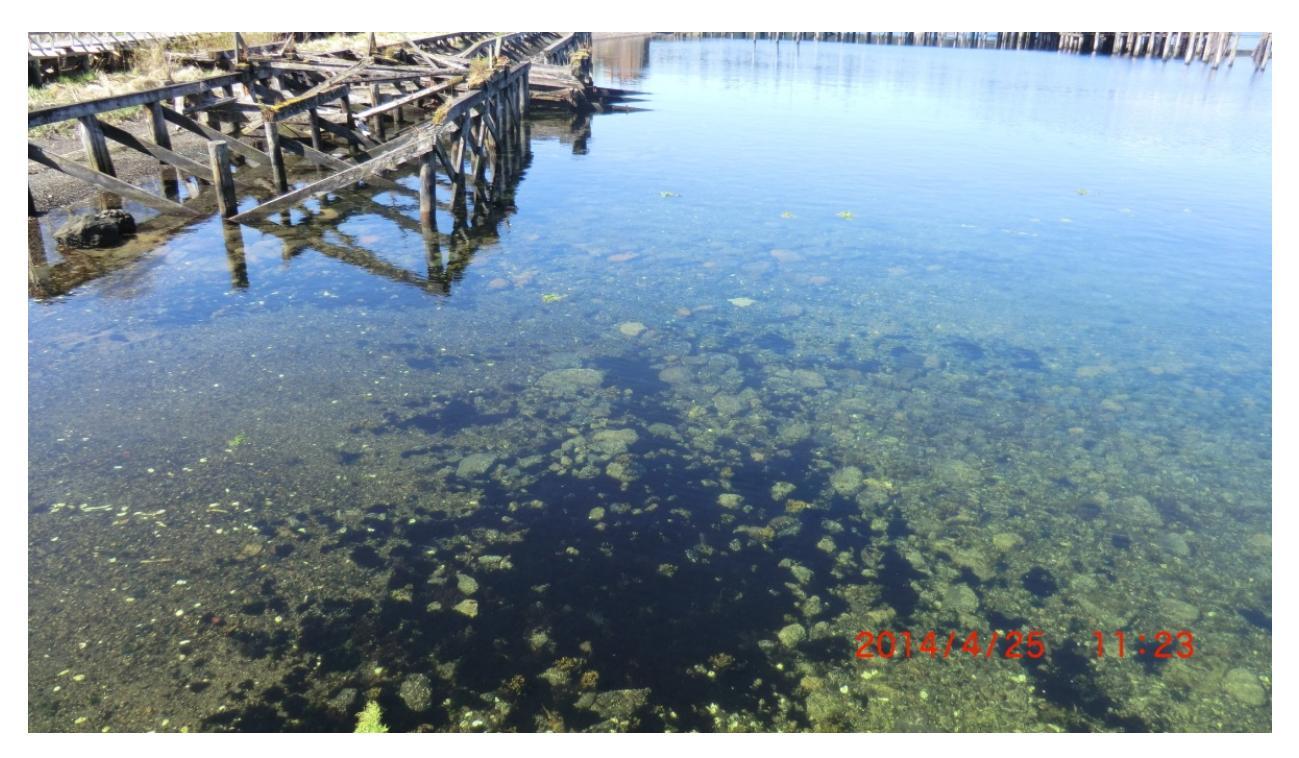
The remains of a decaying timber dock and debris can be seen along the waterfront of the project site. Some steel rigging and machinery can be seen at low tide. Due to the sites past usage, marine related mechanical and structural debris is expected below the water in Wards Cove.

Figure 4. Cobbles and boulders can be seen at the project site near the dilapidated timber dock.

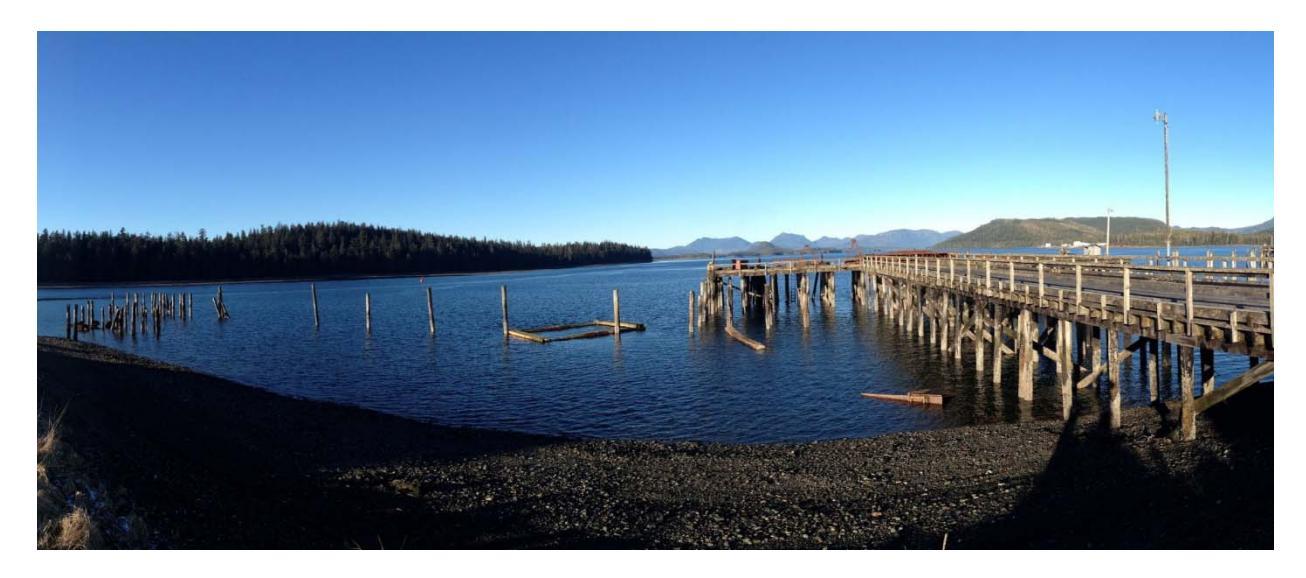
Figure 5. Photograph is looking north; dilapidated wood dock of the Wards Cove Packing Company Cannery site.

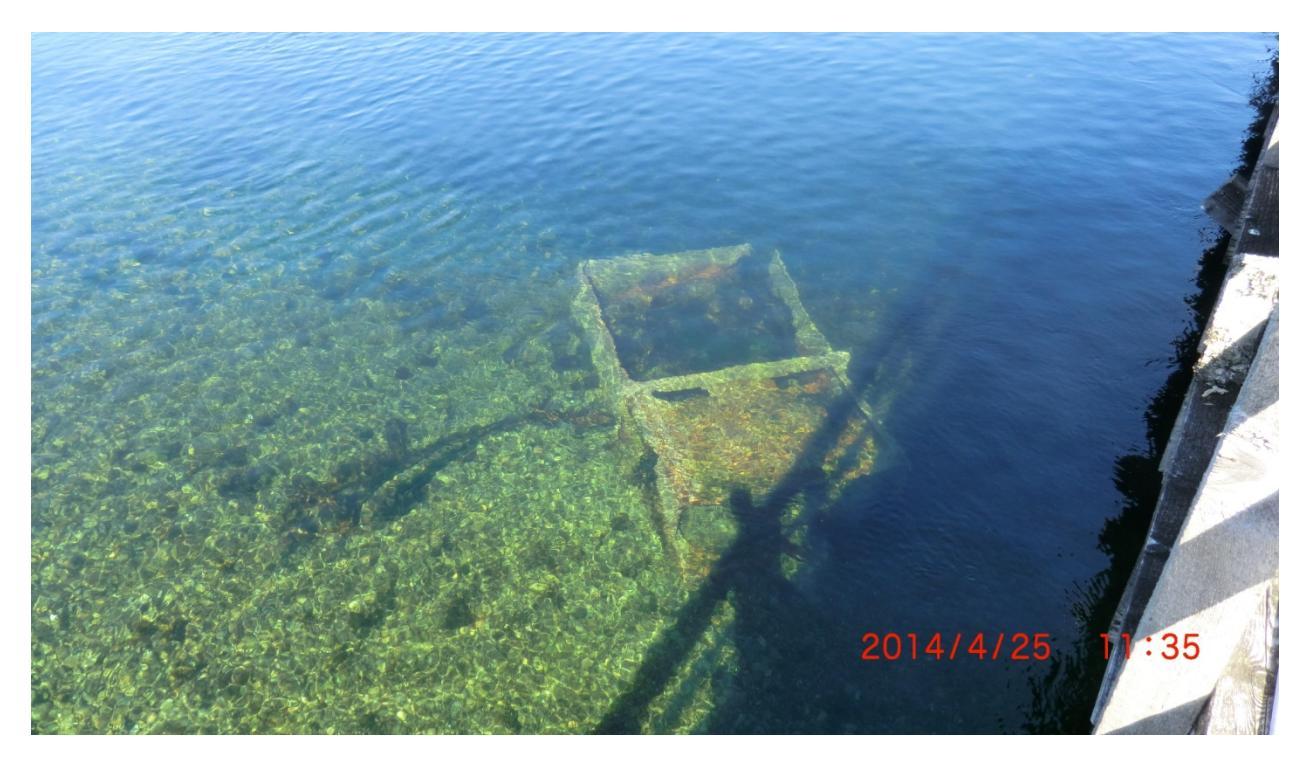
Figure 6. Photograph shows a large unknown piece of iron equipment or machinery off the side of the old dock.
