FLOOD CONTROL
SALMON RIVER
ALASKA
REVISED 1993

SALMON RIVER, HYDER, ALASKA
(CWIS NO. 72857)

Condition of Improvement 30 September 2010

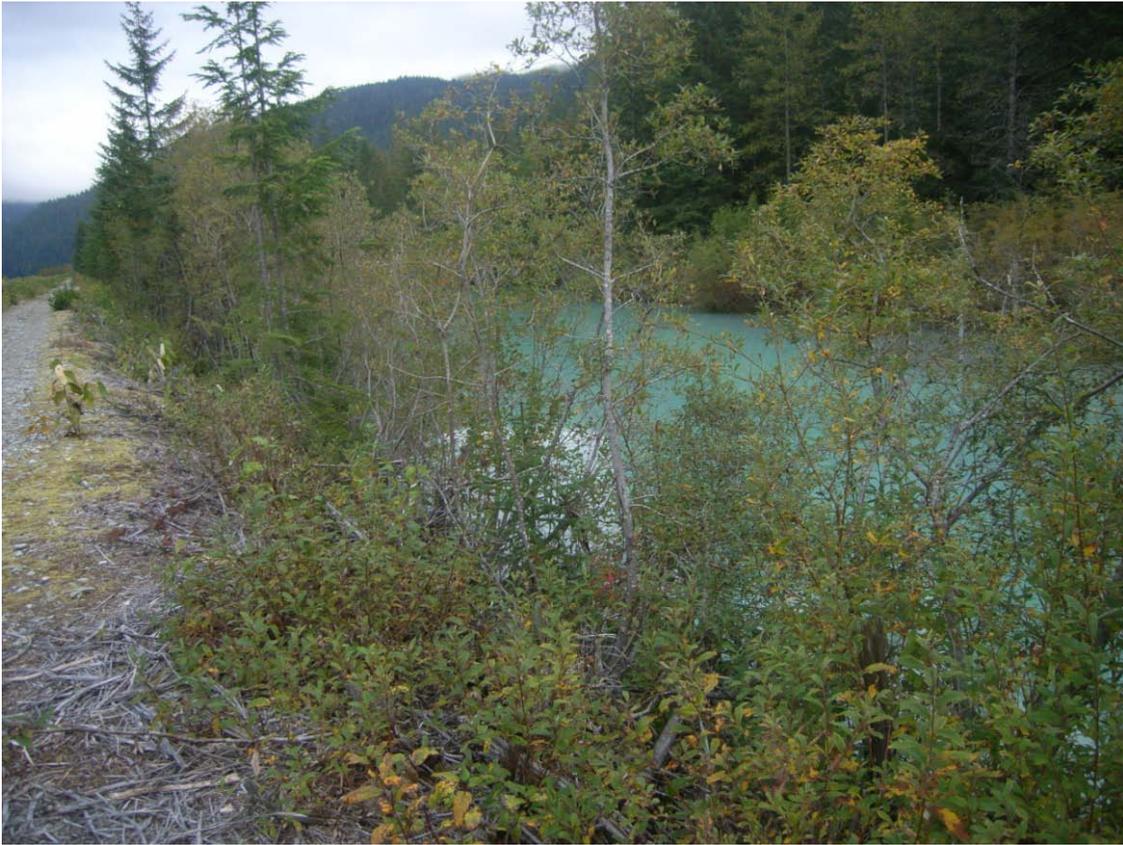
An indication of seepage, a pond on the landward side of the levee has the same water elevation as the river in August 2010.
