**DEERING
STREAM BANK
PROTECTION**

DEERING STREAMBANK PROTECTION, ALASKA
(CWIS NOS. 92906 & 180355)

Condition of Improvement 30 September 2009

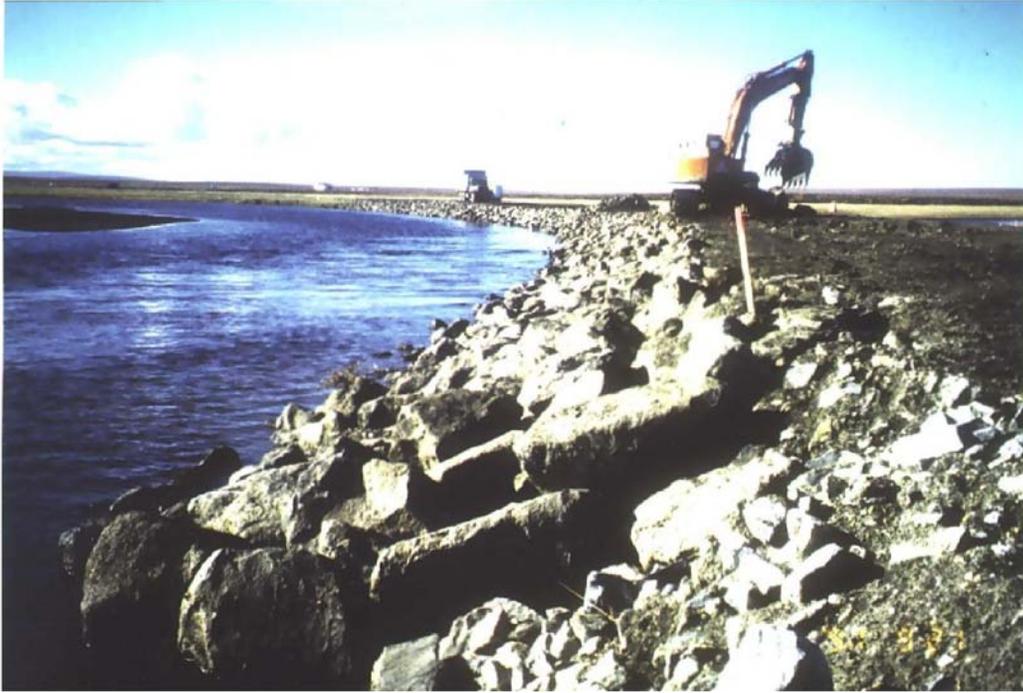
Work in progress at mile 0.5, view upstream, September 1997.

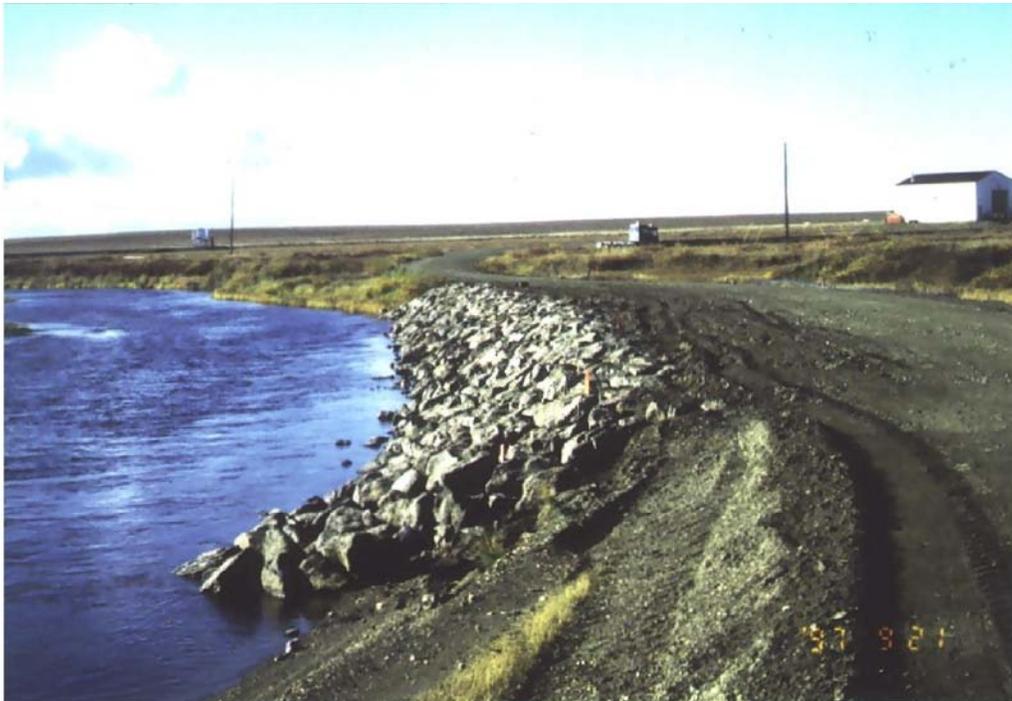
Revetment at mile 0.95, September 1997.
