**KLUTINA RIVER AT  
COPPER CENTER**

**KLUTINA RIVER at COPPER CENTER, ALASKA**  
 (CWIS NO. 003830)  
 Condition of Improvement 30 September 2010

## **Klutina River, Copper Center, Alaska**

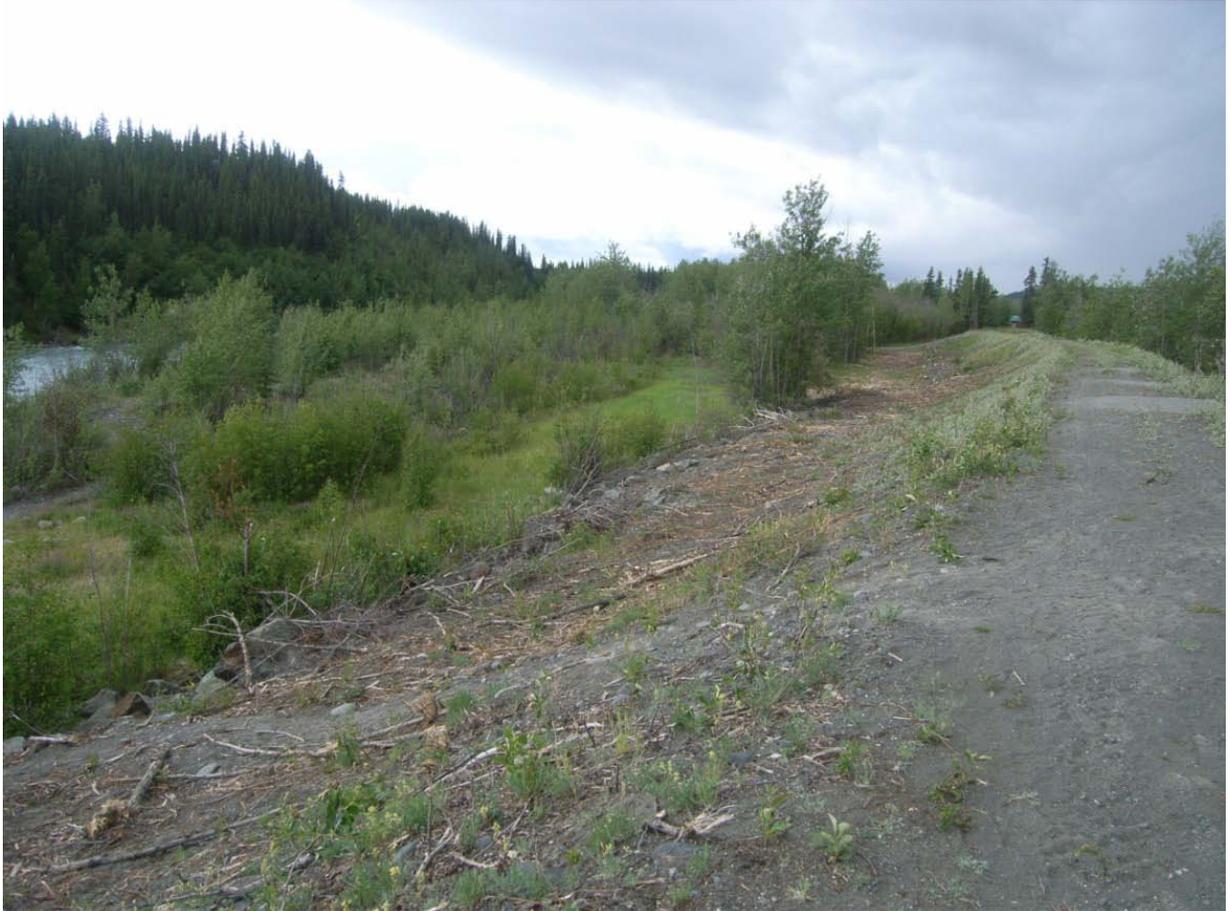
- 2010 - The Klutina Levee was inspected June. The levee received a rating of 'minimally acceptable'. The State of Alaska, Department of Transportation and Public Facilities (ADOT&PF) had removed most vegetation and was still working on repairs and encroachment issues.

Brush cutting and vegetation removal along the riverside slope and toe, June 2010.
