**METLAKATLA  
EROSION  
PROTECTION**

**METALAKATLA EROSION PROTECTION, ALASKA**  
**Cemetery and Fuel Tank Facility**  
 (CWIS Nos. 92796 & 92830)

Condition of Improvement 30 September 2011

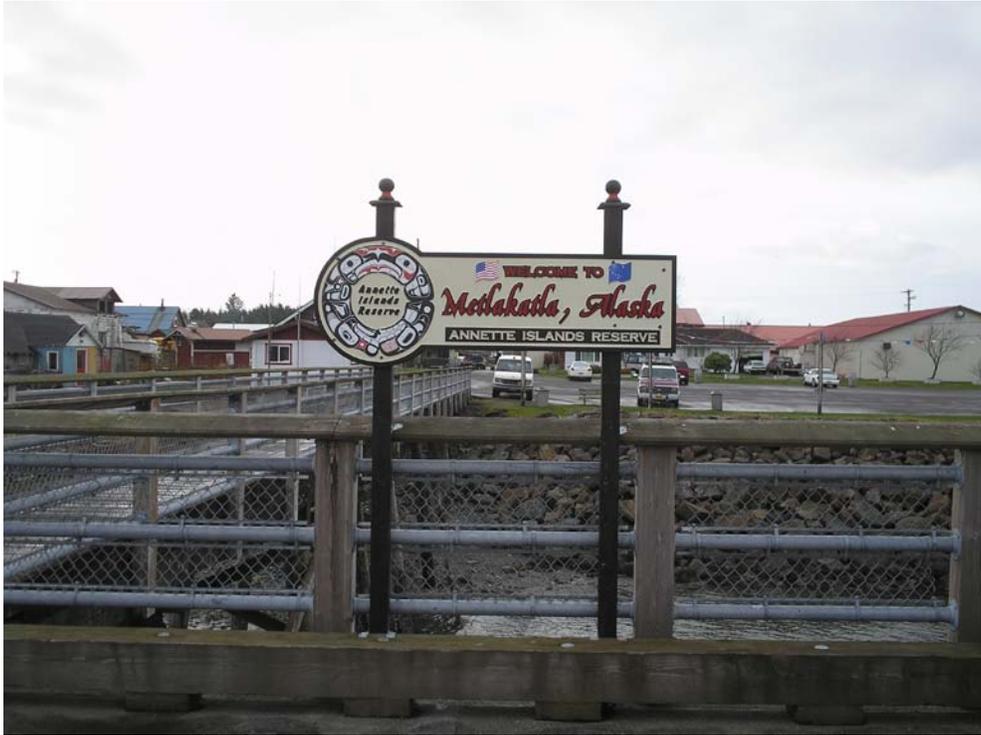
Sign on dock 2008, shore line protection in background.

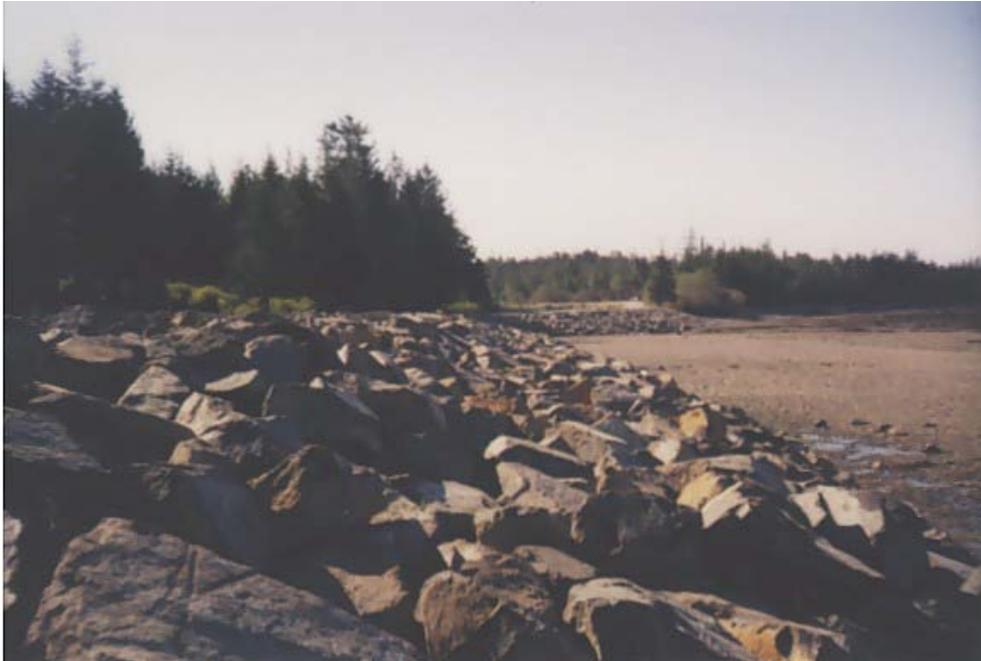
Looking along the shore protection 1999.

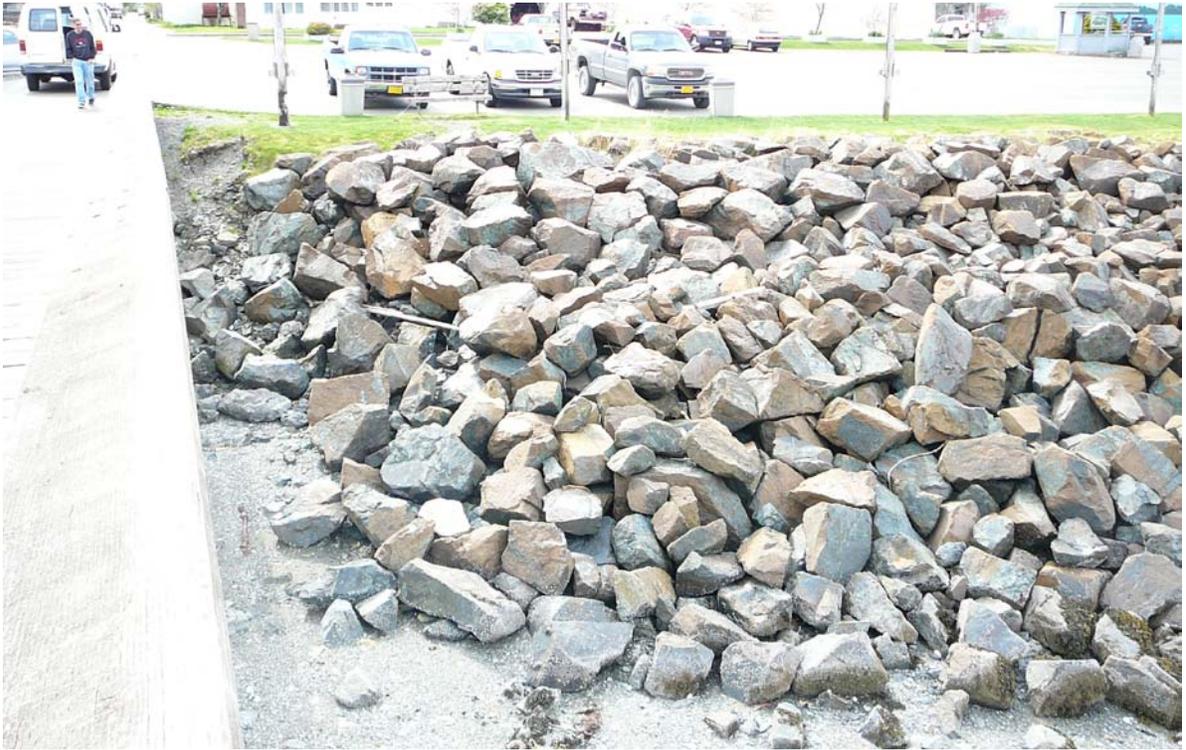
East end of the Fuel Tank Facility Project 2009.

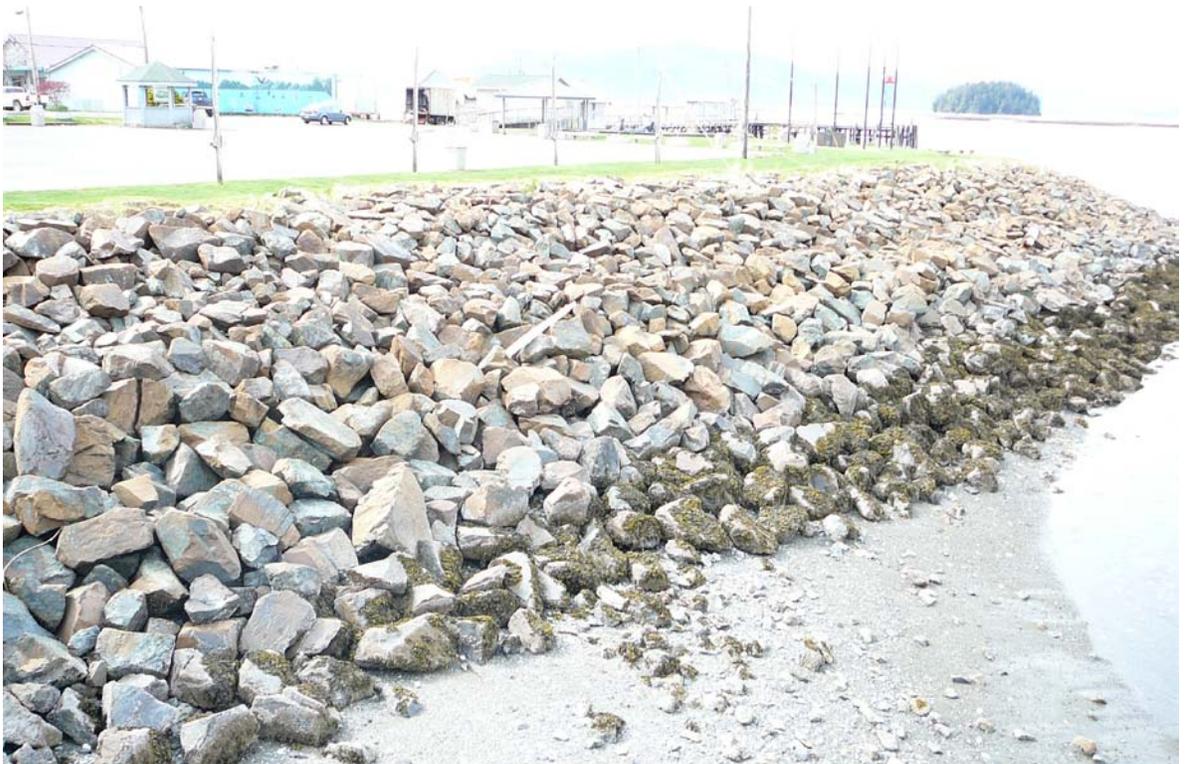
- 2007 - The Corps' inspector finds both projects in acceptable condition. The culvert and both ends of the cemetery revetment need to be monitored.
- 2009 - The revetment slope of the project appears in good condition with essentially no displacement of rock.

Metlakatla erosion protection along the ocean in 2009.

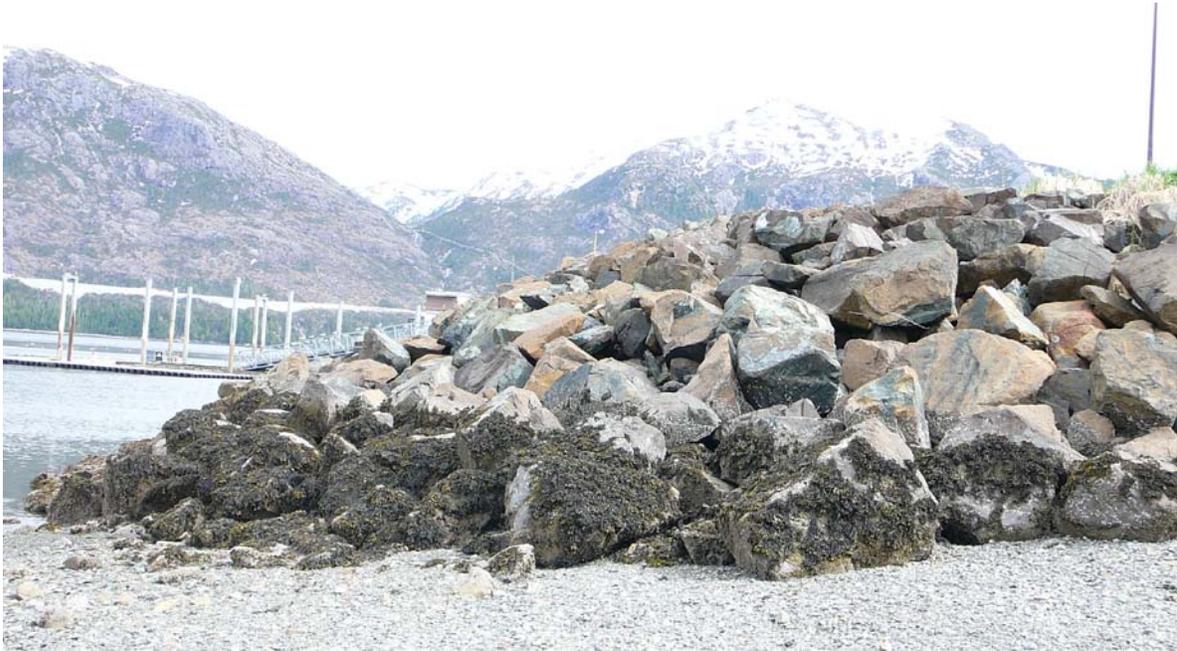
Coast protection near the harbor in 2009.

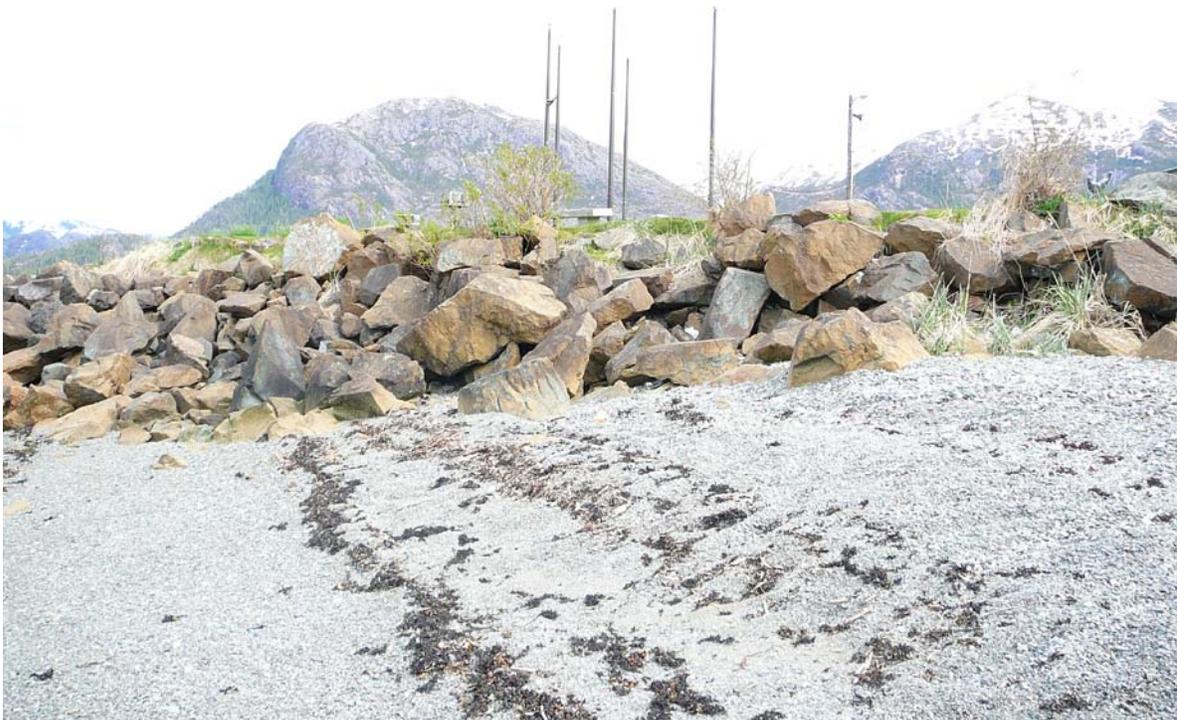
- 2001 - Both projects are found in good condition by the Corps' inspector.
- 2003 - Both revetments are found in good condition by the Corps' inspector in August. Damage to the culvert is cited as a problem at the cemetery site, and some non-Corps stone work immediately west of the tank farm revetment is noted as inadequate.

The non-Corps revetment that is at the west end of the Corps' revetment.
