DOUGLAS HARBOR

DOUGLAS HARBOR
ALASKA
REVISED 2009

DOUGLAS HARBOR, ALASKA
 (CWIS NO. 72789, 180942)
 Condition of Improvement 30 September 2013

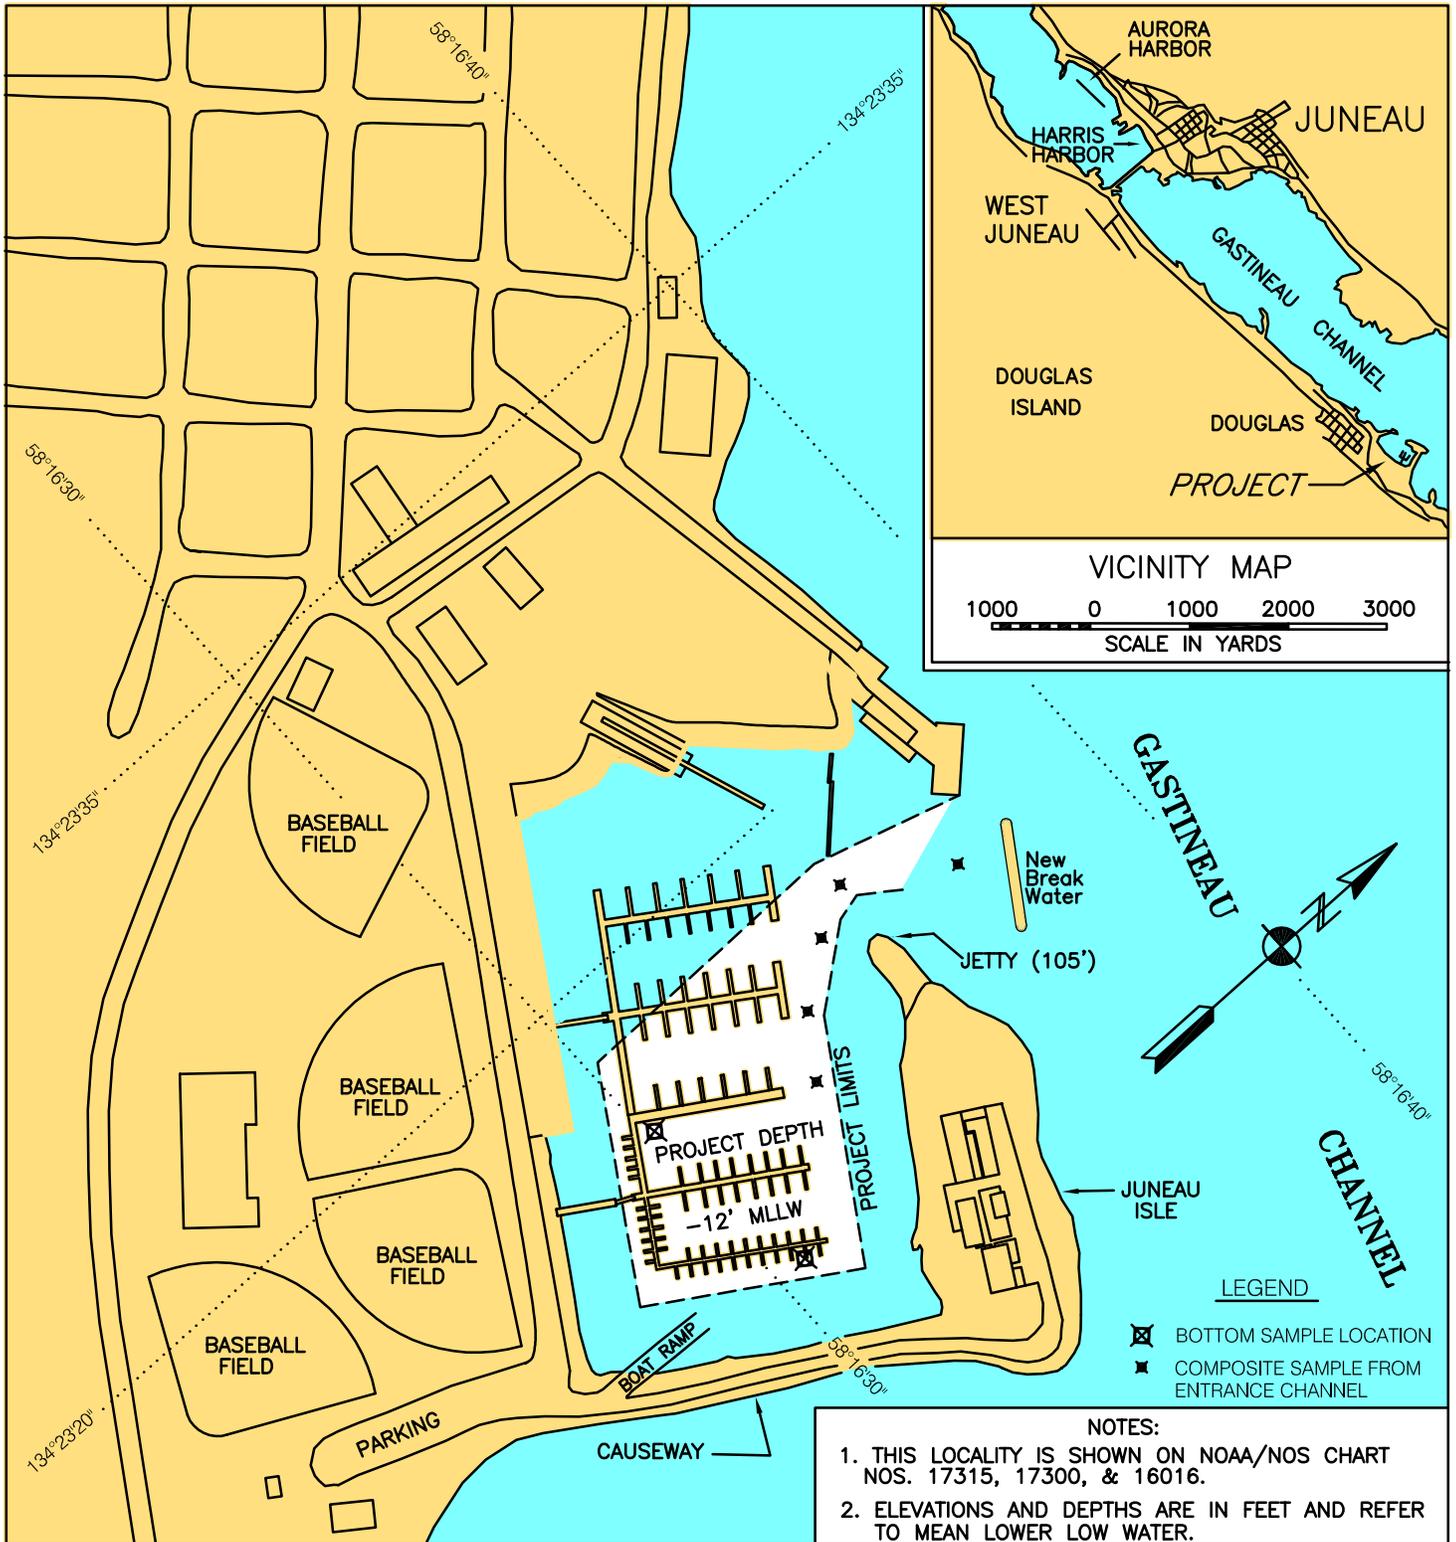
CONTROLLING DEPTH: A depth of -5.3 feet MLLW controls along the southern edge of the harbor basin in 2013.
