HAINES HARBOR ALASKA

HAINES HARBOR, ALASKA
 (CWIS NO. 87015)
 (CWIS NO. 150037)
 (CWIS NO. 13576)

Condition of Improvement 30 September 2011

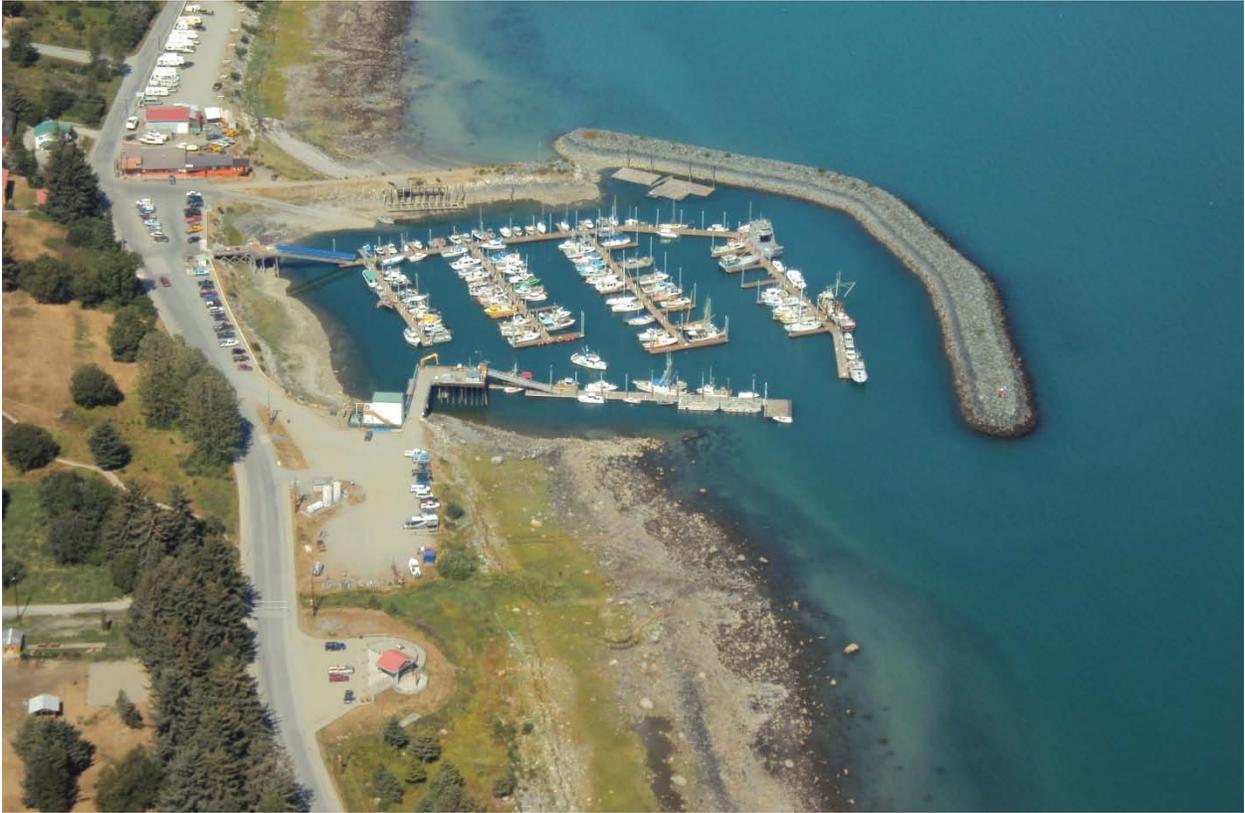
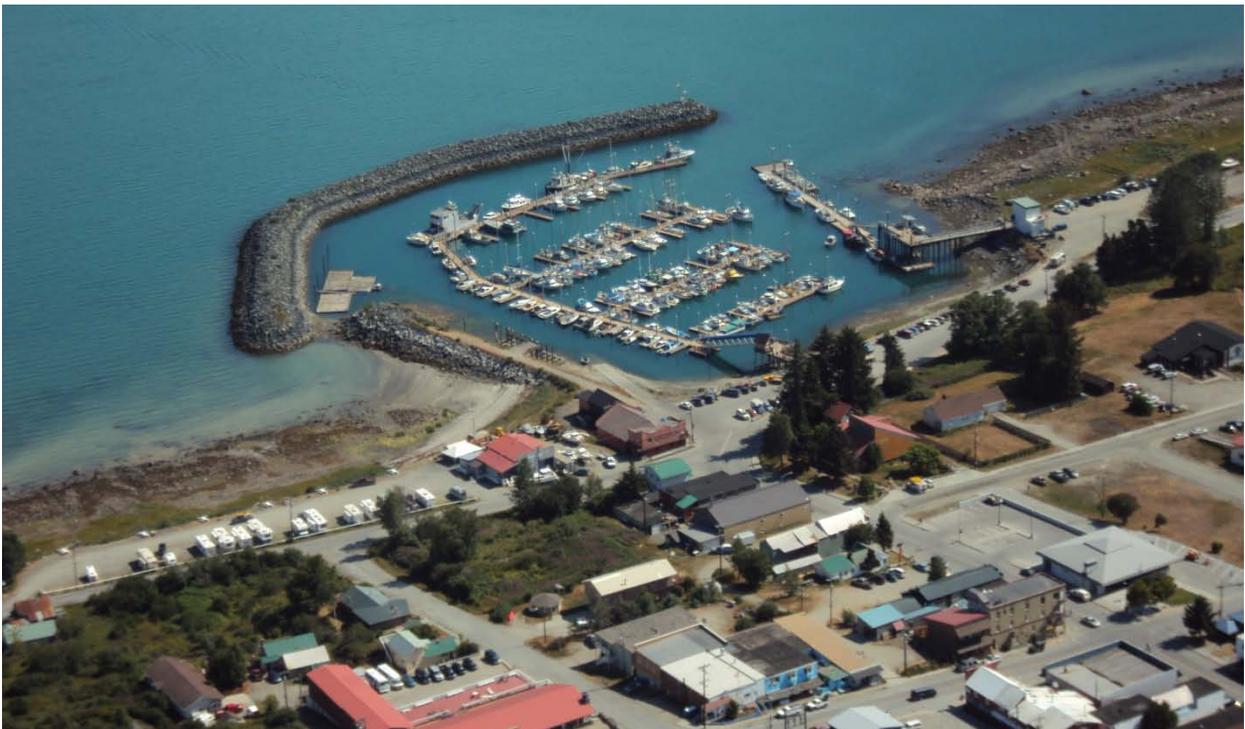
Haines Small Boat Harbor, Haines Alaska

Haines SBH aerials taken in the summer of 2011.

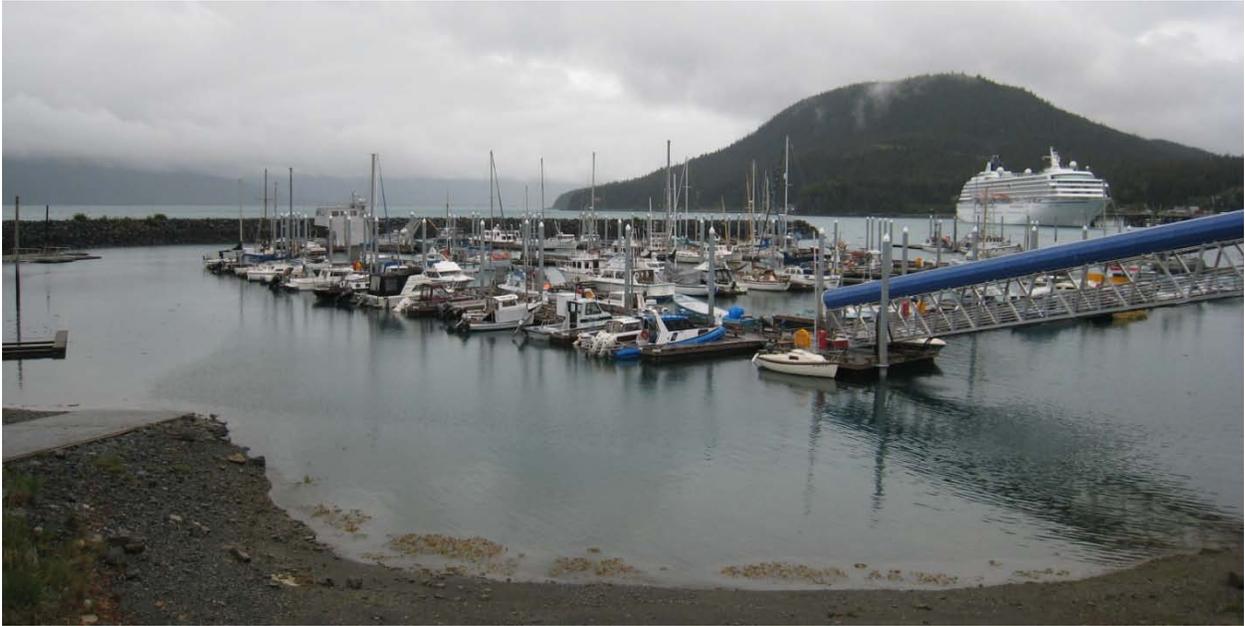
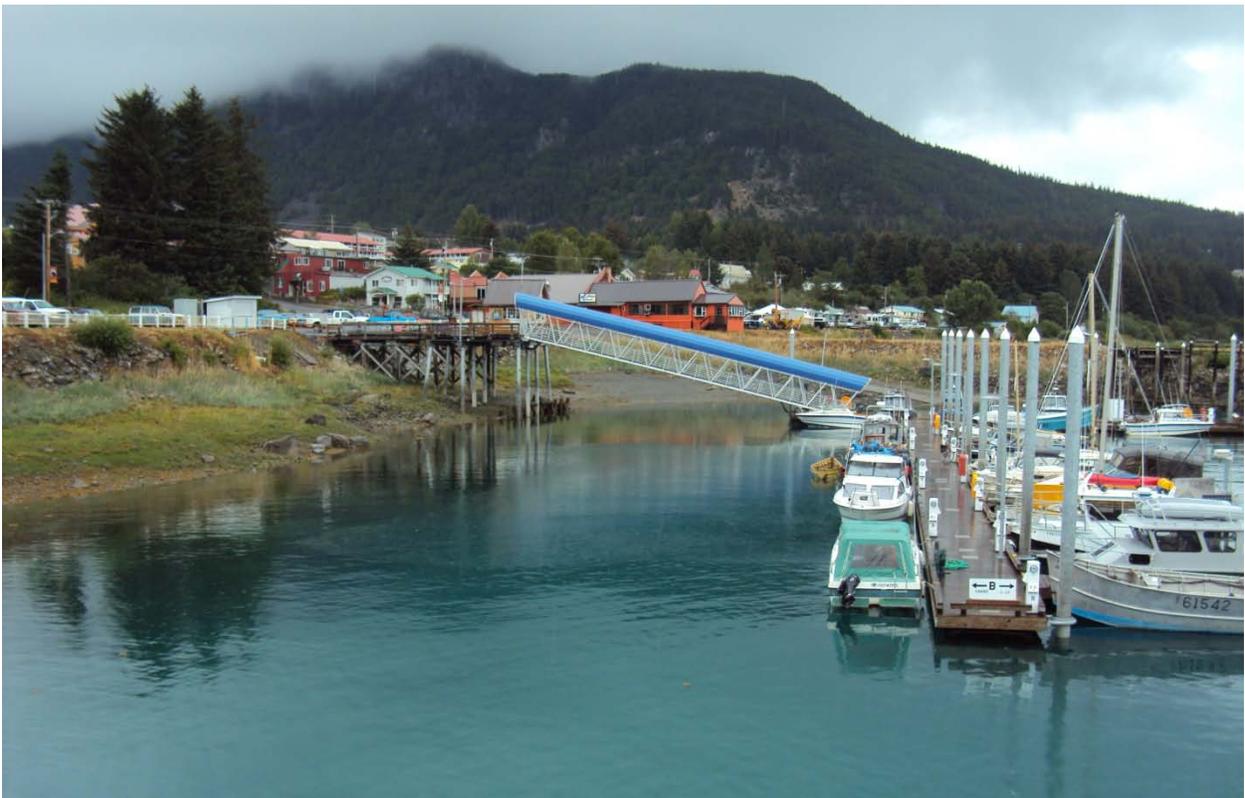
Haines Small Boat Harbor, Haines Alaska

Haines SBH ground pictures taken in the summer of 2011.
