# **Galena Emergency Bank Stabilization**

Condition of Improvements  
31 December 2022  
**Galena Emergency Bank Stabilization, Alaska**  
(CWIS No. 075442)

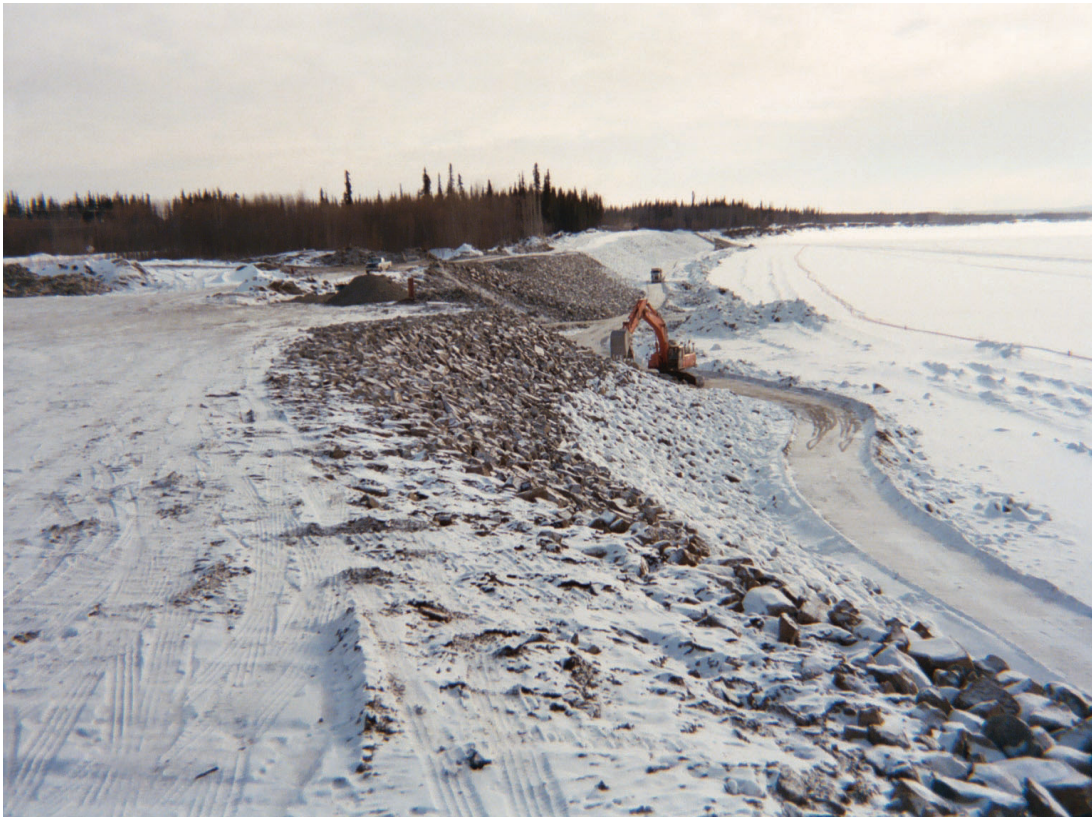
Construction of the emergency bank stabilization, April 2005
