Eagle Nest Survey – Fort Babcock Formerly Used Defense Site (F10AK0353-04), Kruzof Island, Alaska

Date:	29 January 2024
Contract:	W911KB22C0019
Project:	Fort Babcock FUDS (F10AK0353-04) Remedial Action
To:	U.S. Army Corps of Engineers, USFS Tongass National Forest
From:	Brice Engineering, LLC
Attachments:	Figure 1: Site Location and Vicinity Map
	Figure 2: Fort Babcock Eagle Survey Area and Results
	Attachment 1: Eagle Nest Survey Photograph Log
	Attachment 2: Field Documentation
	Attachment 3: Response to Comments

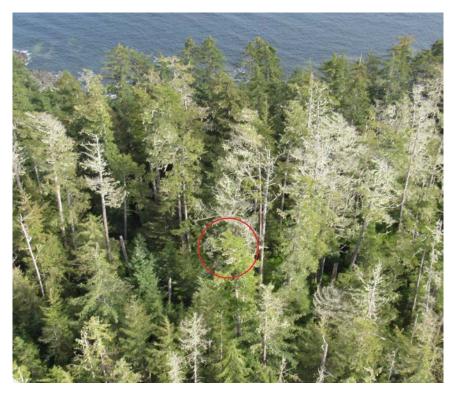
Nest 1 was located 20 feet (6 meters) inside the 330-foot buffer to the southwest of the proposed camp/staging area (Attachment 1, Photographs 1 and 2). Nest 1 was in good condition, and a single fledgling Bald Eagle was observed in the nest. There were copious amounts of fresh whitewash on adjacent limbs, indicating it hatched from this nest in 2022 (Attachment 1, Photograph 2). The fledgling was large and likely flight-capable at the time of the survey in mid-September. This nest was on the west edge of tall Sitka spruce trees distributed along the coastline, which should provide a good visibility buffer between the nest and the proposed road clearing areas along the coast to the east. However, the entire stand of tall trees at the camp/staging area approximately 400 feet (122 meters) to the northeast will be removed, and activities at the camp/staging area are less likely to be buffered by dense vegetation.

Photograph 1: Nest 1 showing the nest location relative to other trees and the coast within the survey area. Facing ENE.

To mitigate potential nest area disturbance by the camp activities, the sleeping quarters and other quieter spaces will be positioned closest to the nest area. Noisier activities, such as operation of vehicles or equipment, will be positioned as far away from the nest area as possible and only allowed to operate out of view of the nest, if possible.

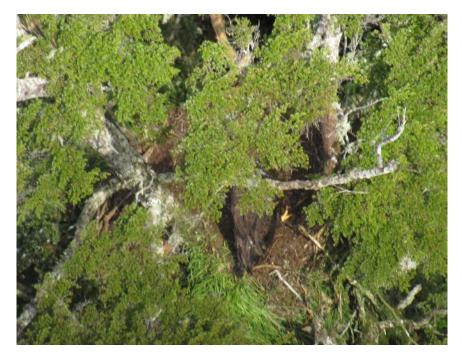
Photograph 2: Birds-eye view of fledgling Bald Eagle in Nest 1. Facing down.

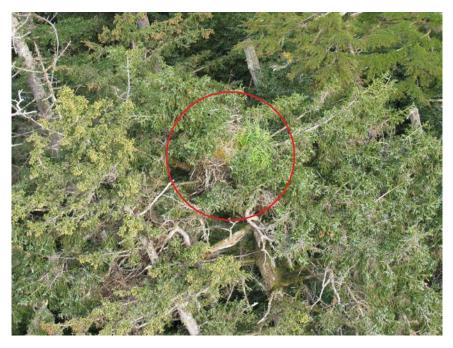
Nest 2 was located 30 feet (9 meters) inside the 330-foot buffer to the south end of the proposed clearing area and 0.58 miles (933 meters) from Nest 1 (Attachment 1, Photograph 3). This nest was overgrown with grass, and it did not look like eagles had used it for several years.

Photograph 3: Closeup of Nest 2 showing the poor condition of the nest. Facing down.

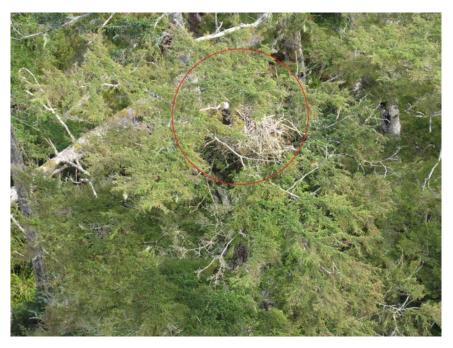
Nest 3 was located outside the 660-foot buffer to the northeast of the proposed clearing area and 0.53 miles (850 meters) from Nest 1 (Attachment 1, Photograph 4). This nest was active, and an adult Bald Eagle was observed perched in the nest and another adult nearby. Copious amounts of whitewash were observed on the adjacent limbs indicating young may have fledged from this nest.

Photograph 4: An adult Bald Eagle perched on Nest 3. Facing down.

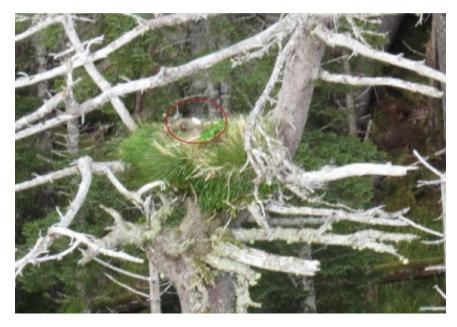
Nest 4 was located in a dead Sitka spruce tree outside the 660-foot buffer to the southwest of the proposed clearing area and 0.68 miles (1,100 meters) from Nest 1 (Attachment 1, Photograph 5). This nest

showed no signs that young were raised or eggs were laid in 2022, and the amount of vegetation growing in it indicated that it likely has not been used for nesting for a few years. However, an adult Bald Eagle was observed between Nest 4 and Nest 1, and a fresh feather was observed on the edge of Nest 4. It was unclear if the feather was from a prey item consumed by a Bald Eagle, a perched Bald Eagle, or from another bird using the nest as a perch.

Photograph 5: Nest 4, including a white feather on the rim of the nest. Facing down.
