# **Galena Emergency Bank Stabilization**

Condition of Improvements  
31 December 2017  
**Galena Emergency Bank Stabilization, Alaska**  
(CWIS No. 075442)

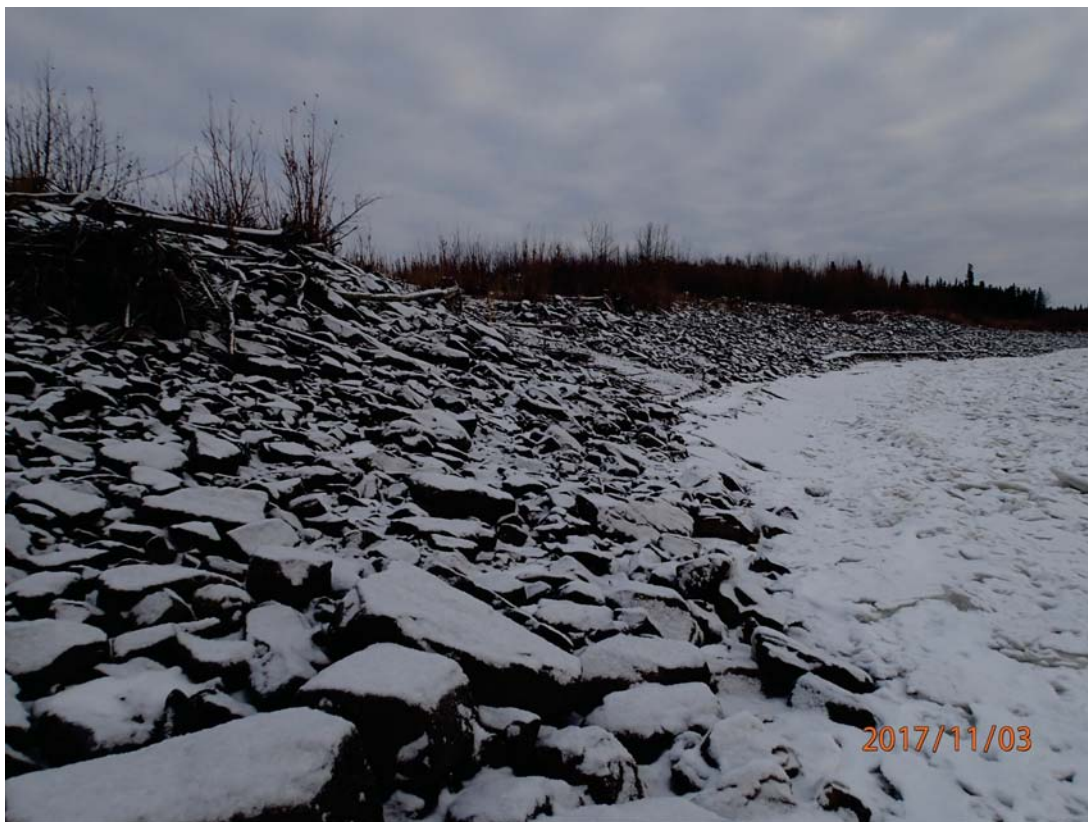
Revetment at access ramp, looking upstream, November 2017

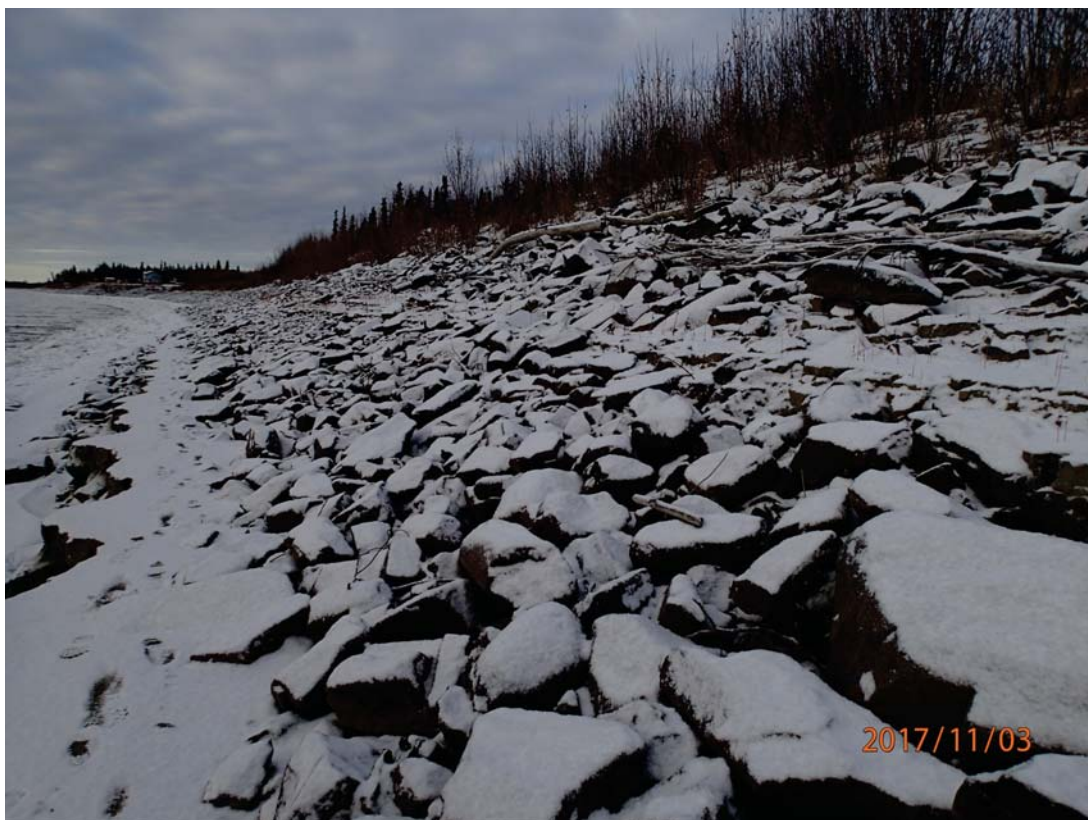
Revetment near upstream end, looking downstream, November 2017
