Rock Quarry Potential Preliminary Investigation State of Alaska

November, 2010

U.S. Army Corps
of Engineers
Alaska District

Appendix C. Field Surface Reconnaissance Report, Potential Large Stone Material Sources.. C 2

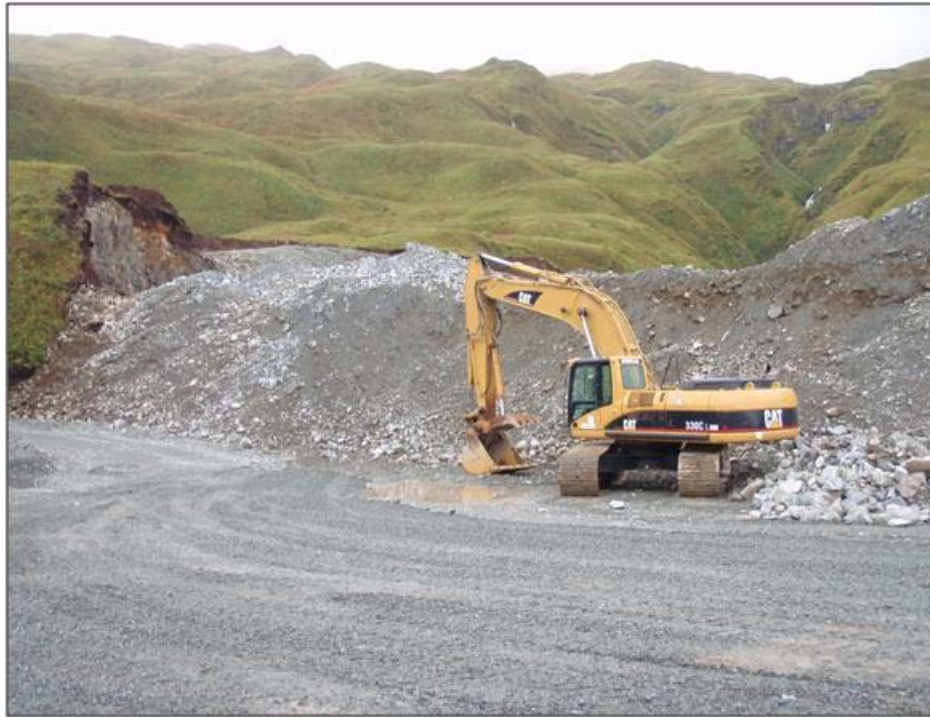
Figure C - 3. View of Bering Shai Quarry from Staging Area

Bering Shai Construction, Bill Shaishnikoff, runs the daily operations of the quarry. The topography of the undeveloped area of the quarry is steep and the surface elevation rises rapidly from Captains Bay. Figure C - 3 provides a view of the quarry from the staging area.

The quarry is located at the edge of Captains Bay and the existing rock production face is within 100 yards of a barge loading ramp. Water depths ranging from 30 to 50 feet deep were reported just offshore in Captains Bay. Barges with ramps have been loaded with crushed aggregate in the past, however it appeared a small amount of dredging may be required near shore to allow deep draft barges within a practical distance of the existing barge loading ramp.

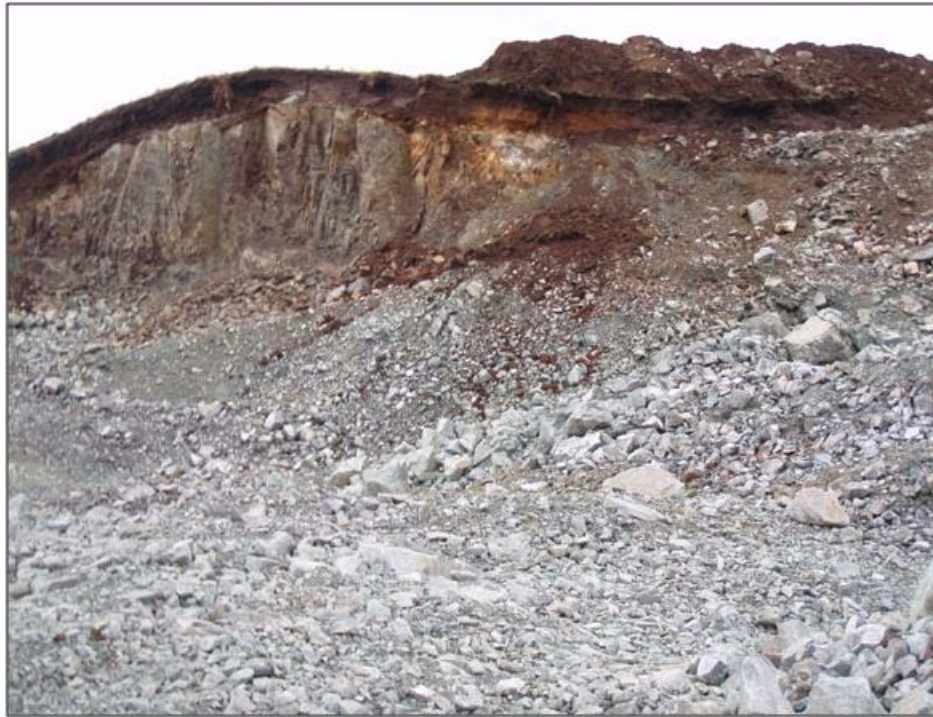
Figure C - 4. Bering Shai Quarry Production Face

Overburden at the quarry consisted of surface organics and silt ranging in depths of four feet within the higher elevations and eight feet or thicker in the smaller drainage gullies. The overburden currently has no economic value and is considered waste material. The rock exposed in the production face of the quarry appears to be from an igneous source and most likely consists of diorite. Limited portions of unweathered rock exposure were visible within the existing production face. The quarry is in the initial stages of development with very little rock production faces exposed. It was reported that only six production shots ranging in volume from 5,000 to 10,000 cubic yards have been blasted. According to Mr. Shaishnikoff the quantity of material reserves was unknown. Overall, the exposed faces of rock were fractured, however, Mr. Shaishnikoff expressed that the rock joint spacing and overall quality has improved as the production face has advanced into the hillside. Figure C - 4 provides a view of the production face during our site visit.

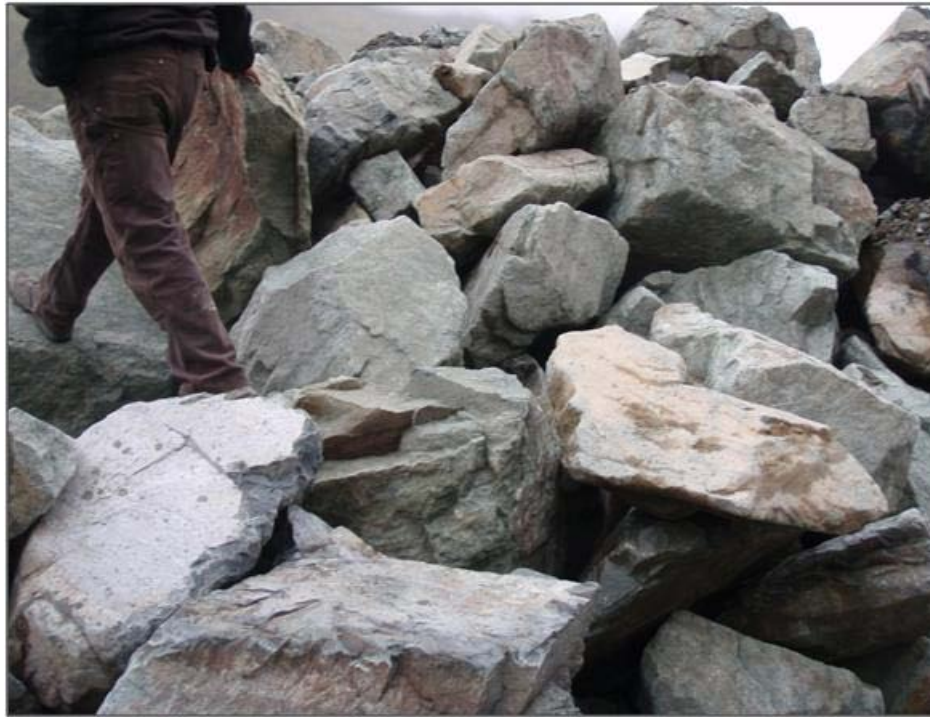
Figure C - 5. Stockpile of Large Stone Consisting of Two-Foot to Five-Foot Diameter Boulders

The joint and fracture spacing of the existing rock exposures ranged from approximately six inches to about three feet. A small stockpile of large stone consisting of two-foot to five-foot diameter boulders were seen in the quarry staging area. An example of these stones can be seen in Figure C - 5. Mr. Shaishnikoff reported that all of the production blasting was designed to produce a two inch minus product after crushing and screening. So the power factors and blast hole layout were not conducive to producing large stone. If drilling and blasting were conducted with the intention of producing larger stone for shore protection, a higher yield of larger rock could be expected. USACE estimates that the Bering Shai Quarry has the potential to produce larger stone for future harbor and shore protection projects if rock quality test results are acceptable.

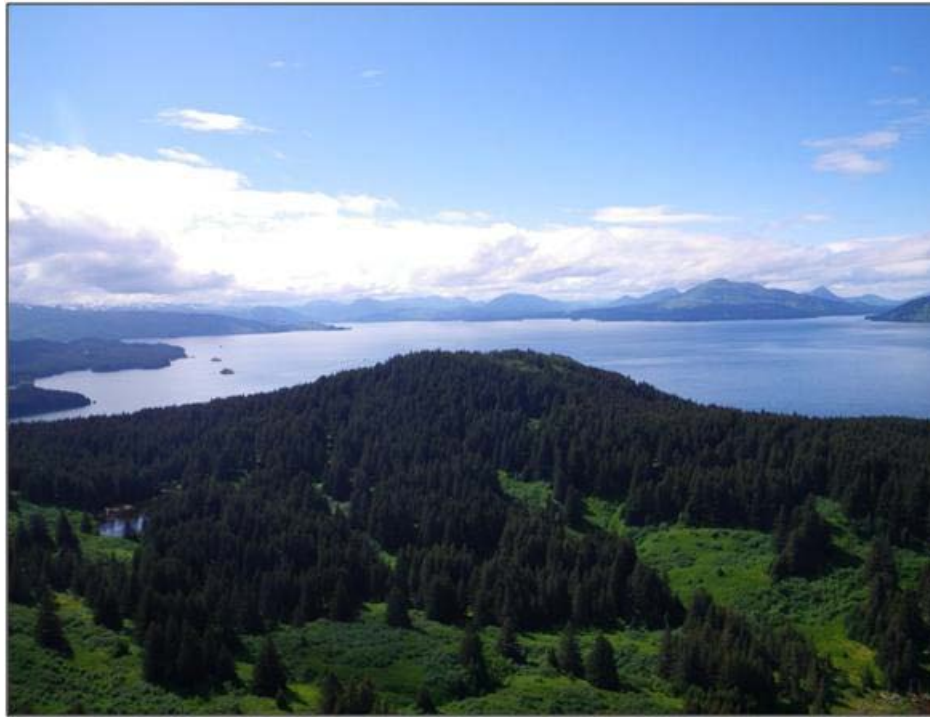
Figure C - 7. Northward View from a High Knob Overlooking the Proposed Material Source Development Area

The Shakmanof Cove potential material source is undeveloped and located on the north side of Kodiak Island near Kizhuyak Point between Anton Larsen Bay and Shakmanof Cove. A Location and Vicinity Map of the approximate area proposed for development is shown in Figure C - 6. The Ouzinkie Native Corporation and Koniag Incorporated have ownership of the land. Currently the site is only accessed by boat or helicopter. The topography of the area from the beach is steep for the first 200 feet of elevation and then becomes more gradual to an elevation of 1000 feet along a ridge. Surface vegetation in the area consists of large spruce trees and dense brush. Figure C - 7 provides a northward view from a high knob overlooking the proposed material source development area. Shakmanof Cove is the body of water on the right side of the photograph.

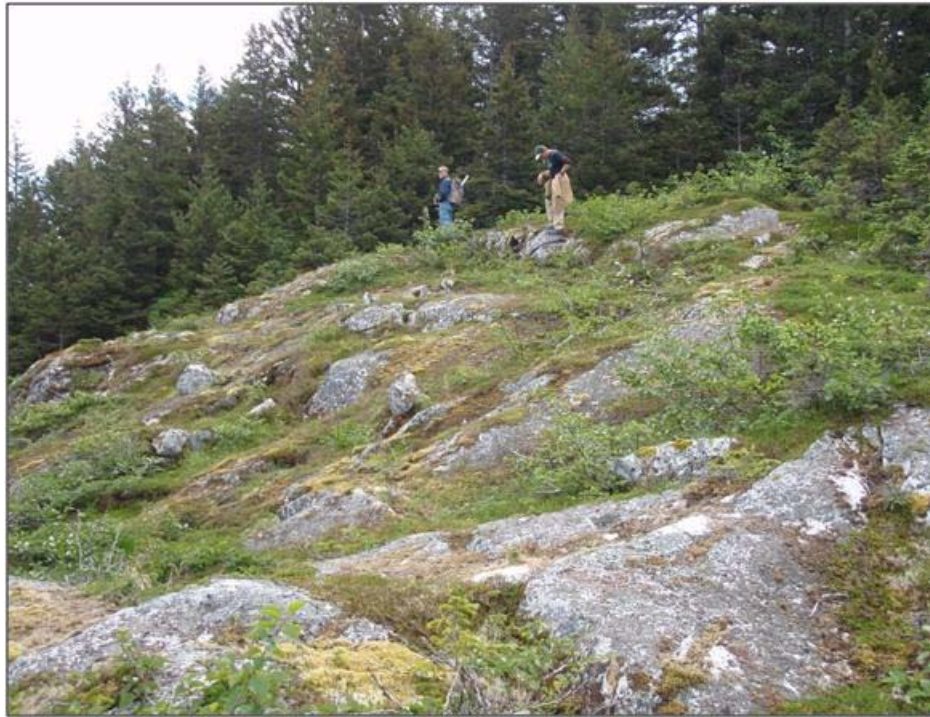
Figure C - 8. Vegetation of Exposed Rock at the Surface

Overburden at the site generally consisted of moss and vegetation overlying a layer of silt and volcanic ash. The thickness of the surface organics and fine grained soils was reported to range from two feet or less in high areas to twenty feet or greater in small valleys and gullies. A limited number of outcrops were viewed during our site visit because most of the rock was covered with a layer of moss and vegetation. Figure C - 8 provides a view of the vegetation and exposed rock at the surface. In the rock outcrops that were visible, joint sets had spacing ranging from approximately six inches to eight feet or larger. Visual examination of the granite showed it to be greenish gray to brownish gray, very strong, and generally free of cracks and deleterious material.

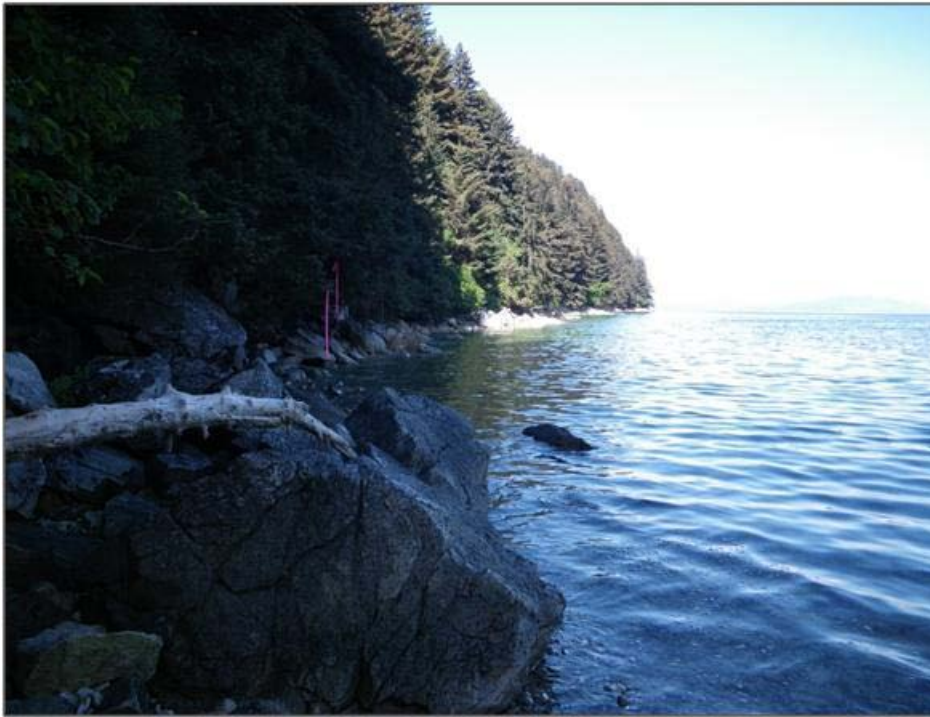
Figure C - 9. Northward View of the Shoreline on the West Side of Shakmanof Cove

Currently, Angayuk Construction is planning to construct an access road from Shakmanof Cove to higher elevations. The construction of this road would provide rock for coastal infrastructure needed for site access such as barge loading facilities and material staging areas. Drilling and blasting for construction of the road would also supplement the subsurface exploration and better define the material source. Figure C - 9 provides a northward view of the shoreline on the west side of Shakmanof Cove.

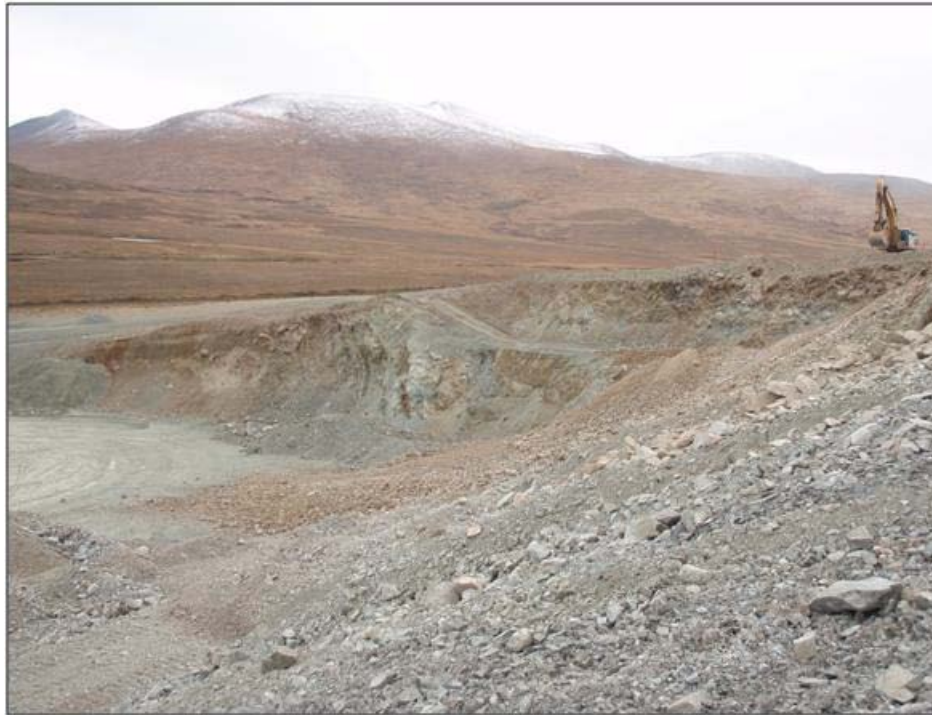
Figure C - 11. Southeastern View of the Platinum Quarry

The topography of the area around the quarry contains moderately steep hills and mountains with surface vegetation consisting of tundra and low brush along creek bottoms. Figure C - 11 provides a southeastern view of the quarry. Overburden at the quarry consists of a thin layer of surface organics overlying silt, sand, and gravel ranging in depths of two to six feet.

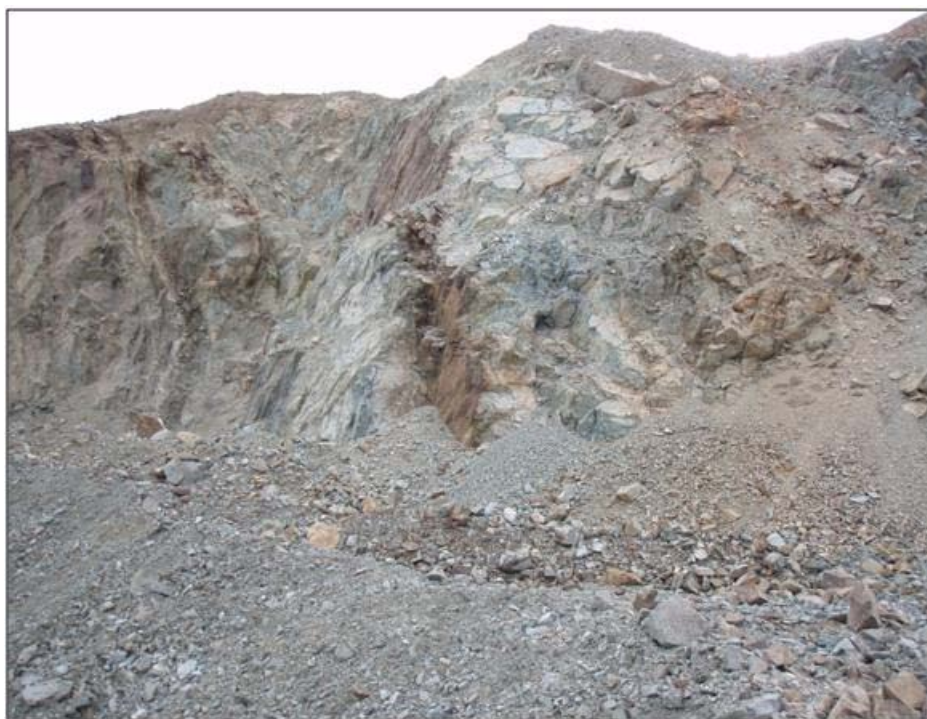
Figure C - 12. Working Face of Platinum Quarry

The metamorphic rock exposed in the production face of the quarry varies in quality with medium weak rock having a slightly weathered reddish brown color and strong to very strong rock having a greenish gray color. Cobble sized stones from the reddish brown colored areas could be fractured with a single firm blow of a geologic hammer. Overall the exposed faces of rock within the quarry were fractured. The discontinuity spacing ranged from less than six inches to about two feet. This can be attributed to the quarry normally producing aggregate products for roads and airfields. An example of the rock at the working face of the quarry can be seen in Figure C - 12.

In late 2004 Knik Construction submitted rock samples from the Platinum Quarry to the U.S. Army Engineer Research and Development Center (ERDC) for laboratory rock quality testing. The purpose of the testing was to determine the suitability of material from the Platinum Quarry for use as slope protection on future USACE projects. Results from the laboratory rock quality testing conducted by ERDC are provided in Table C - 6.

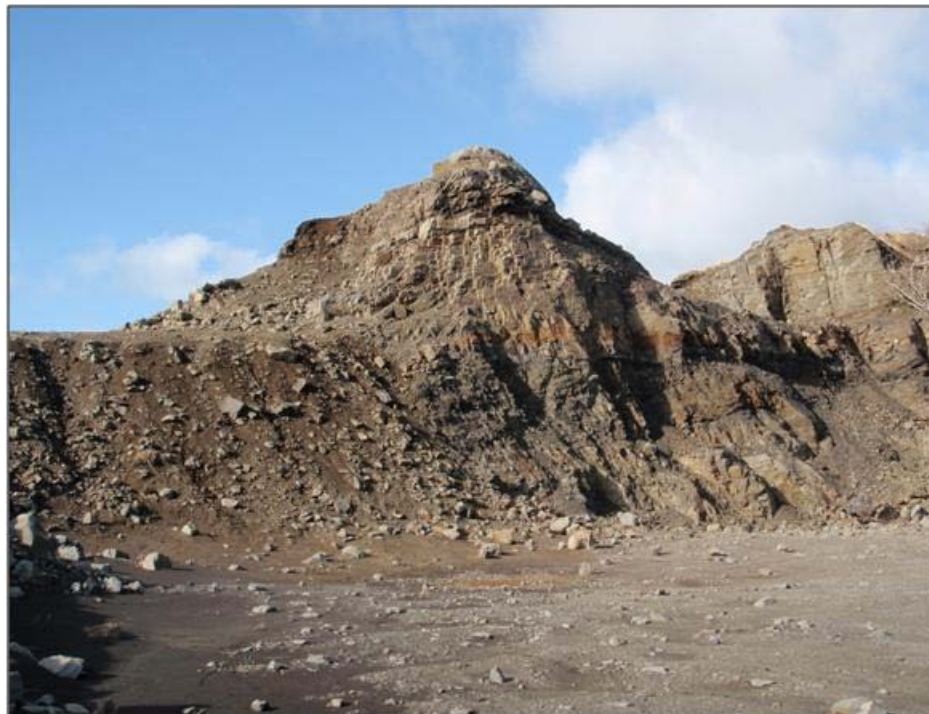
Figure C - 14. View of Existing Perryville Quarry Production Face

The Perryville Quarry is composed of a sedimentary sandstone and conglomerate rock. Varying degrees of rock quality were seen throughout the production face of the quarry. Bands of lower quality, friable rock were intermixed with better quality, intact rock. The conglomerate contained well rounded gravel sized particles cemented within the sandstone. The exposed rock was well fractured and displayed a joint pattern with bedding planes. Large

stones in excess of four feet in diameter were seen at the base of the quarry. Visible cracks and fissures were evident in all the large stones observed. These large stones were remnants of past quarry operations which provided material for construction of the Perryville Airport runway embankment. The quality of material from the Perryville Quarry did not meet the ADOT&PF's rock quality requirements for crushed aggregate surface course. Because of the poor material quality, crushed aggregate surface course material had to be imported by barge from another location. Figure C - 14 provides a view of the existing quarry production face.

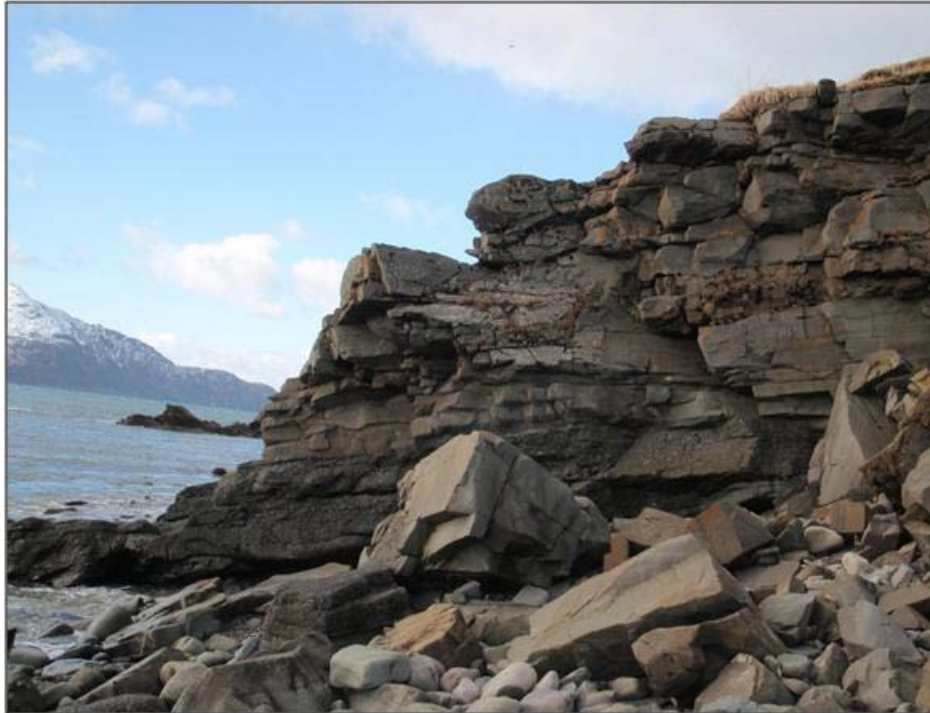
Figure C - 15. Sandstone and Conglomerate at Three Star Point

The four rock outcrops appeared to be composed of the same sandstone and conglomerate rock as the existing quarry. The gravel particles observed in the conglomerate were generally two inch minus in size. The rock outcrop at Three Star Point exhibited distinctly different bands of rock. Larger boulder sized stones located at the base of this outcrop were highly fractured. Figure C - 15 provides a view of the sandstone and conglomerate at Three Star Point. The rock outcrop located northwest of the Perryville Runway appeared to be of the highest quality of the four outcrops visited. Large stones with diameters greater than four feet were observed along the base of this outcrop. However, bands of lower quality rock were also observed within the face. The rock outcrop located east of the Perryville tsunami shelter had an orange-to-red pigmentation. The rock outcrop located east of Perryville was highly fractured and bedding layers from its deposit were still evident. USACE estimates that the sandstone and conglomerate rock available at the Perryville Quarry and surrounding rock

outcrops would not produce suitable quality or quantity large stone for the construction of harbor or shore protection projects.

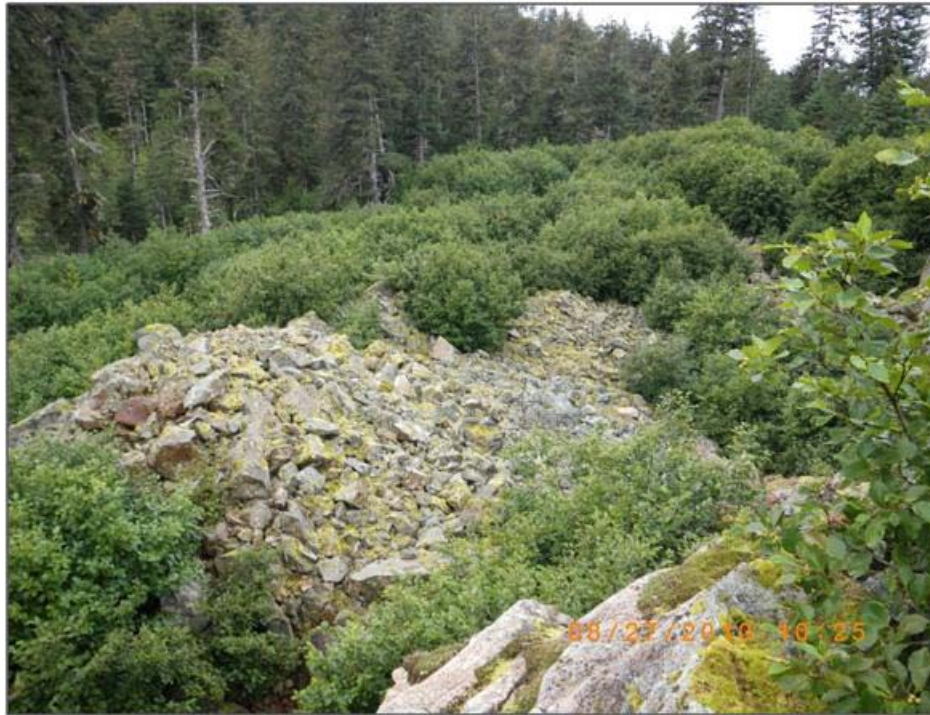
Figure C - 17. Rubble Pile of Rock and Overgrown Staging Area at the Flat Island Quarry

The quarry was initially developed to provide a material source for the construction of logging roads. The topography of the undeveloped area of the quarry is steep. Surface vegetation in the area consists of large spruce trees and dense brush. Alders and dense brush have started to overgrow the staging area and rubble piles of rock left from past construction activity. Figure C - 17 provides a view of the overgrown staging area.

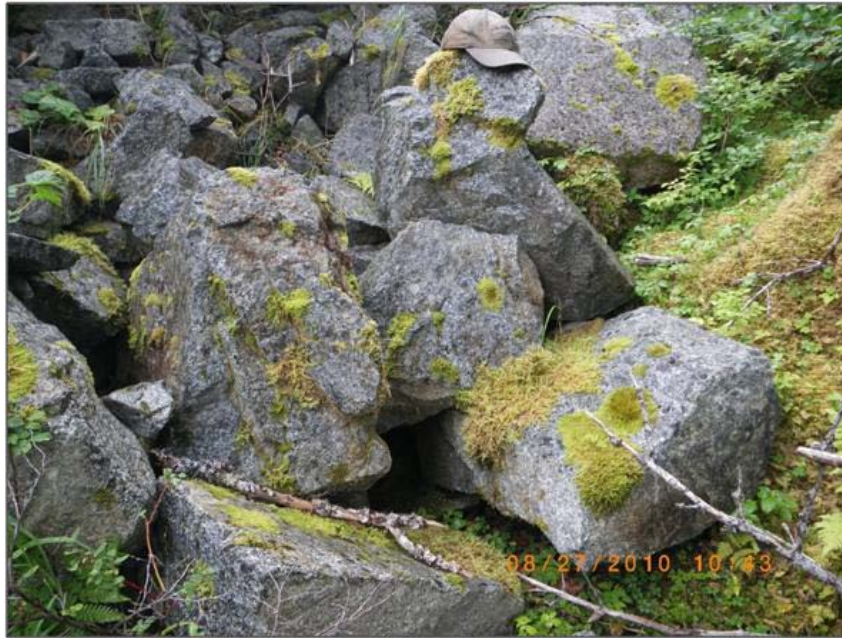
Figure C - 18. Example of Granite Rock Seen in Staging Area at the Flat Island Quarry

The rock exposed in the production face of the quarry appears to be from an igneous source and is most likely granite. Overall, the exposed faces of rock were fractured from blasting. The joint spacing of the existing rock exposures ranged from approximately one to about four feet. Small stockpiles of large stones weighing between 4,000 and 8,000 pounds were frequently encountered within the staging area and along the production faces of the quarry. Visual examination of the granite showed it to be strong and competent. An example of the granite can be seen in Figure C - 18.

Rock quality test results from the English Bay Corporation are provided in Table C - 7. The Flat Island Quarry has the potential to produce an acceptable product for the construction of harbors and shore protection projects if additional rock quality test results are acceptable.

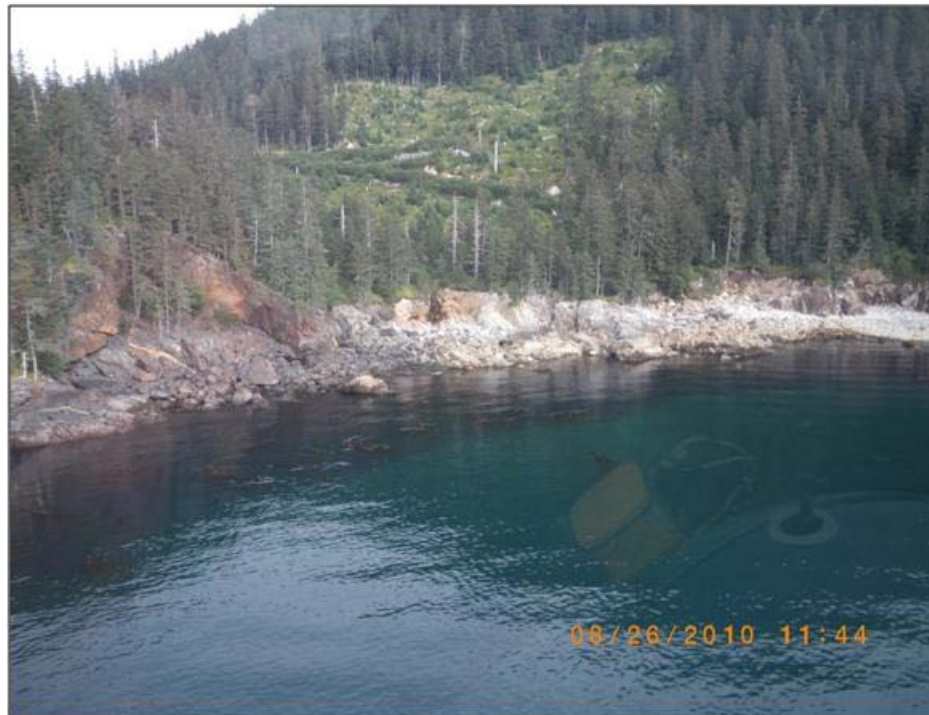
Figure C - 20. View of the Beach References as Chug1

Figure C - 20 provides a view of the beach referenced as Chug1 in the Chugach Alaska Corporation Report. The light grey rock was mapped as granodiorite and the darker rock which bounds both sides of the intrusive rock was mapped as metasediments, primarily black carbonaceous argillites. Rock outcrops that were visible from the beach had joint set spacings and fractures ranging from approximately two inches to about four feet. Visual examination of the granodiorite showed it to be light gray and very strong. We do agree with the assessment that granodiorite rock exposed at the Chug1 beach has potential to produce large stone for the construction of harbors and shore protection projects. Boulders on the beach were generally subrounded to well rounded indicating they had been exposed to wave action for an extended period of time. Most boulders weighed between an estimated 2,000 to 16,000 pounds with a majority between an estimated weight of 4,000 and 6,000 pounds. Figure C - 21 provides a view of rock outcrops on the beach at Chug1.

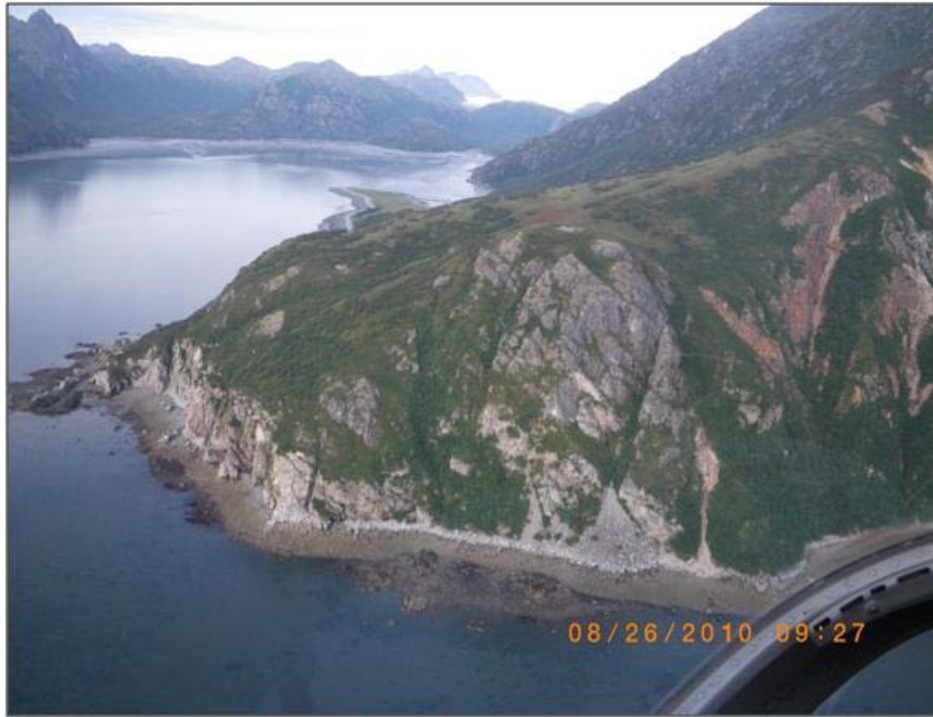
Figure C - 23. Western View of Diamond Point with Cottonwood Bay in the Background

The Diamond Point potential material source is undeveloped and located in Iliamna Bay, northeast of Cottonwood Bay. A Location and Vicinity Map of the approximate area proposed for development is shown in Figure C - 22. Diamond Point, LLC owns approximately 30 acres of undeveloped land containing an estimated 15 million cubic yards of material. Currently, the site is only accessed by boat, airplane, or helicopter. The topography of the area from the beach is steep with rock cliffs and surface vegetation at higher elevations consisting of alders and dense brush. It was noted during a fly-over of the area that numerous rock outcrops exist at higher elevations of the proposed material source and it is believed that excavation and removal of overburden would be minimal. Figure C - 23 provides a western view of Diamond Point with Cottonwood Bay in the background.

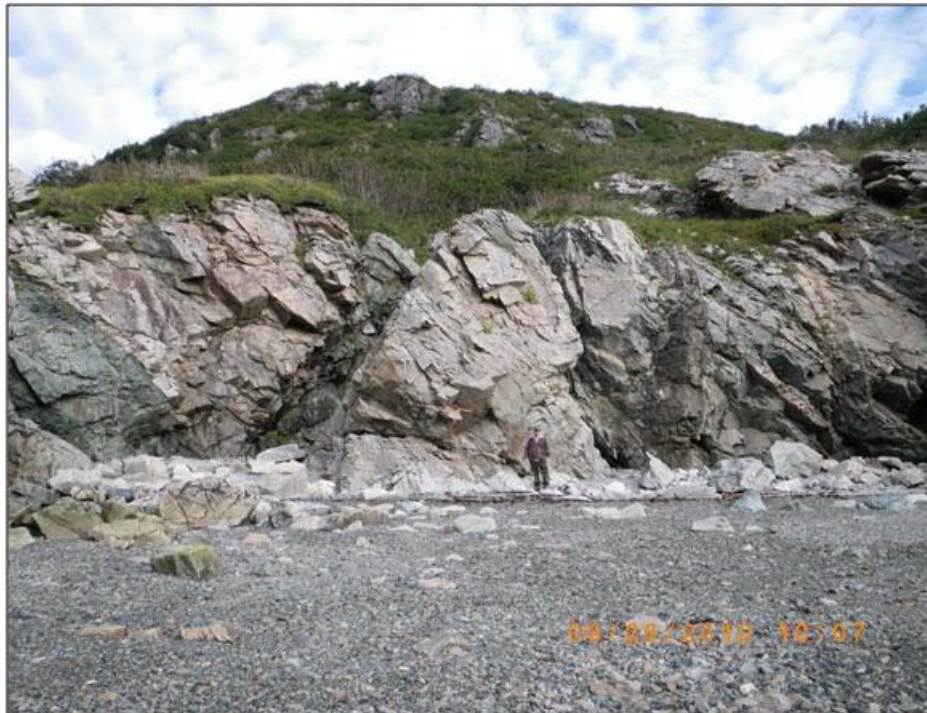
Figure C - 24. Rock Cliffs Viewed from the Beach at Diamond Point

Additional characterization of the proposed Diamond Point material source, including rock quality testing and detailed geologic mapping, would be required to evaluate the feasibility of any material source development in the area. USACE estimates that rock from Diamond Point would most likely produce an acceptable product for the construction of harbors and shore protection projects if rock quality test results show the source to be acceptable.

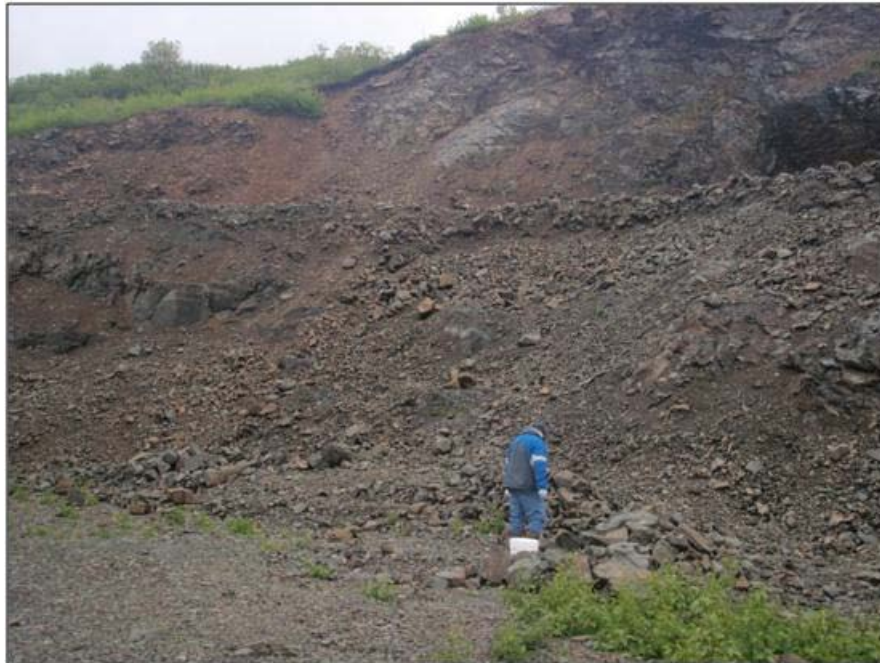
Figure C - 26. Snake Lake Quarry Production Face

The topography of the area around the quarry contains moderately steep hills and mountains with surface vegetation at the higher elevations consisting of tundra, low brush, and alders. Figure C - 26 provides a view of the production face of the quarry. Overburden at the quarry consists of a layer of surface organics overlying fine grain soils ranging in depths from six inches to about two feet. The rock exposed in the production face of the quarry appears to be sedimentary and is most likely Greywacke. Overall, the exposed faces of rock were fractured from blasting. The joint and fracture spacing of the existing rock exposures ranged from approximately six inches to about two feet. The largest stone seen in the staging area and along the production faces of the quarry weighed between an estimated 125 to 600 pounds. Visual examination of the rock showed it to be strong and competent. An example of the rock is presented in Figure C - 27.

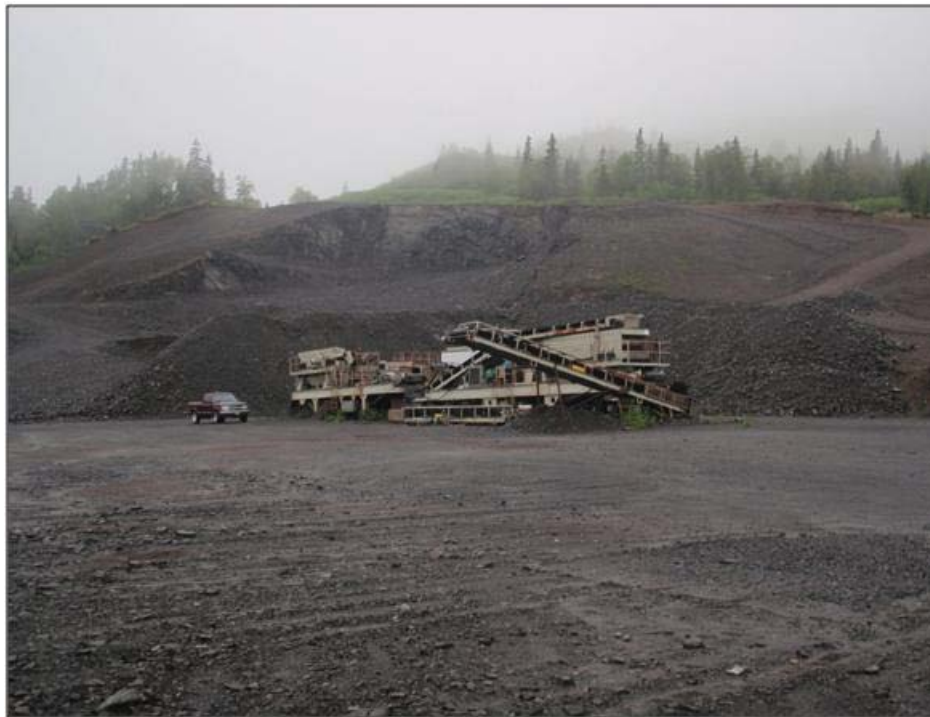
Figure C - 28. View of Ekuk Quarry Production Face, Crusher, and Screens

The rock exposed in the production face of the quarry appears to be from a sedimentary source and is most likely Greywacke. Overall, the exposed faces of rock were fractured from blasting. The joint and fracture spacing of the existing rock exposures ranged from approximately six inches to about four feet. Visual examination of the Greywacke showed it to be strong and competent and an example of the rock is presented in Figure C - 29.

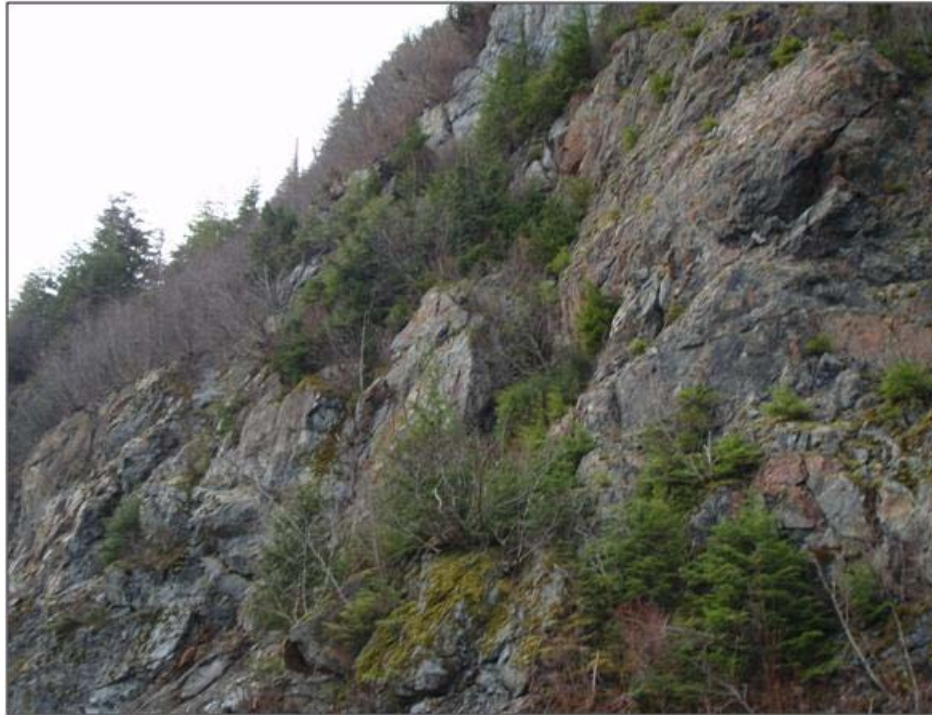
Figure C - 31. Existing Rock Ledge Adjacent to the Sitka Highway

A potential material source exists along the Sitka Highway in Sawmill Cove about 4.5 miles east of the community of Sitka and just west of the old pulp mill. It has been reported that the Alaska Department of Transportation may soon develop the existing rock exposure adjacent to the Sitka Highway into a material source for local projects. A Location and Vicinity Map of the potential material source is shown in Figure C - 30 and Figure C - 31 provides a view of the existing rock ledge.
