ALASKA BASELINE EROSION ASSESSMENT

Erosion Information Paper - Chignik Lake, Alaska

Current as of March 10, 2009

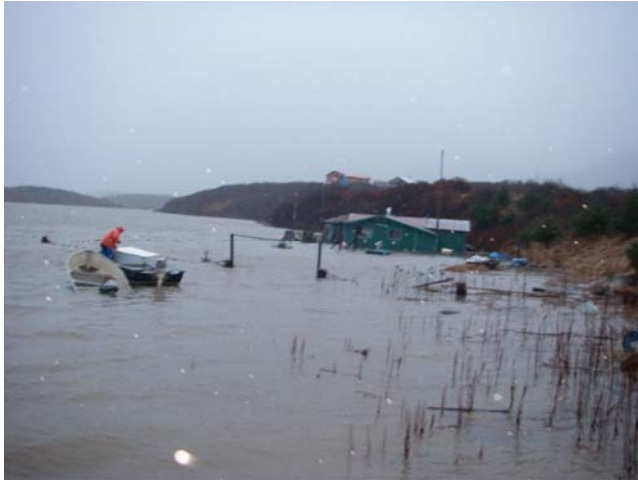
**Photo 1: Chignik Lake flooding in November & December 2007.
Photo taken on December 1, 2007.**

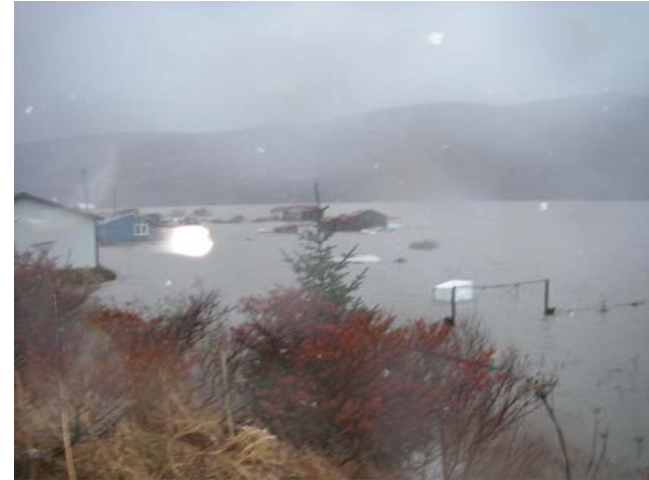
Photo 2: High water levels then freeze-up prevented an assessment of erosion and other damage until spring. Photo taken on December 1, 2007.

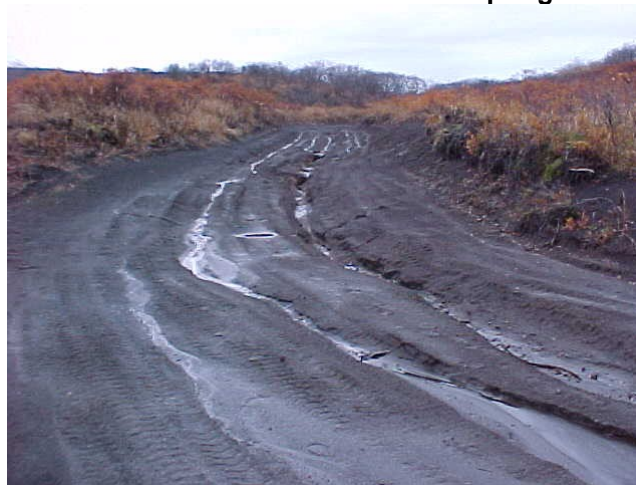
**Photo 3: Erosion damage to the road out of Chignik Lake.
Photo taken on November 5, 2002.**

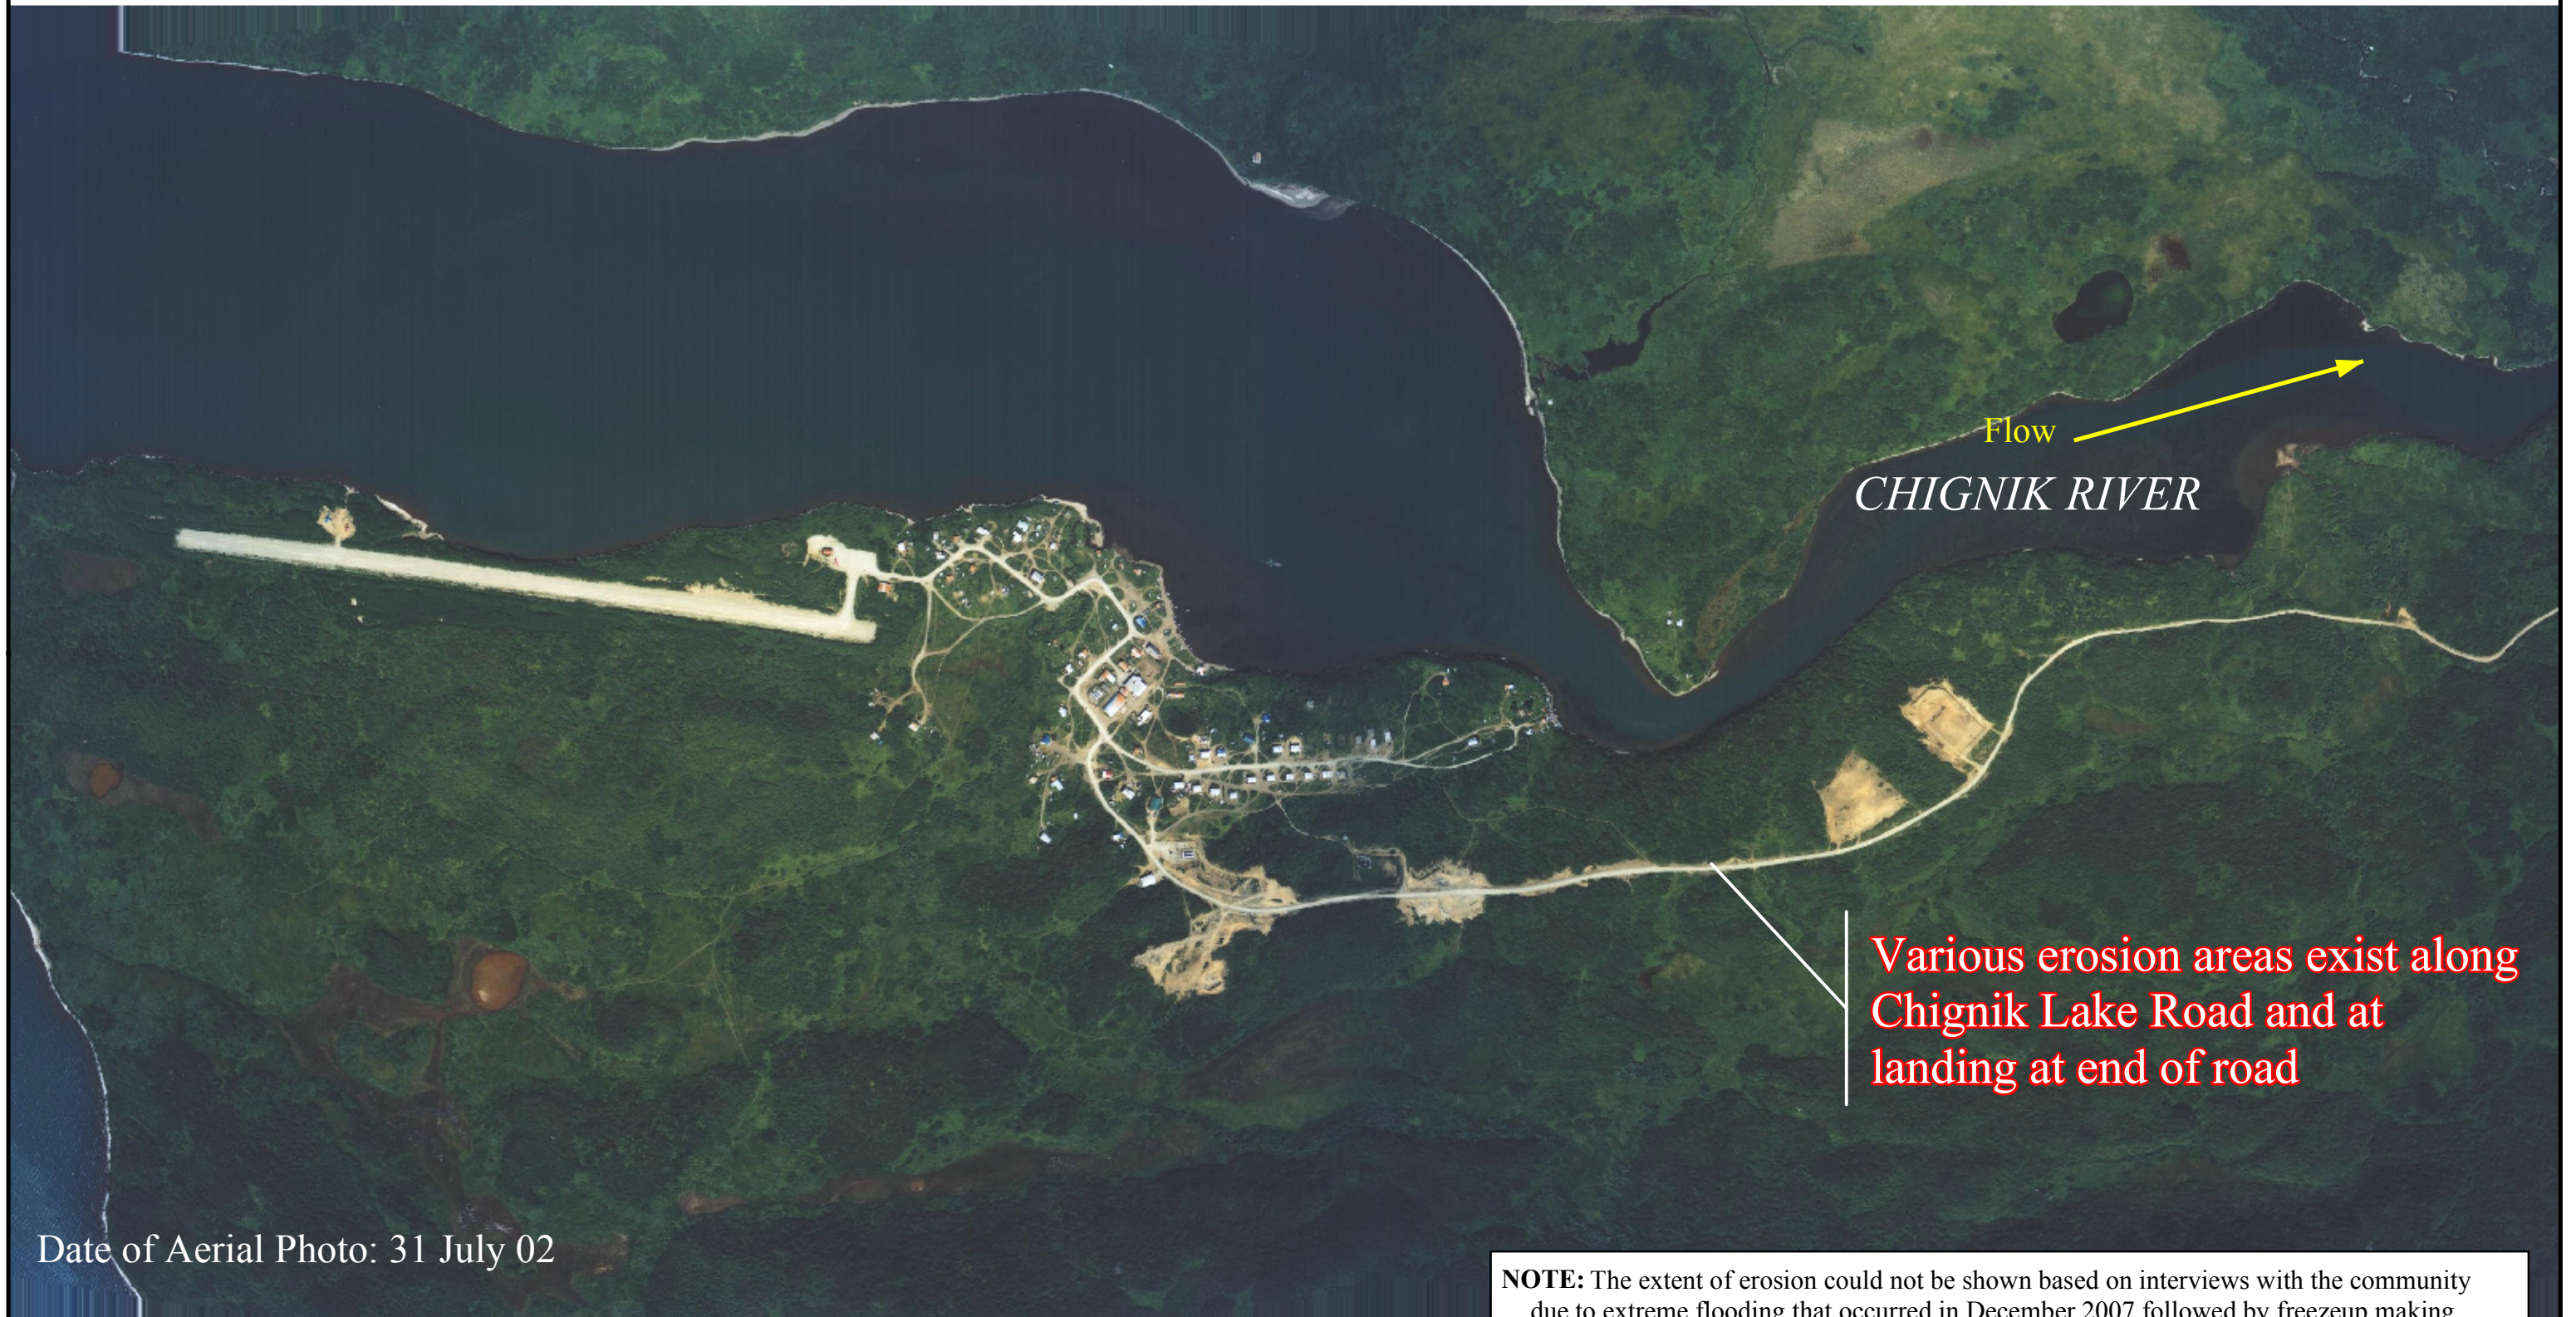
Alaska Baseline Erosion
Chignik Lake, Alaska

NOTE: The extent of erosion could not be shown based on interviews with the community due to extreme flooding that occurred in December 2007 followed by freezeup making identification of erosion impossible until spring 2008.
