**Community Erosion Assessment
Shaktoolik, Alaska
11 March 2009**

1. Community: Shaktoolik, Alaska

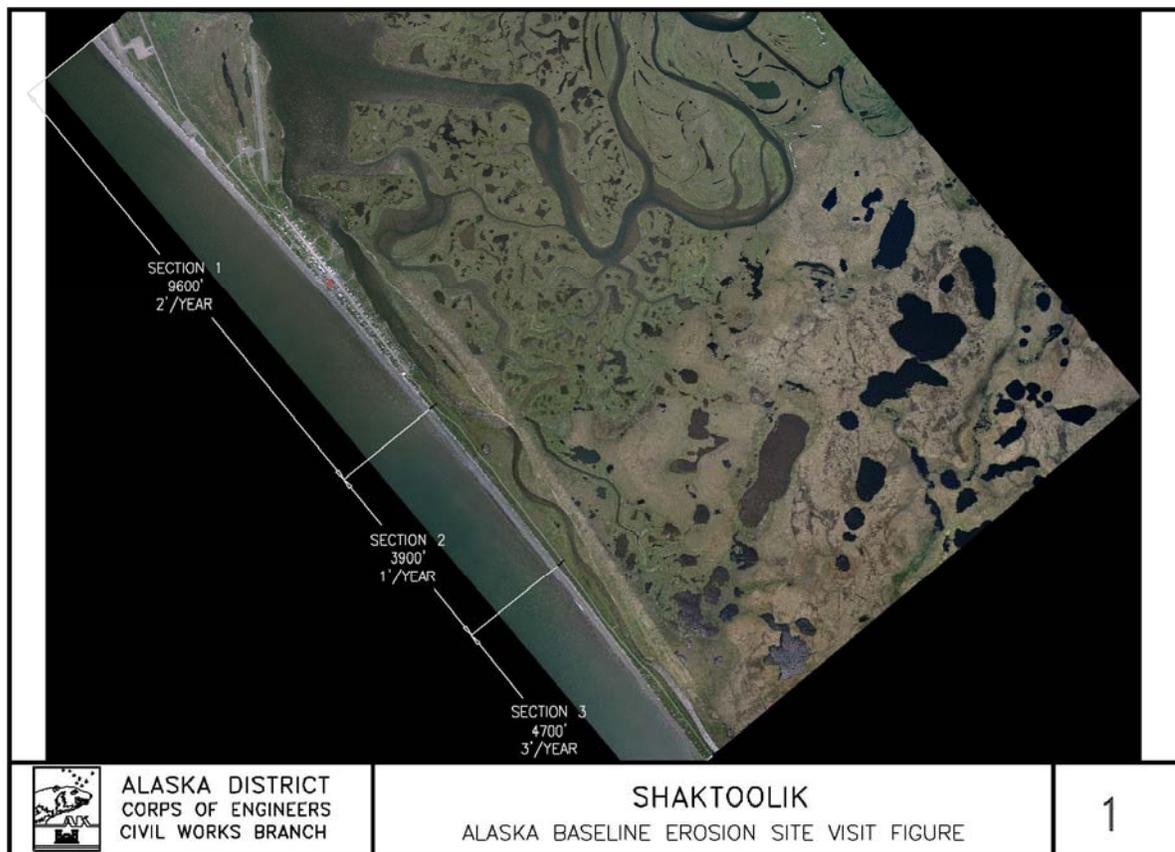
Figure 2. Shaktoolik Erosion Map

For this study the area was divided into three reaches. Reach 1 is a 9,600-foot portion of coastline that fronts the community and is eroding at a rate of 2.0 feet per year. Reach 2 is a 3,900-foot portion of coastline south of Reach 1 and is eroding at a rate of 1 foot per year. Reach 3 is a 4,700-foot portion of coastline south of Reach 2 and is eroding at 3.0 feet per year.

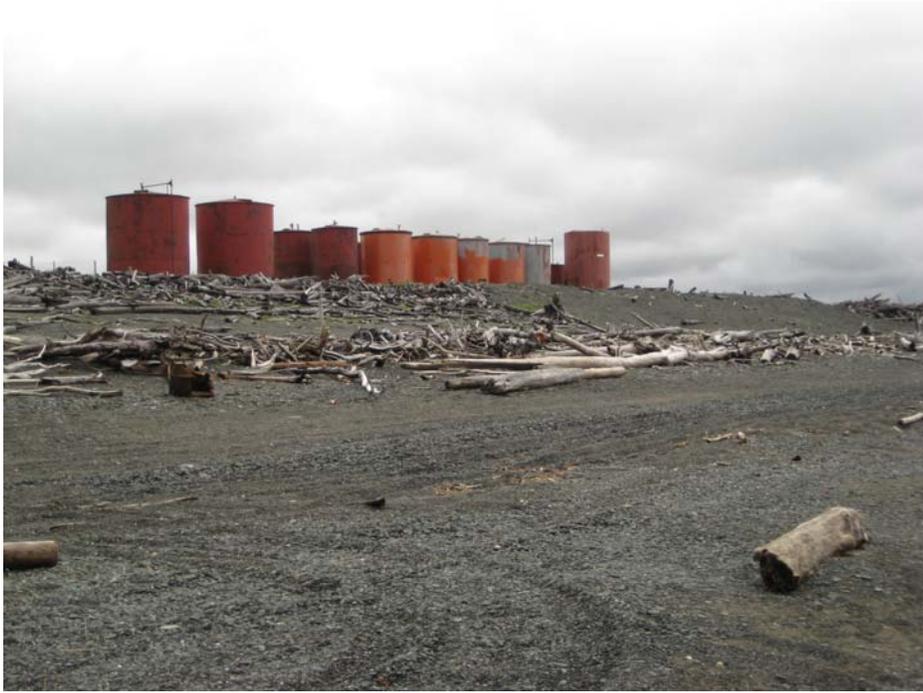
Photo 1: Shaktoolik tank farm threatened by wave-driven driftwood and erosion

The tank farm on the south side of town and the retail store located nearby will be lost prior to year 10. Three other commercial outbuildings will be lost in years 40-50. Our estimates likely understate the commercial damages. Were these structures to be lost, it would compromise the income earning opportunities for the businesses and the residents they employ. It is expected that relocation efforts would impact these facilities as well.

Environmental concerns in Shaktoolik include damage to two fuel farms, sewage spillage, and loss of fresh water source. The tanks located in both farms are still in use. The surrounding soils may be contaminated and will pose a threat to the local ecosystem and related fish stocks when eroded away. Decommission and closure of the facility is essential to avoid these harmful effects. Based on the above assumptions, the south tank farm will need decommissioning in the next ten years and the north tank farm will need decommissioning in the 11 to 30-year timeframe. Utilizing values from previous studies, including the Shishmaref Relocation Study, it is estimated that these processes have a combined cost of \$2.3 million with a net present value of \$1.3 million and an average annual cost is \$68,500.

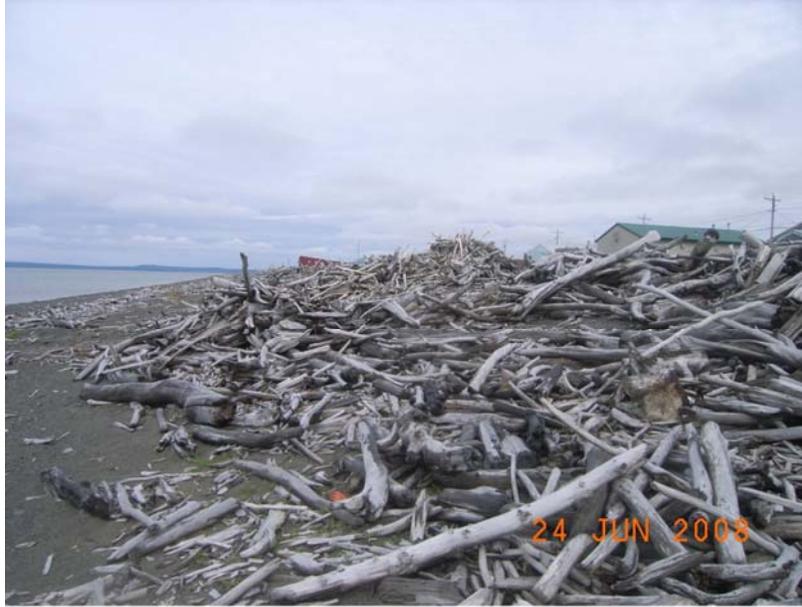
Photo 2: Woody debris piles exceed 6 feet in height near the community

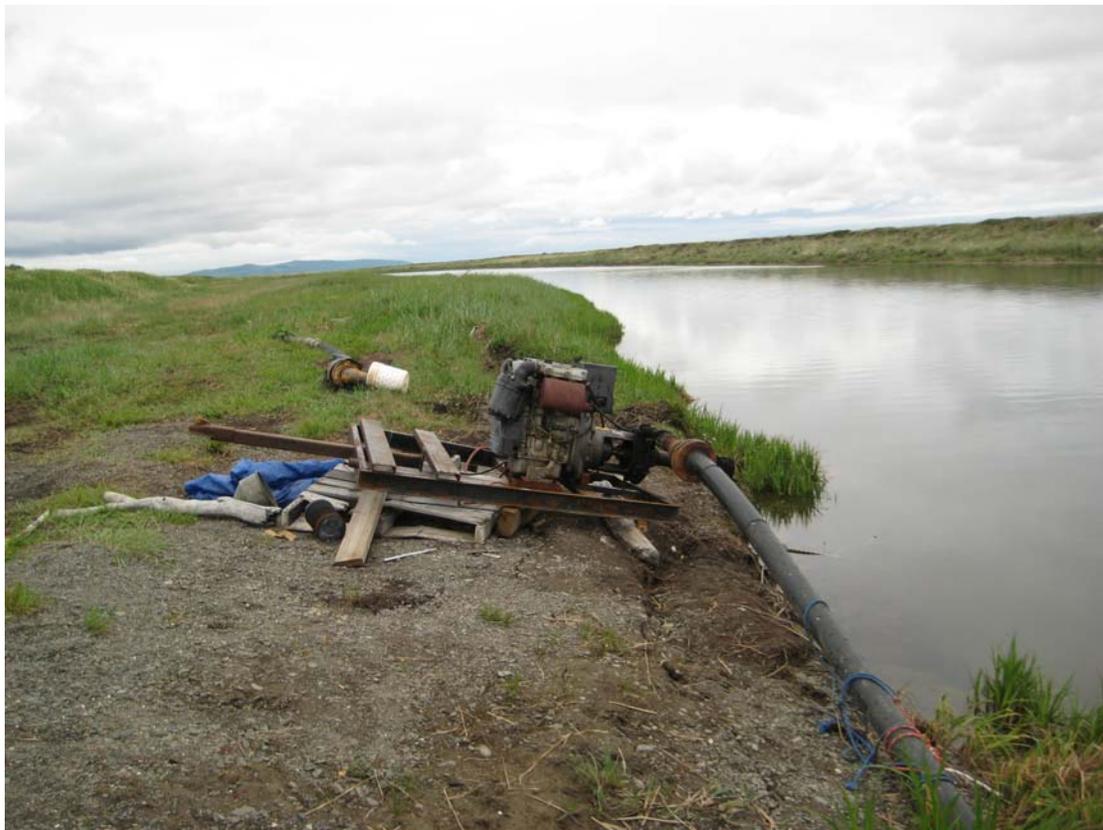
Photo 3: Shaktoolik Water Intake Structure

Non-structural solutions include relocation of threatened buildings and infrastructure, specifically the threatened fresh water intake; construction of an evacuation route to give the community access to refuge during storm events, and village relocation. As costs of village relocation may be prohibitive and a consortium of entities including the State of Alaska, the Denali Commission, and Kawerak Corporation are working to construct an evacuation route the most feasible non-structural solution is relocation of the fresh water intake.

Structural solutions include: constructing a 4,500-foot revetment that would protect the entire community at a cost of \$29.2 million or approximately \$6,500 per linear foot, constructing a 3,350-foot revetment to protect the community's fresh water intake at a cost of \$18.6 million or approximately \$5,600 per linear foot, constructing a groin field to trap sand that is migrating parallel to the shore, causing accretion on the beach itself at a cost of \$30.8 million, and conducting beach nourishment at a cost of \$36.5 million.

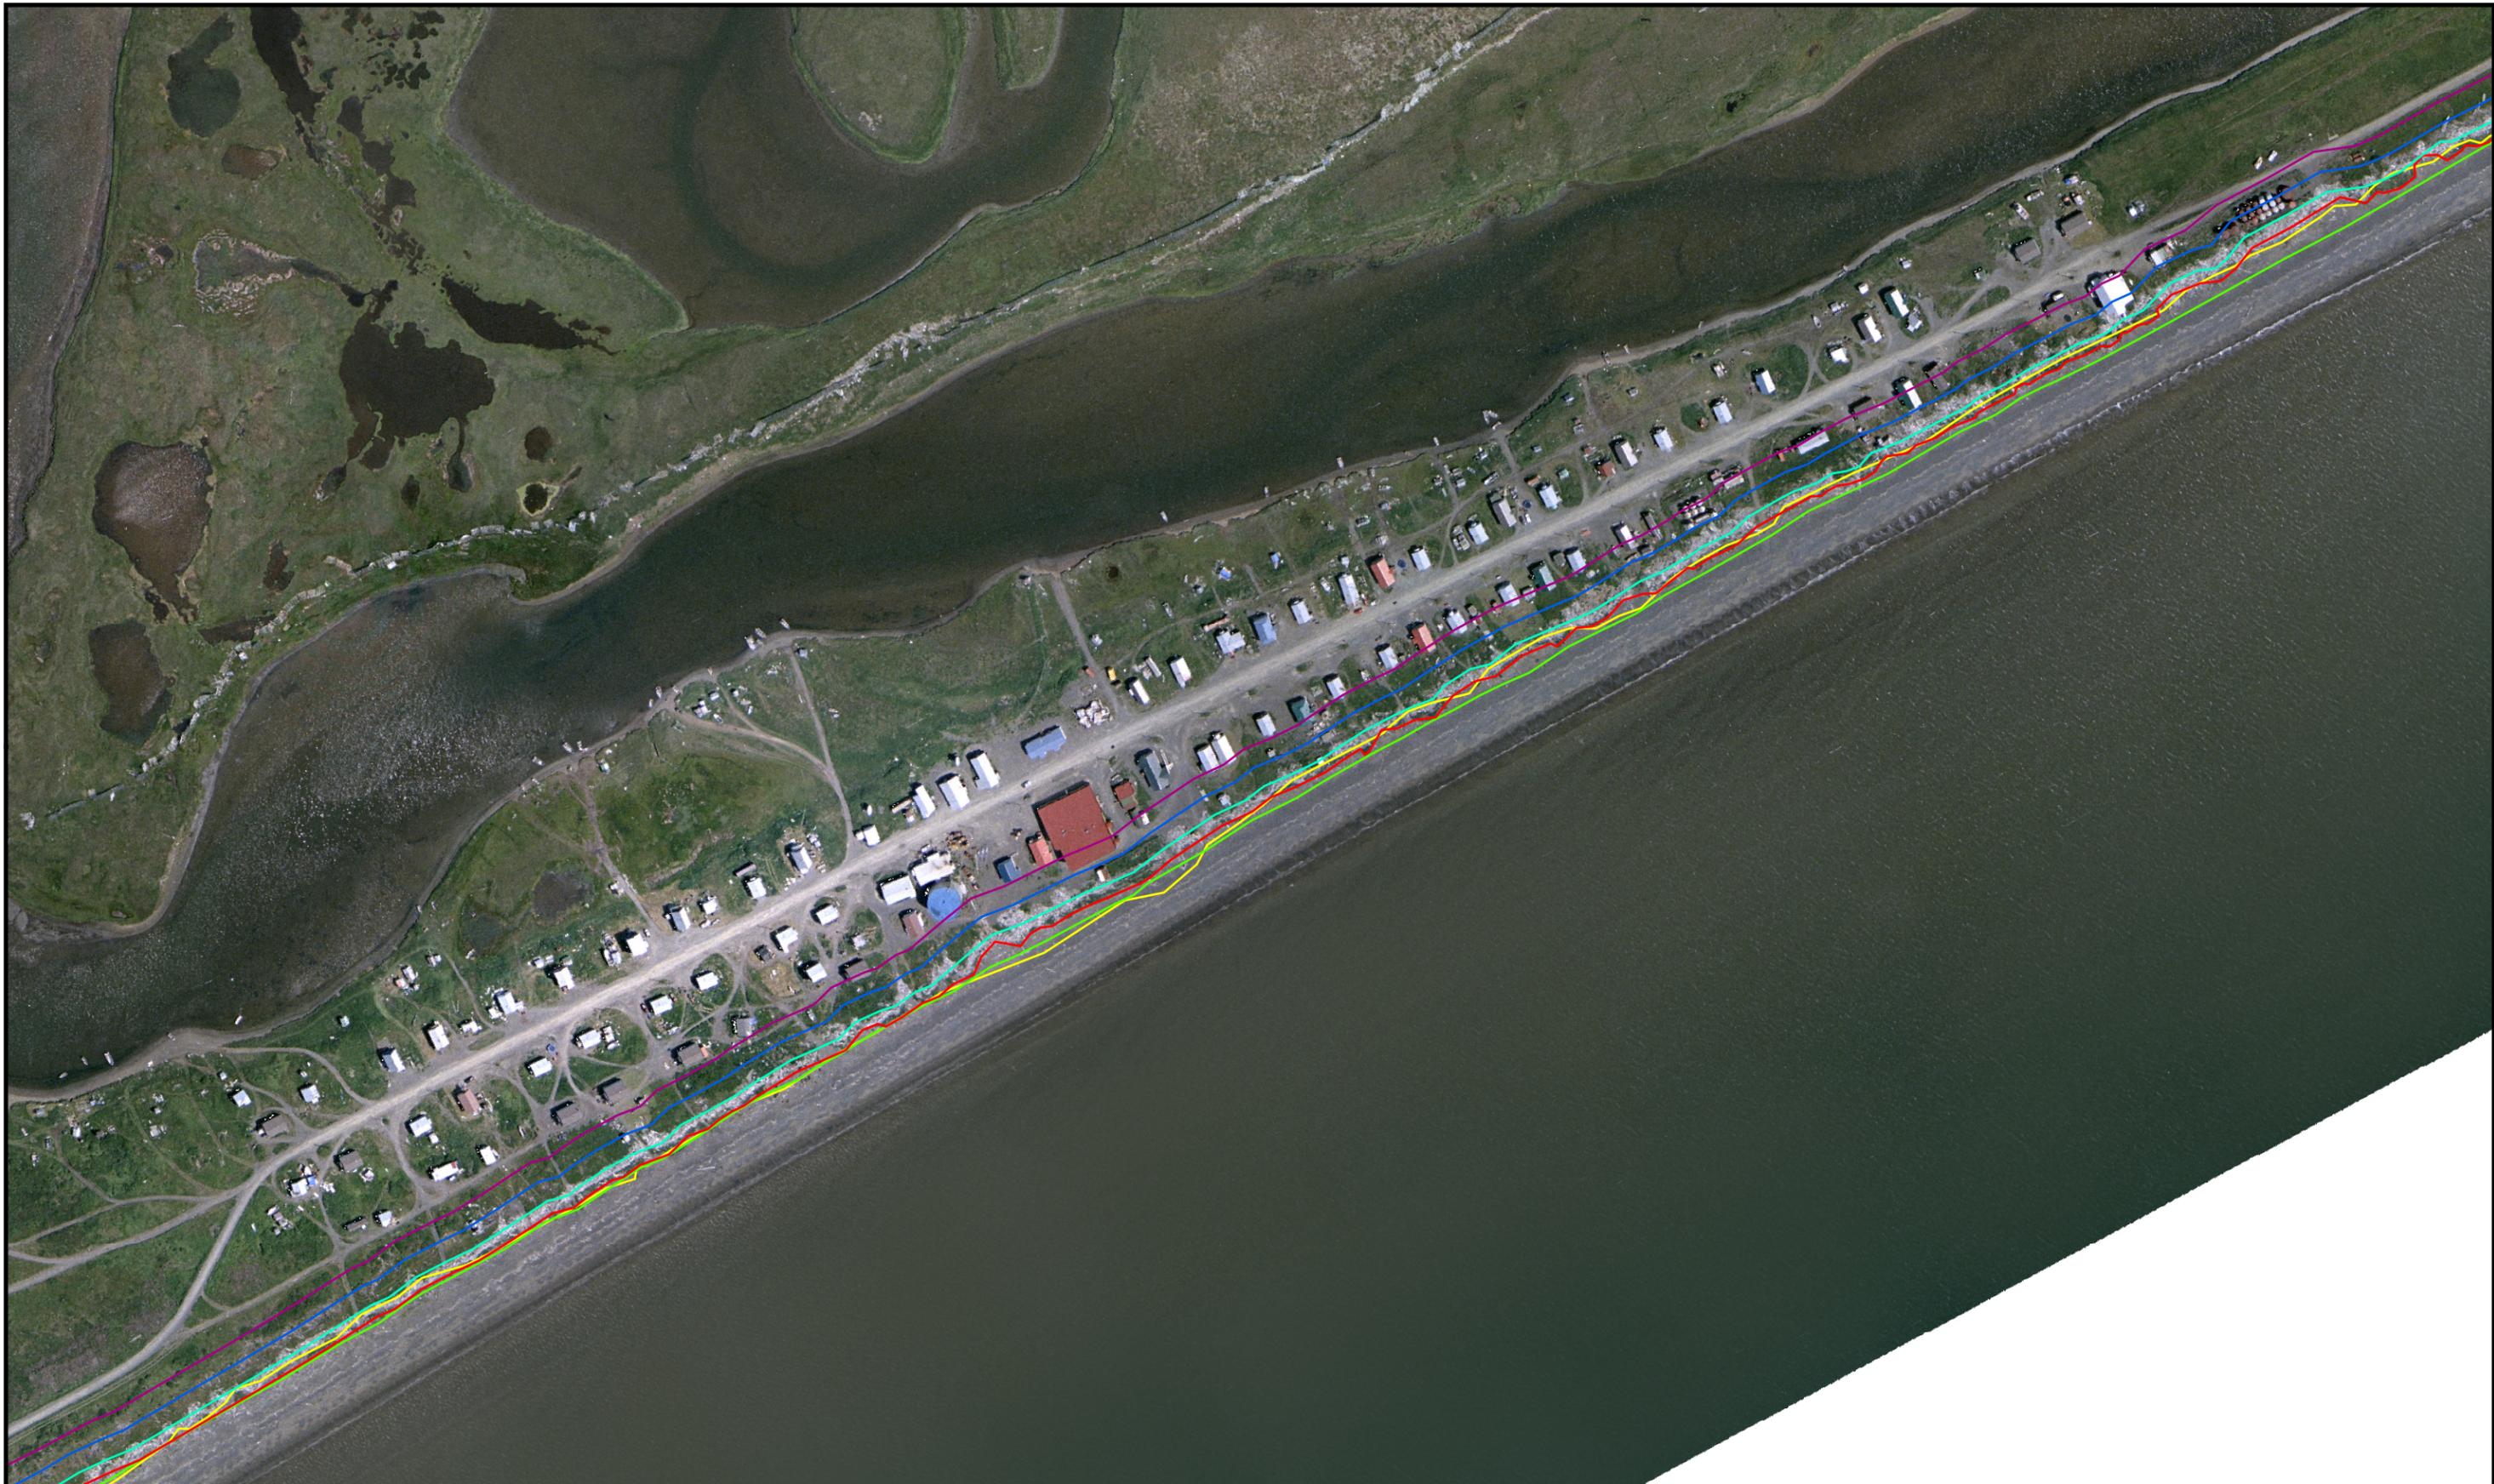
<p>Alaska District Corps of Engineers Civil Works Branch</p>	<p>Predicted and Historical Shorelines</p> <p>Legend</p> <table border="0"> <tr> <td></td> <td>1980</td> <td></td> <td>2004</td> <td></td> <td>2037</td> </tr> <tr> <td></td> <td>1994</td> <td></td> <td>2017</td> <td></td> <td>2057</td> </tr> </table>		1980		2004		2037		1994		2017		2057		<p>0 190 380 760 Feet</p> <p>0 55 110 220 Meters</p> <p>1 inch equals 300 feet Image dated June 2004</p>	<p>Alaska Baseline Erosion Shaktolik, Alaska</p>	
	1980		2004		2037													
	1994		2017		2057
